All Seasons Arena Facility Assessment

Mankato, MN

The City of Mankato (the City) retained ISG to perform this facility assessment in connection with assessing existing conditions of All Seasons Arena, located at 1251 Monks Avenue, Mankato, Minnesota. It is ISG's understanding that the primary interest of the City is to locate and evaluate materials and building system deficiencies that might significantly impact the Arena's useful lifespan and continued operations. The conclusions and recommendations presented in this report are based on the review of the plans and records made available to Kevin Hildebrandt, CPE, CPS, and observations made during the walk-through site visit conducted on June 13, 2022, and ISG's experience with similar facilities.

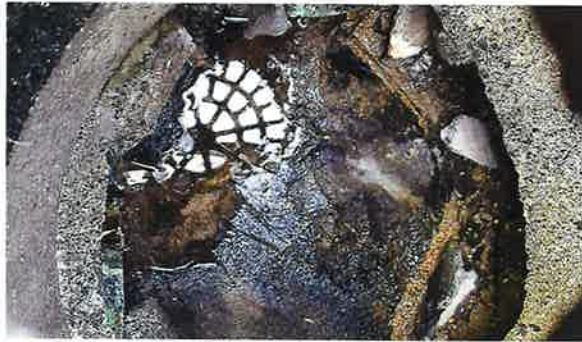
South Catch Basin - East Parking Lot

Sub Category	Element/Location	Condition	Priority	Details	Recommendations	Estimated Cost
Drainage	North Catch Basin/ East Parking Lot	Good	2	There is sediment buildup in the bottom of the catch basin.	Remove sediment.	\$670
Drainage	South Catch Basin/ East Parking Lot	Poor	1	There is sediment buildup in the bottom of the catch basin. Concrete has broken off the catch basin and is visible in the bottom of the basin.	Remove and replace catch basin.	\$6,700
Drainage	Southeast Catch Basin/ West Parking Lot	Good	2	There is sediment buildup in the bottom of the catch basin.	Remove sediment.	\$670
Grounds Turf	Turf Area/South	Fair	2	The ground adjacent to the foundation is sloped. Gutter drainage flows back towards the building and does not meet building code drainage requirements.	Regrade turf areas to provide drainage away from the building.	\$6,000
Vehicle Routes	Entrance Apron	Poor	1	Entrance apron has a steep grade that exceeds 14.5%, and shows signs of vehicles bottoming out.	Remove apron and regrade parking lot.	\$11,200

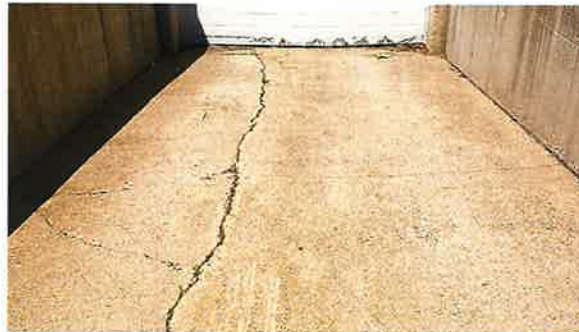
Vehicle Ramp - East Parking Lot

Vehicle Routes	Vehicle Ramp/ East Parking Lot	Poor	1	The concrete is extensive cracked, and there is no exterior drain to collect stormwater.	Remove and replace concrete pavement. Install trench drain and connect to existing storm sewer.	\$13,300
Vehicle Routes	ADA Accessible Stalls/ East Parking Lot	Poor	1	The accessible parking stall slopes are too steep and do not meet ADA Standards.	Regrade parking stalls to meet ADA standards.	\$2,700
Vehicle Routes	East Parking Lot	Poor	1	Northeast corner of parking lot drainage has no outlet so it ponds and overland flows to apartment complex drive or catch basin to the west. The parking lot has extensive cracking and pot holes.	Perform a full depth parking lot reconstruction.	\$357,000

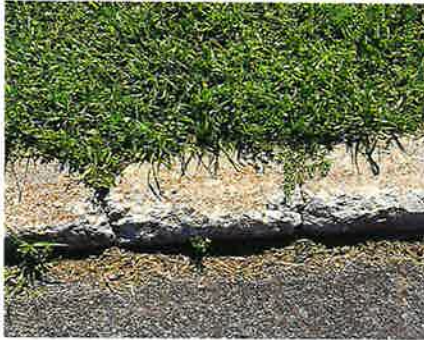
Curb - East Parking Lot

Sub Category	Element/Location	Condition	Priority	Details	Recommendations	Estimated Cost
Vehicle Routes	Curb/East Parking Lot	Poor	1	The curb is extensively cracked.	Remove and replace curb.	\$26,000
Vehicle Routes	Curb/West Parking Lot	Good	2	Curb and gutter have minor chips and cracking from routine snow removal.	Perform regular maintenance.	\$0
Vehicle Routes	West Parking Lot	Poor	1	The parking lot is extensively cracked with multiple pot holes.	Perform a full depth parking lot reconstruction.	\$121,000
Vehicle Routes	ADA Accessible Stalls/ West Parking Lot	Poor	1	Accessible parking signs are not aligned with stalls and there are no accessible aisle signs as required per ADA Standards.	Relocate accessible signs and install accessible access aisle signs.	\$1,400
Pedestrian Routes	ADA Door 6 + 7	Poor	2	There is a curb step from the street level to the stoop. This does not meet ADA standards due to lack of a pedestrian ramp.	Construct pedestrian ramp between doors.	\$2,000

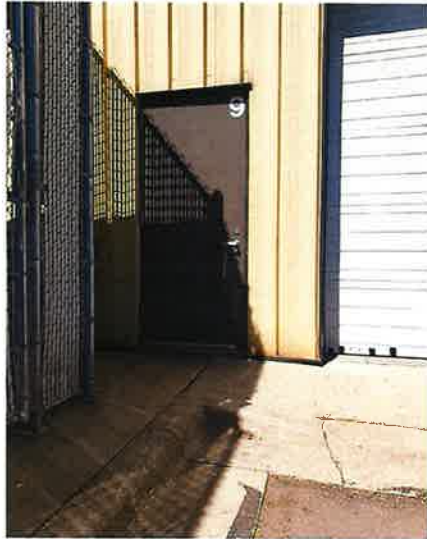
Sub Category	Element/Location	Condition	Priority	Details	Recommendations	Estimated Cost
Pedestrian Routes	ADA Door 9	Poor	3	The landing slope is too steep and does not meet ADA Standards.	Remove landing and regrade to meet ADA standards.	\$1,400
Pedestrian Routes	ADA Door 3	Poor	3	There is a curb step from the street level to the stoop that does not meet ADA Standards due to lack of a pedestrian ramp. The exterior step height exceeds maximum allowed per ADA Standards. The bottom landing is sloped toward the building. Concrete walk from stairs to public trail has extensive cracking.	Remove and replace landing to meet maximum step height and provide positive drainage away from the building. Remove and replace concrete walk.	\$6,700
Pedestrian Routes	ADA Pedestrian Ramp/Door 4	Fair	2	The ramp has large cracks and concrete is popping out. Meets accessibility standards for existing buildings but not new construction.	Remove and replace concrete walk.	\$5,000

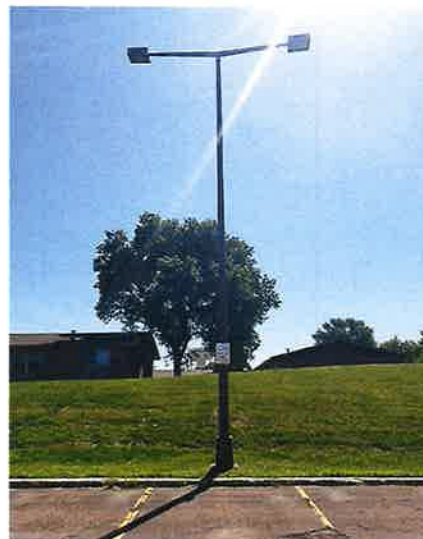
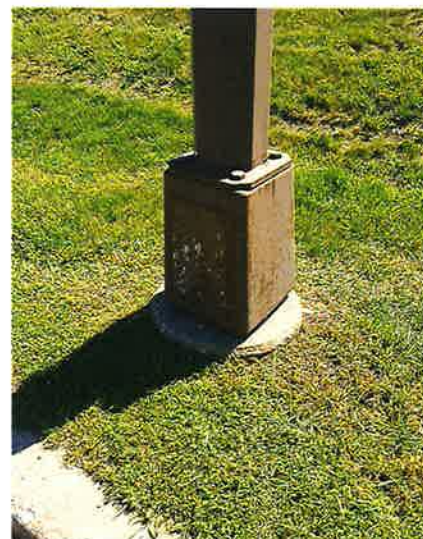
Light Poles - East Parking Lot

Pedestrian Routes	ADA Door 5	Good	3	The door is accessible.	Perform regular maintenance.	\$0
Other Site Civil	Light Poles	Fair	2	Light pole bases are rusted.	Remove and replace light pole, bases, and wiring.	\$20,000

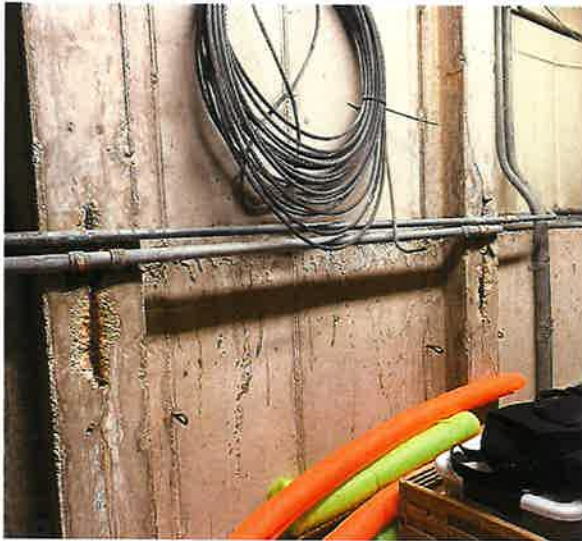
Deterioration of Concrete Below Bleachers

Sub Category	Element/Location	Condition	Priority	Details	Recommendations	Estimated Cost
Interior Walls	Concrete Walls	Poor	2	There is minor deterioration of the interior face of the concrete walls in the utility space below the south bleachers. There are no major immediate structural concerns, but some rebar is exposed and corroding.	Patch the deteriorated concrete areas with a new repair mortar before the rebar corrosion spreads and becomes an issue.	\$2,000
Interior Floors	Flooring	Good	2	Flooring throughout the building is worn and dated.	Replace flooring as required.	\$586,000
Interior Floors	Elevated Concrete Floor	Fair	3	Some larger floor cracks were visible in the second floor weight room of the addition. The cracks are present in the concrete topping slab of the elevated floor structure. The cracks were likely caused by shrinkage and temperature changes in the slab over time. The cracks do not represent any structural concerns that need to be addressed.	Repair of the cracks would only be a small aesthetic upgrade that has minimal benefit; ISG does not recommend repairing the cracks for this reason.	\$0

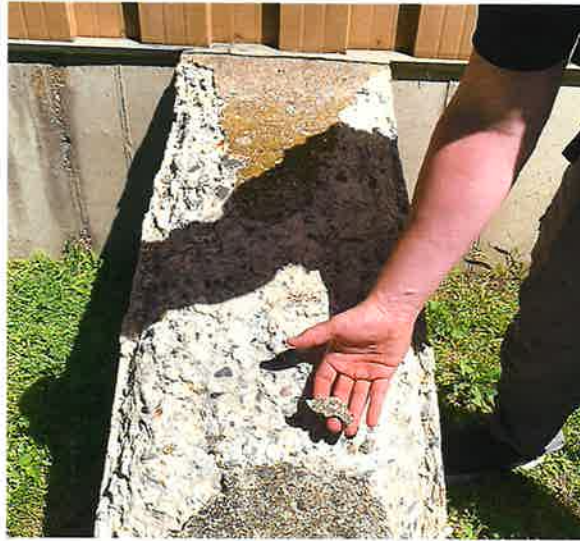
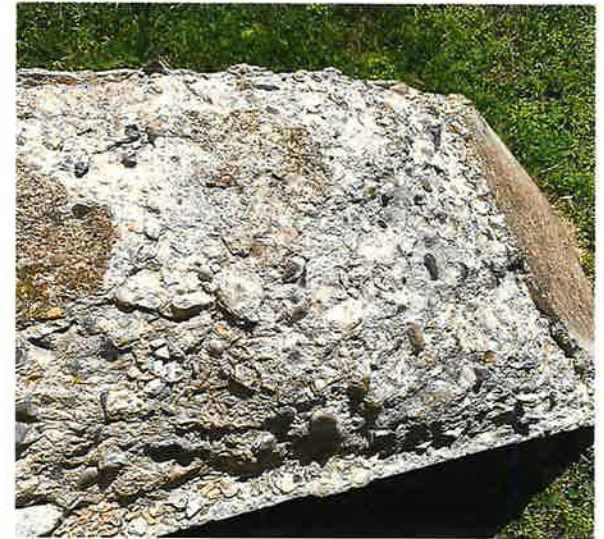
Deterioration at Concrete Buttresses

Exterior Other	Concrete Buttresses	Poor	1	The tops of the concrete buttresses on the south exterior wall of the original building is deteriorated. Nearly every buttress will require patching in the near future (a few locations have already been patched).	Patch the deteriorated concrete buttresses with a new repair mortar.	\$20,000
Interior Walls	Existing Interior Walls	Fair	2	Walls are worn and damaged in spots.	Repair/repaint existing interior walls.	\$25,000

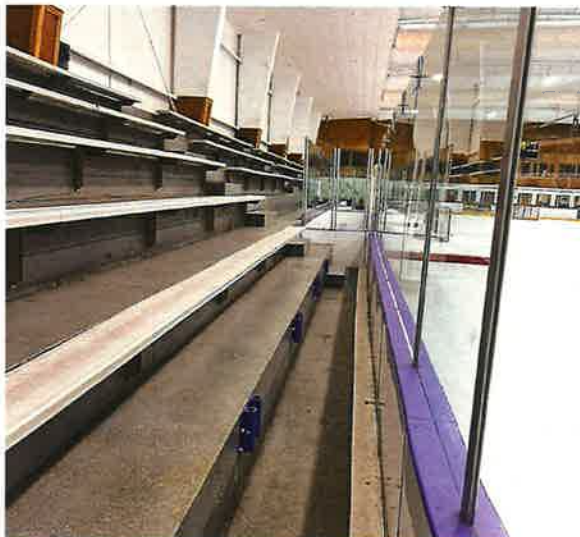
South Rink Concrete Bleachers

Interior Other	ADA South Rink Bleachers	Poor	1	The concrete risers are not in code compliance and are not accessible due to a lack of a ramp and viewing areas. The upper tier of bleachers are accessible.	Remove and replace with new accessible bleachers.	\$832,000
Interior Other	ADA South Rink-First Floor Toilet Rooms	Fair	2	The accessible stalls and sink do not meet Americans with Disabilities Act (ADA) Standards due to size and height.	Remove two toilet fixtures to make an accessible toilet stall. Drop one sink to 34" to meet ADA Standards.	\$25,900

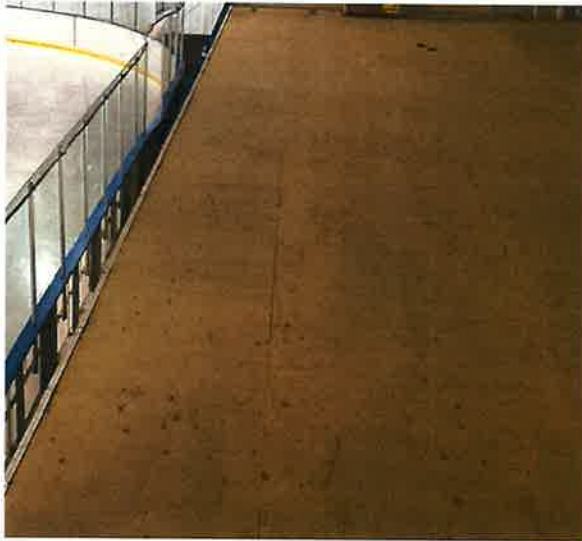
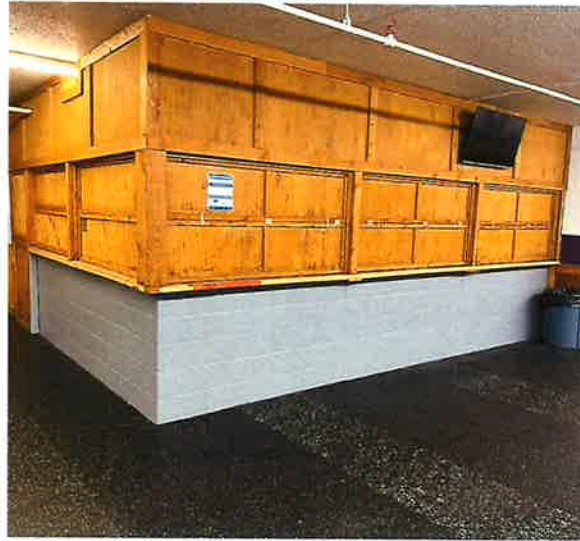
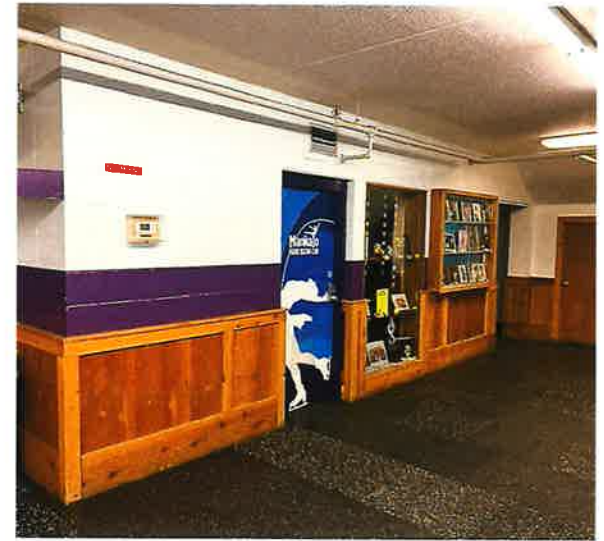
Combustible Materials

Sub Category	Element/Location	Condition	Priority	Details	Recommendations	Estimated Cost
Interior Other	Combustible Construction Materials/Throughout	Poor	1	Combustible construction materials were used at the south rink concessions area and the north rink east mezzanine area.	Replace all combustible construction materials with approved materials.	\$699,000
Interior Other	Wainscot/Throughout	Poor	1	Interior finishes include combustible wainscot materials.	Replace all combustible construction used with approved materials.	\$66,500
Interior Other	ADA North Rink Locker Rooms	Fair	2	Toilet, sinks, and showers are not accessible due to sizes, heights, and clearance.	Renovate for accessibility.	\$30,000
Interior Other	LIFE SAFETY North Rink Mezzanine	Poor	1	There is no safety railing located on the mezzanine to protect workers when accessed. In addition, there is no ladder to access mechanical room.	Install safety railing and ladders.	\$10,000

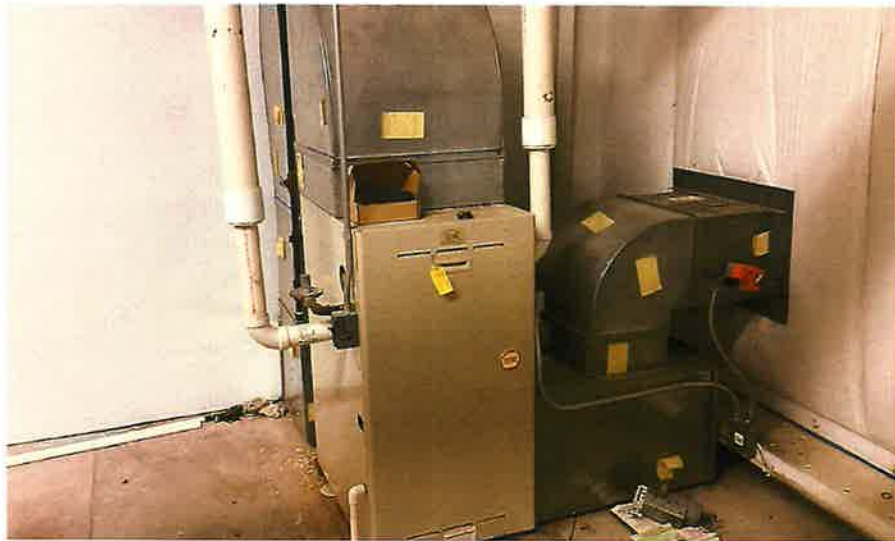
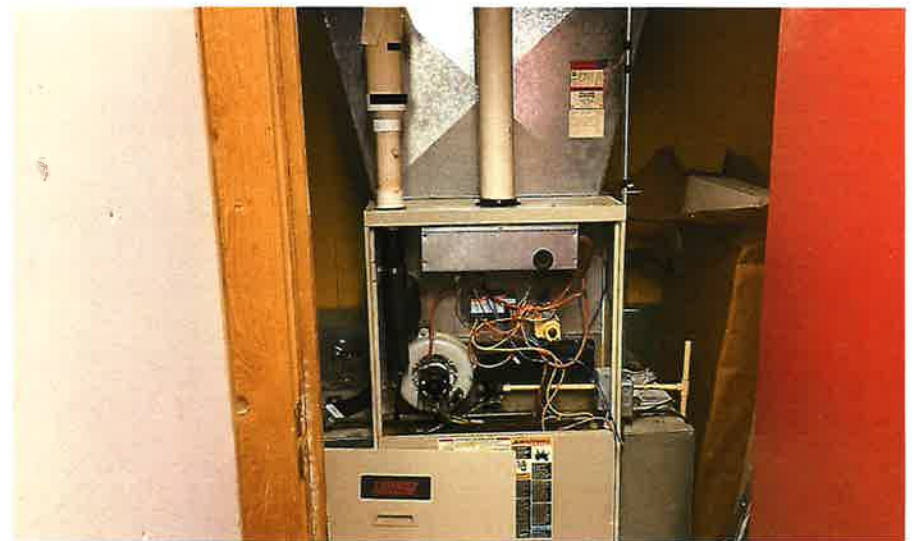
Furnace

Heating Cooling	Original Building/Furnaces	Fair	2	There are five Lennox brand condensing furnaces throughout the original building that serves all spaces with the exception of the rink. Four of the five units were installed in 2001. The average useful life of a condensing furnace is 15 years.	Replace furnace units.	\$33,300

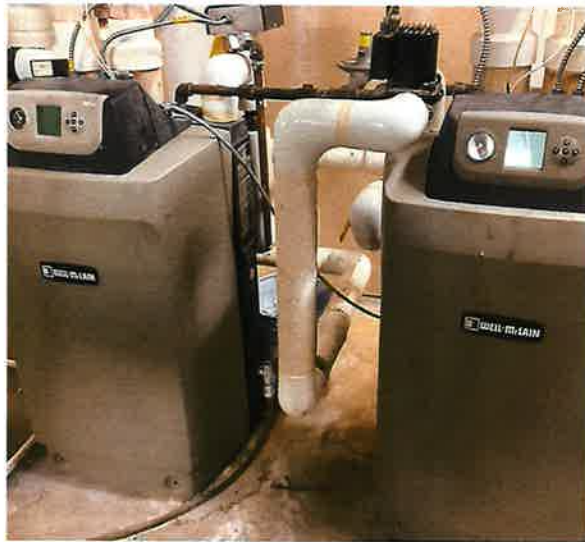
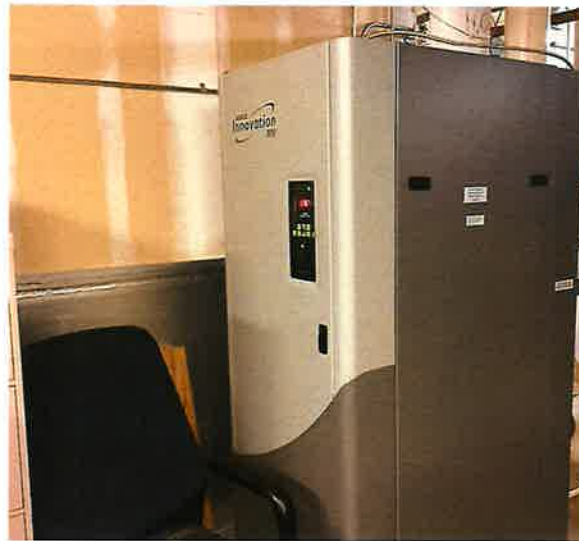
Boilers

Sub Category	Element/Location	Condition	Priority	Details	Recommendations	Estimated Cost
Heating Cooling	Addition/West Mechanical Room	Poor	1	Two Weil-McLain brand hot water boilers were installed in 1998 and serve the Trane AHU and multiple reheat coils throughout the west end of the building. The maintenance staff report having issues with these boilers. The average useful life of these type of boilers is 15 years.	Replace boilers.	\$32,000
Heating Cooling	Addition/West Mechanical Room	Good	3	The Aerco brand boiler provides domestic hot water only and was installed in 2012. The average useful life of this type of boiler is 15 years.	Perform regular maintenance.	\$0
Plumbing Water	Addition Rink Mezzanine	Good	3	The AO Smith brand water heater serves the ice resurfacing machine. It was installed in 2019. The average useful life of a water heater is 15 years.	Perform regular maintenance.	\$0
Plumbing Water	Addition Rink Mezzanine	Good	3	The State Industries brand water heater serves the east portion of the addition. The install date is unknown. The average useful life of an electric water heater is 15 years.	Perform regular maintenance.	\$0

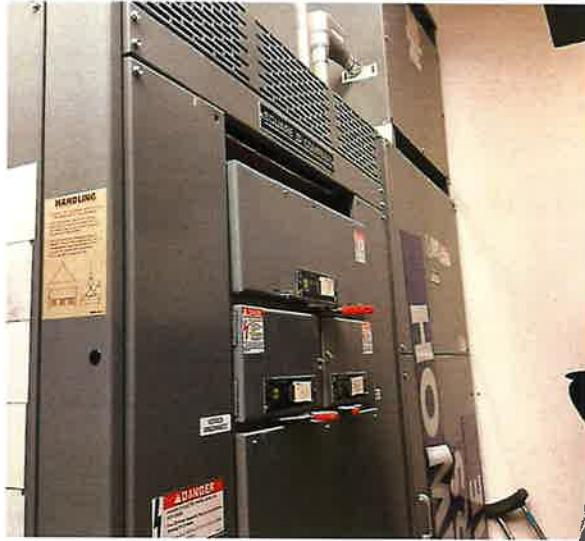
Sub Category	Element/Location	Condition	Priority	Details	Recommendations	Estimated Cost
Power Supply	Main Distribution Panel	Good	3	The Square D brand, 2,000 amp panel, was installed in 1998 and serves the entire building. The average useful life of a main distribution panel is 40 years.	Perform regular maintenance.	\$0
Power Supply	Branch Panels	Good	3	Branch panels are located throughout the building's mechanical rooms. There is a combination of original and updated equipment. The average useful life of a branch panel is 30 years.	Replace original branch panels.	\$28,000
Power Supply	Motor Control Center (MCC)	Good	3	The GE brand MCC feeds the pumps for the two ice rinks and was installed in 2006. The average useful life of an MCC is 30 years.	Perform regular maintenance.	\$0
Exterior Lighting	Exterior Lighting	Fair	2	The exterior lighting of the building appears to be older wall packs that were retrofitted with LED bulbs.	Perform regular maintenance.	\$0

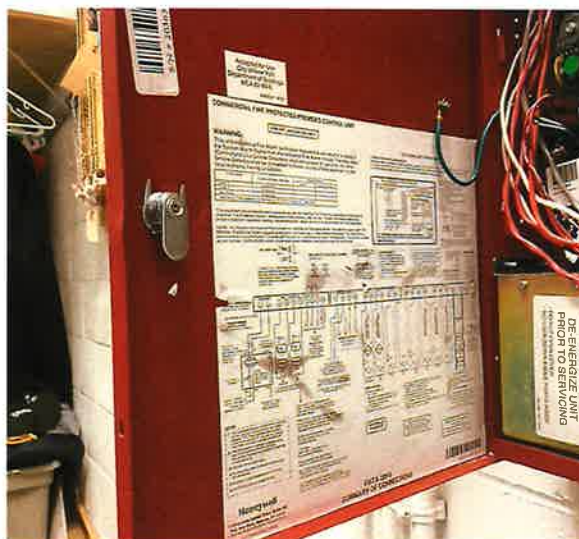
Interior Lighting	Throughout	Fair	1	The lighting in the two rinks was converted to LED. The remaining fluorescent fixtures are original to construction.	Replace light fixtures with LED and install occupancy sensing controls.	\$326,000
Life Safety	LIFE SAFETY Fire Alarm	Fair	1	The fire alarm system is original to the addition construction, making it 24 years old. The average useful life of a fire alarm system is 15 years.	Replace fire alarm system and all associated devices.	\$63,900
