Facility Assessment

North Mankato Swim Pond North Mankato, MN

February 23, 2017

USAQUATICS
AQUATIC CONSULTING & DESIGN
124 BRIDGE AVENUE, P.O. BOX 86
DELANO, MN 55328
763-972-5897

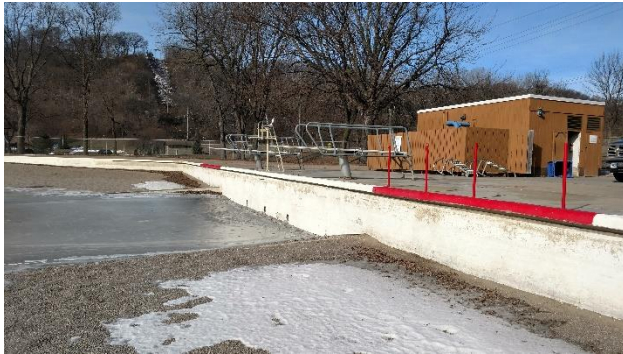
Swimming Pond at deep end

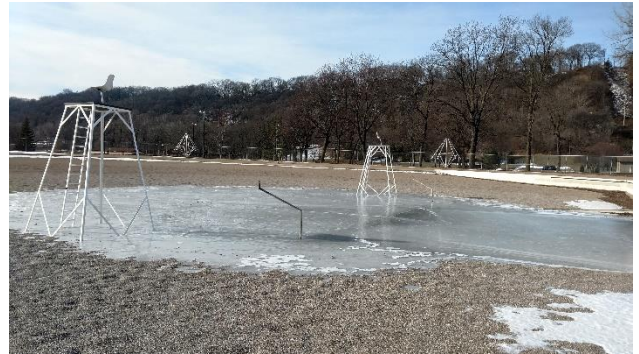
Swim Pond conditions

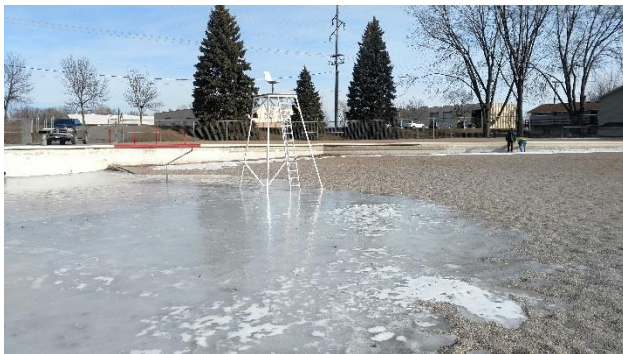
Swimming Pond conditions

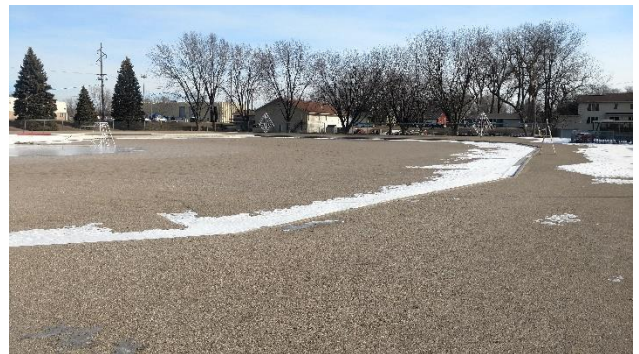
Swim Pond at shallow end

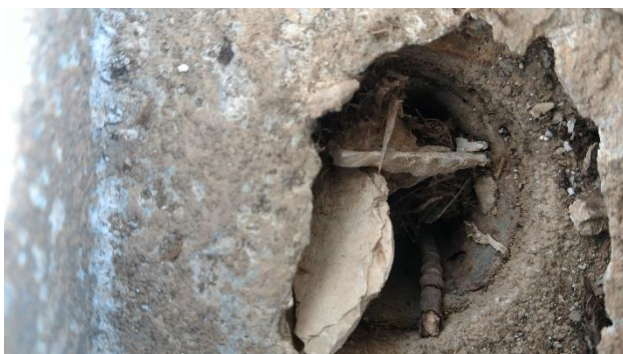
The swimming pond has an aluminum gutter system along the North end of the swim pond. The pond was not in operation during the time of the site visit. The majority of the gutter drop-outs were scaled shut and only a small percentage of the existing drop-outs were able to be located.

Inlet scaled shut

We recommend demolition and removal of the existing gutter system and replacement with a new stainless steel recirculation gutter, grating and integral recirculation inlets that would be extended to the corners on the East and West sides. Additionally, the perimeter piping is in need of replacement to allow for new inlets which would all be pvc. The main drain and cover would be replaced along with related plumbing. The main drain covers would be ASME/ANSI compliant, per the Federal Law requirements.

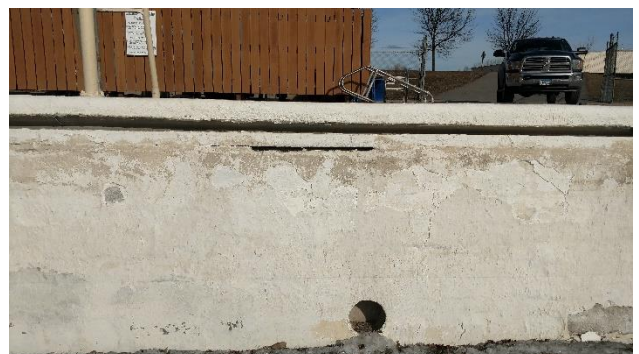
The concrete in the diving well is in fair to poor condition. The walls along the North end of the pond are in the same condition and in need of attention. The top of the concrete curb around the diving well is completely missing and the pvc waterstop is exposed. Since the concrete is in poor condition and the main drain is in need of replacement, a new 8" thick reinforced shotcrete shell should be installed in the diving well and North walls. The existing concrete would be utilized as a form only to place the new 8" thick reinforced shotcrete. The additional 8" to the walls would also allow for a larger gutter along the North side of the pond. The new liner could also terminate at the new pvc waterstop to prevent potential leaks.

Wall conditions/deterioration

We recommend the addition of 8" thick reinforced floors on top of the existing floors when the main drain is replaced, along with the addition of 8" thick reinforced walls along the North end.

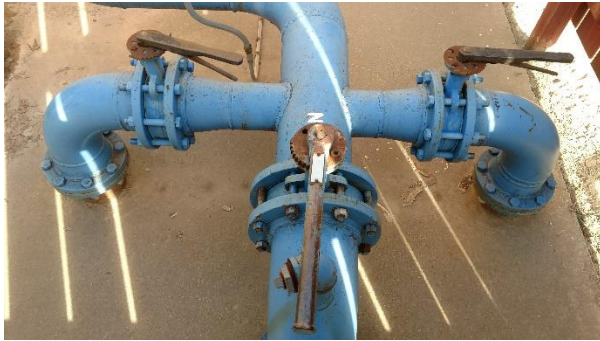
The pool equipment is housed in a separate mechanical house on the North end of the facility. The equipment within is largely original to the facility with a few exceptions. The equipment has met the needs of the facility for several years; however, for the most part it is outdated and very inefficient in terms of operation. The plumbing is cast-iron and in fair condition; however, valves and gauges are in poor condition. The majority of the plumbing is undersized to handle the flows required.

Cast-iron piping w/ lever valves

We recommend complete replacement of valves, piping, and gauges.

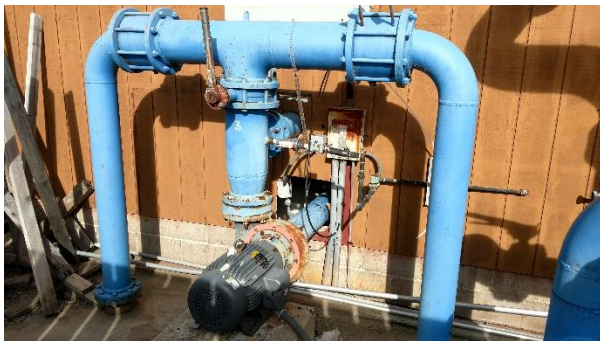
The swim pond recirculation is handled by a single 7.5HP recirculation pump with an integral strainer that is in extremely poor condition and has well exceeded its useful lifespan. The pump is located above water level, which is problematic when it comes to priming. The pump does not have a strainer that would allow the operator to see potential blockages. The pump also lacks a flow meter and vacuum limit switch.

Pipe/Pump conditions

We recommend replacing the existing pump with a dual pump system, complete with variable frequency drives, that are capable of flow rates required to bring the turn-over rate considerably lower than the 21-22 hours the facility currently has.

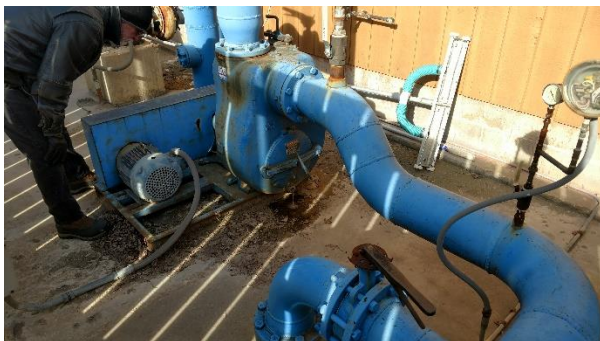
Plumbing into pump

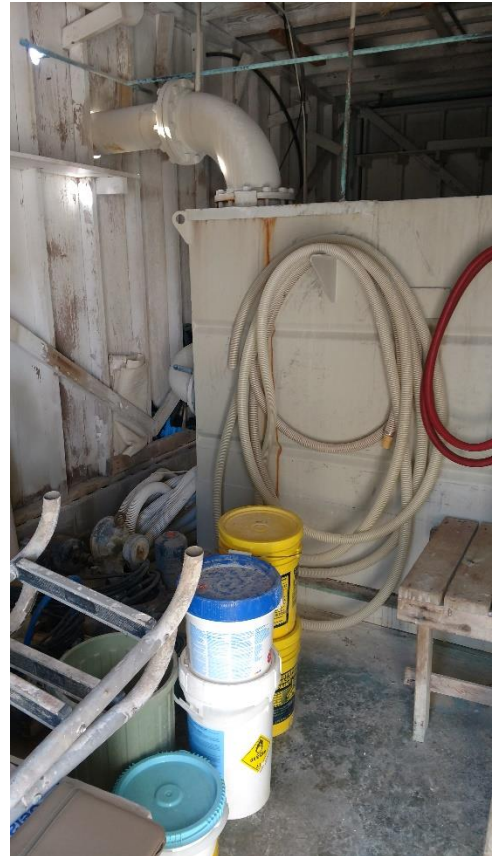
Pool filtration is currently handled by a vacuum DE filter that is very ineffective in terms of operation, as well as being undersized for the facility. Additionally, DE filters are known for requiring a very labor intensive cleaning process to maintain operation. For replacement, there are essentially two options: pressure sand filtration and regenerative media filtration. Regenerative media filters require a much smaller footprint and would easily fit within the current equipment building while pressure sand filters would need to be installed outside and within close proximity to the equipment building which would likely result in additional concrete work and fencing.

Vacuum DE filter

We recommend replacement of the existing vacuum DE filter with Regenerative Media filtration. As part of this assessment, calculations will be completed to determine the payback scenario for both pressure sand and regenerative media filtration. To filter the volume of water required, two filters will be required.
