RAVINE MANAGEMENT

October 2020

Prepared by: The City of North Mankato

Date: September 23, 2020
To: John Harrenstein, City Administrator
From: Daniel R. Sarff, P.E., City Engineer
CC: Nate Host, Public Works Director
Subject: Lake Street Bluff Drainage and Erosion Issues
BMI Project No. OM1.122664

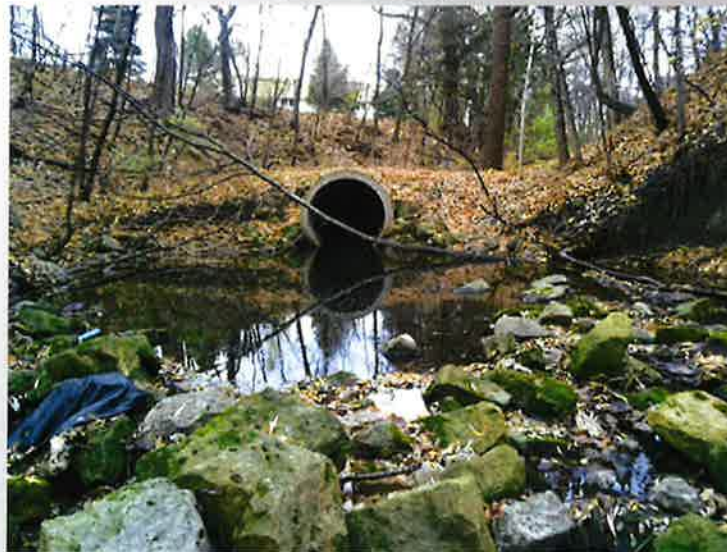
Upstream of 72" Pipe at Northridge Ravine

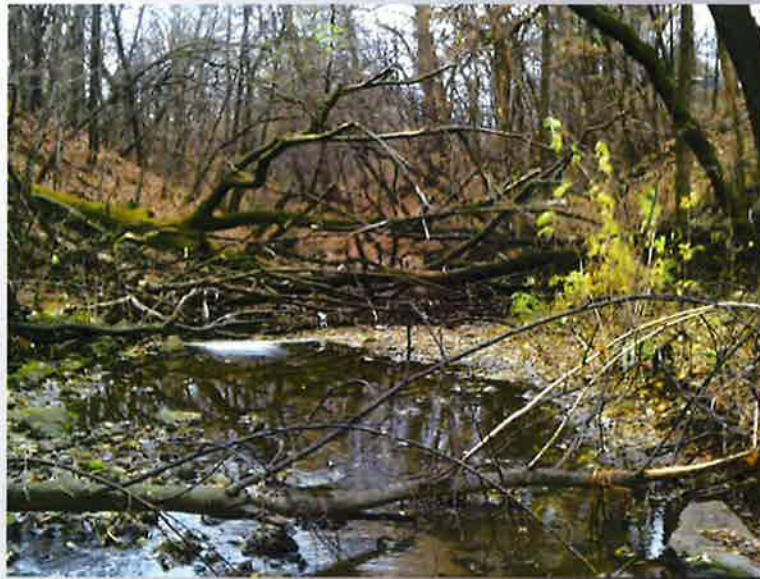
Downstream of 72" Pipe at Northridge Ravine

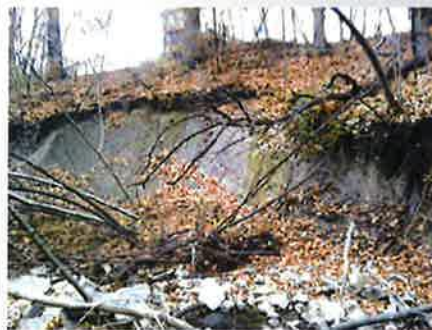
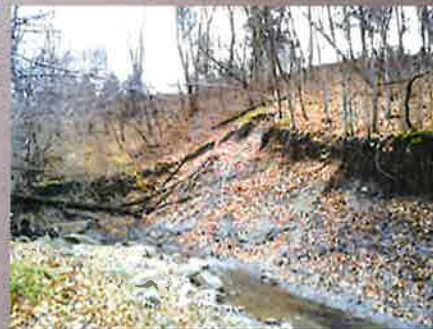
Large Scarping of Side slopes

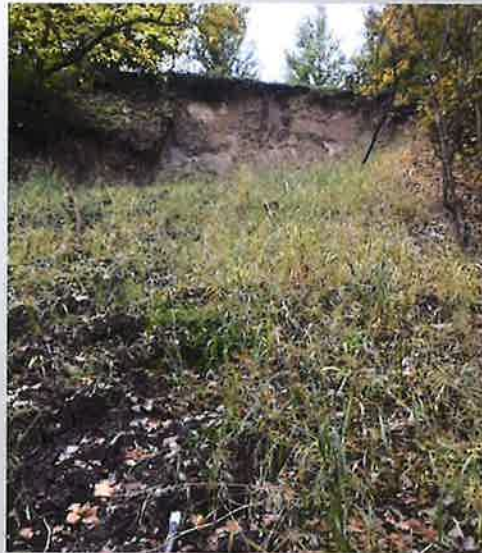
Large Scarping of Side slope

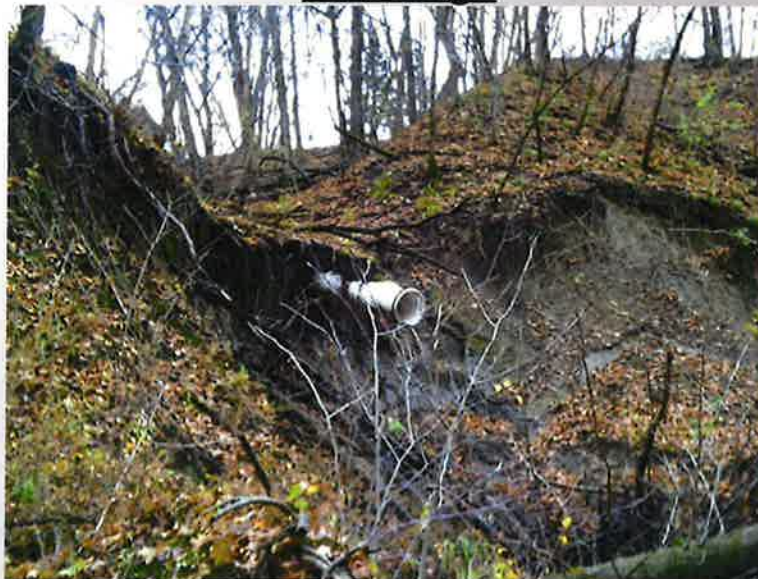
Outlet That Needs Correction

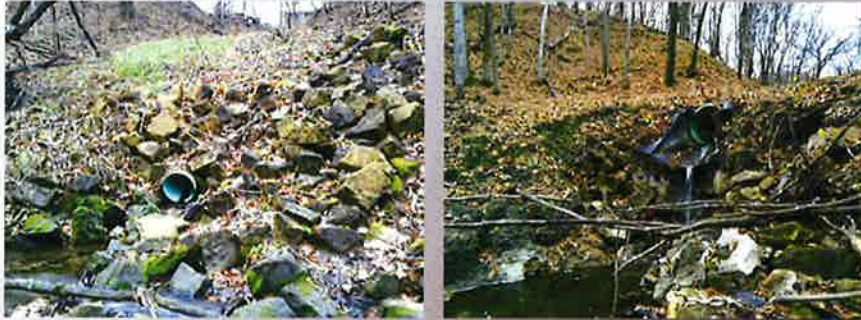
Correct Outlet Piping

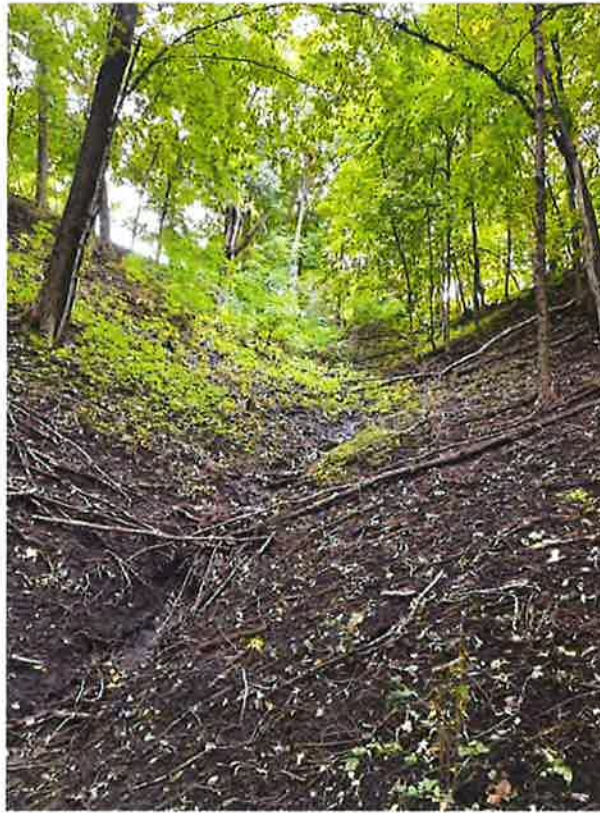
Example of a ravine with minimal erosion

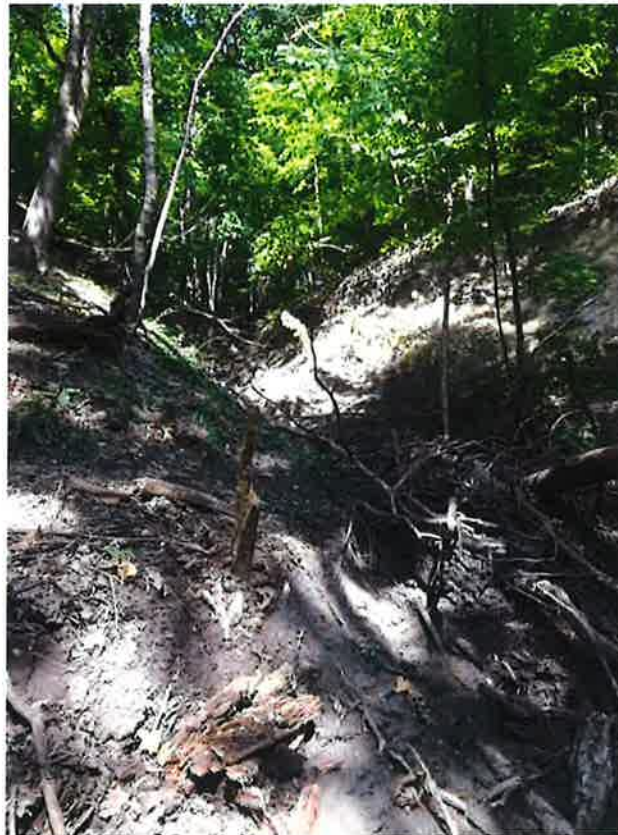
Example of ravine that has eroded and sloughed

City staff has taken efforts to re-establish the vegetation in the eroded areas on the bluff, utilizing special seed mixtures that thrive in shady conditions. These efforts have been successful in several areas and should be continued.

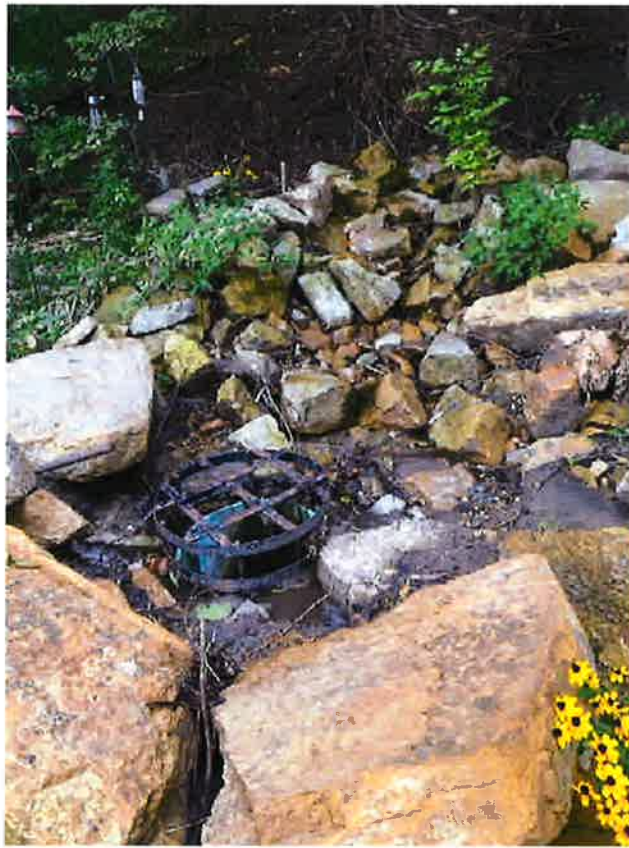
EXHIBIT 4 – INLET AT 806 GARFIELD AVENUE

Many years ago, the City installed a storm sewer inlet just west of the retaining wall on the west side of the driveway at 806 Garfield Avenue. A 6" diameter pipe was constructed from the inlet to an existing 8" diameter pipe that connects to the existing City storm sewer system at the intersection of Lake Street and Garfield Avenue. Exhibit 4 shows the inlet on the 806 Garfield Avenue property. Over the years City crews have also installed riprap around and upstream from the inlet to help control erosion and to direct more of the runoff into the inlet. Exhibit 4 shows the inlet at 806 Garfield Avenue.

Inlet at 806 Garfield Avenue

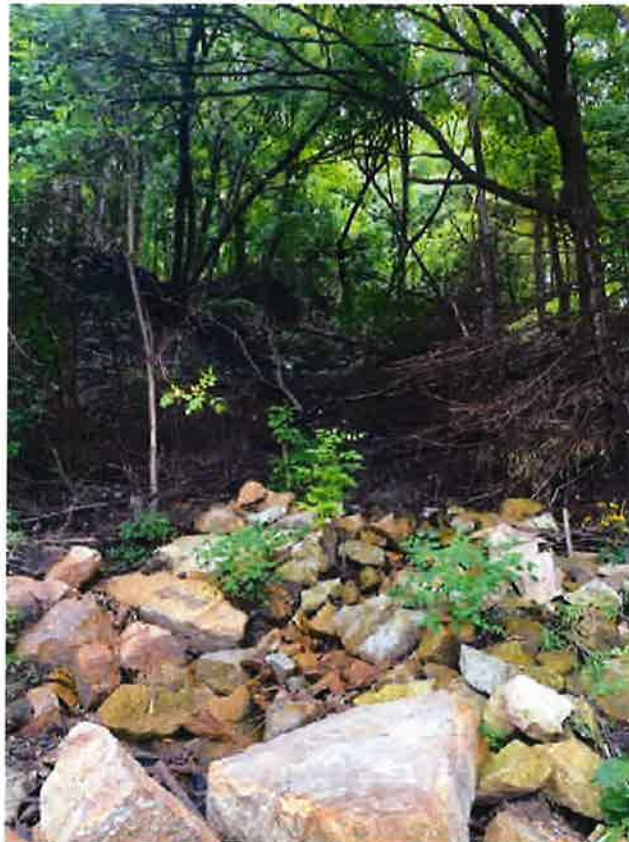
Rip-rap installed around inlet and upstream from inlet

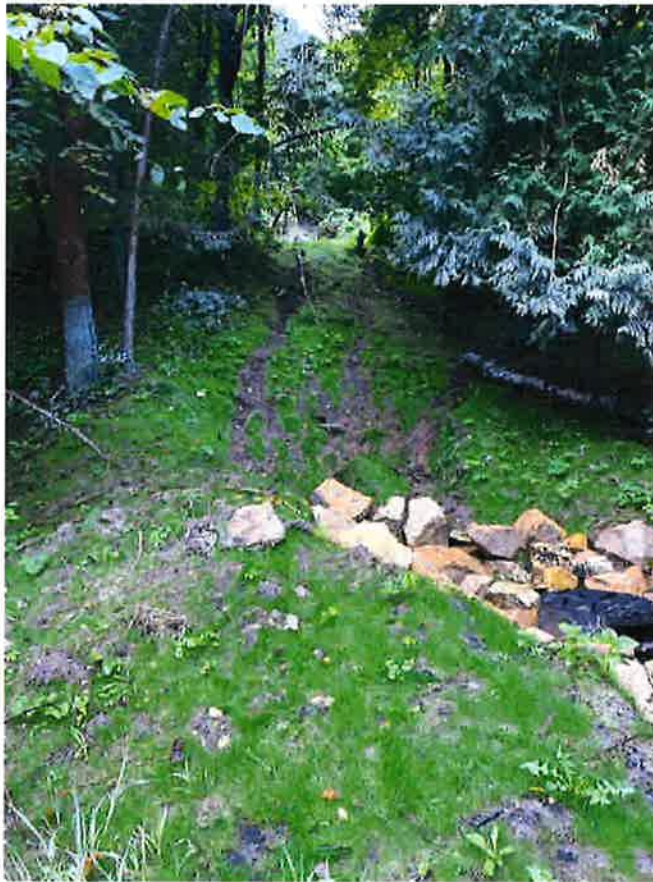
EXHIBIT 7 – RIP-RAP AND SEEDING AT 919 LAKE STREET

Rip-rap and seeding upstream from inlets

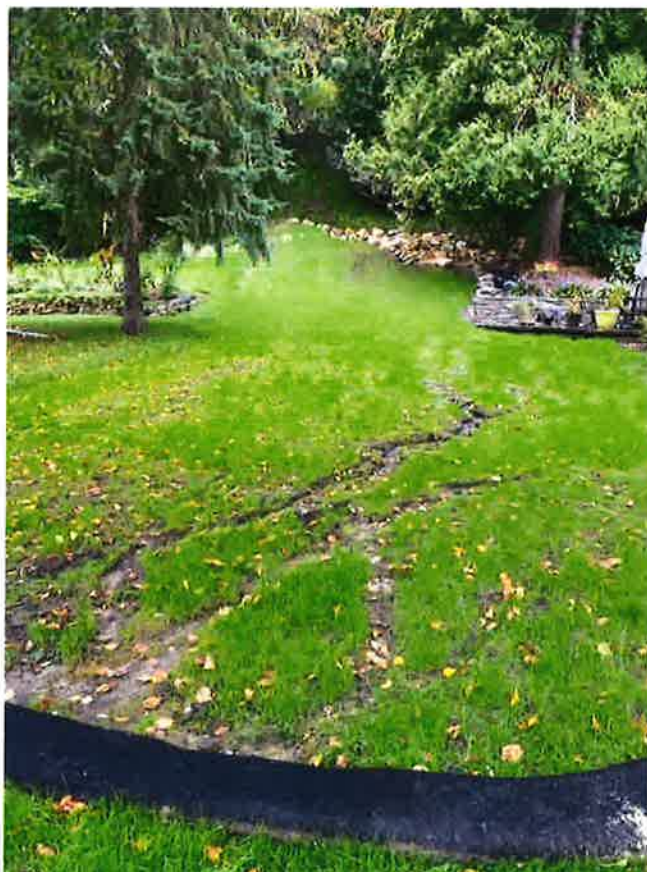
Seeding of area from base of bluff to Lake Street
