# WILKINS TOWNSHIP MUNICIPAL BUILDING

110 Peffer Road.  
Turtle Creek, PA 15145

Date: April 6, 2023

**McKim & Creed Project # 07406-0001**

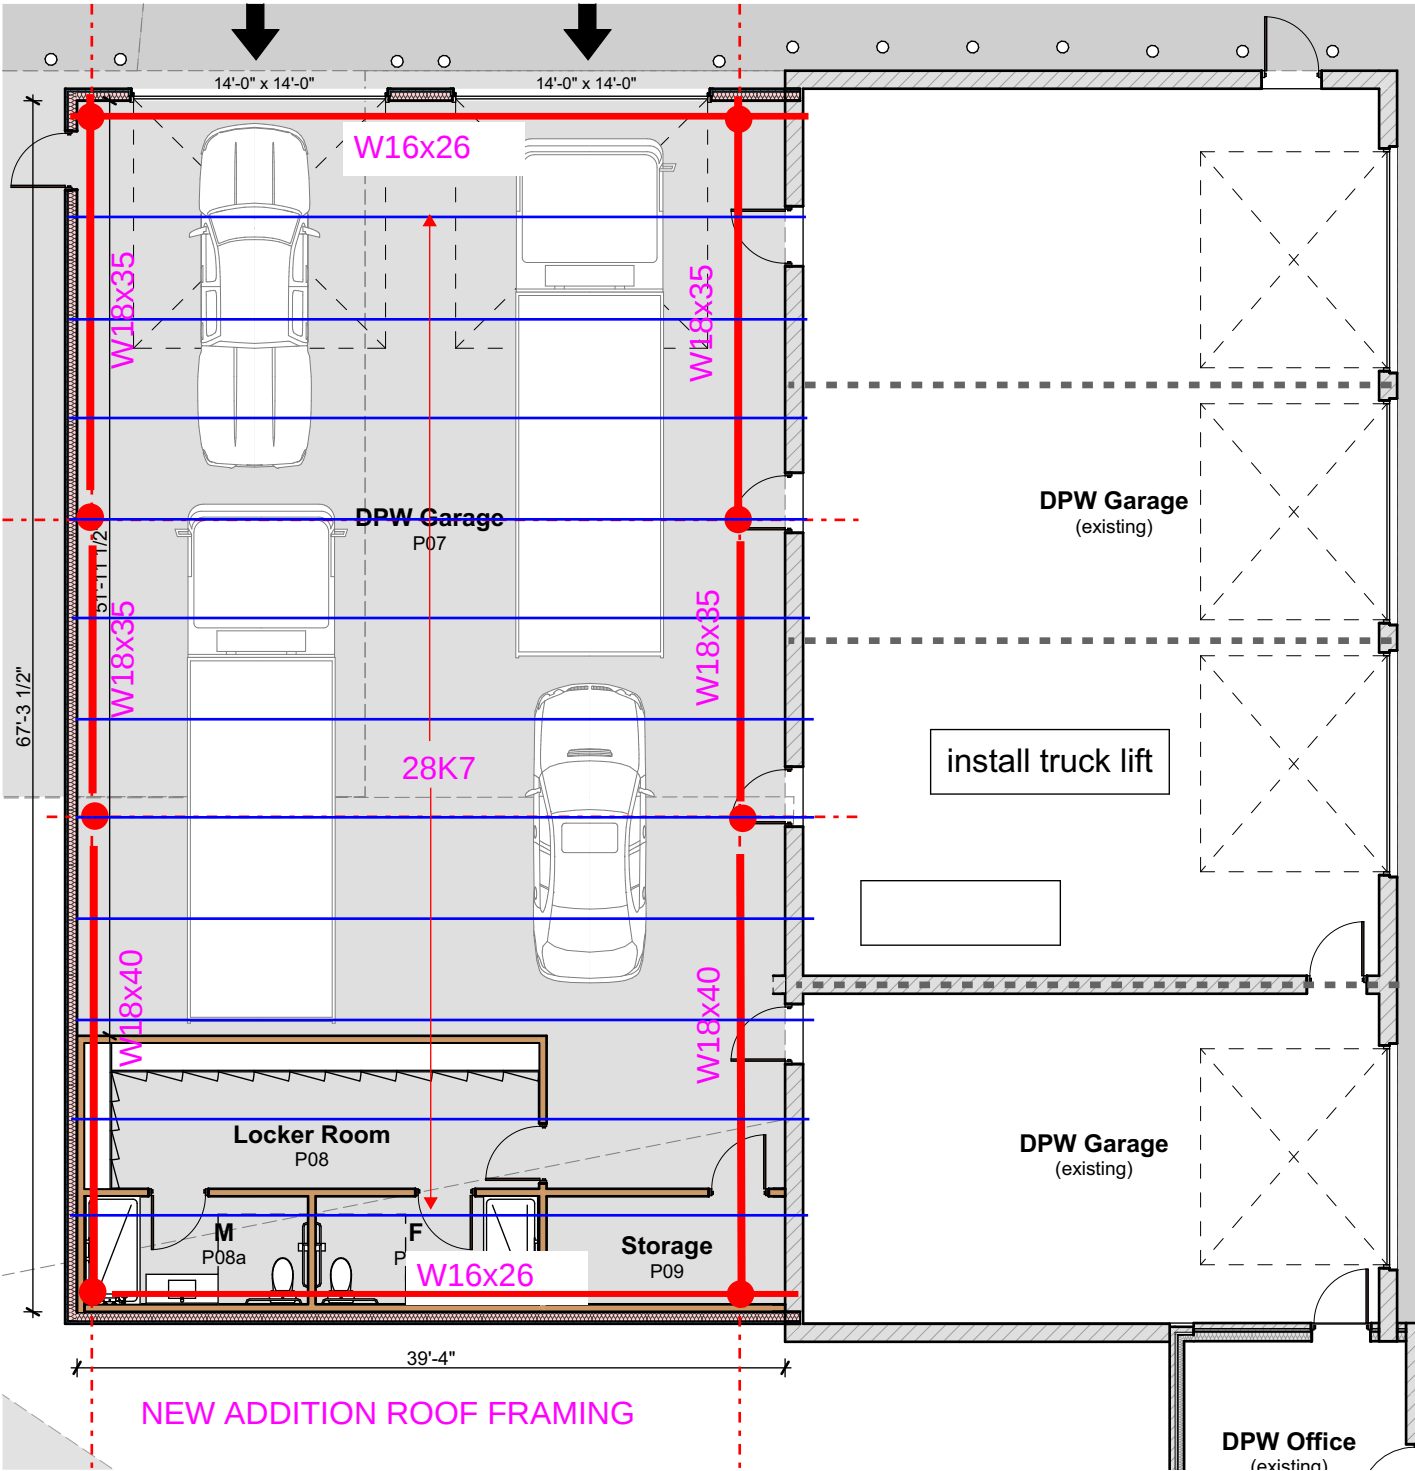
APPENDIX B  
New DPW Garage Addition Schematic Framing

The proposed scope also includes a 40' x 67' addition to the east of the DPW garage. Because the existing garage has focused beam pockets on the existing west wall we suspect this wall is not designed to accept additional or future loading. The project would prefer to have a column free garage space and we have developed a Schematic Design with roof joists spanning east/west which bear on the new east wall and on new framing along the west wall. This allows for the new roof to be higher than the current garage and avoids impacts to the existing foundations. Roof framing will use 28" deep bar joists with steel framing and posts. The least cost envelop option would be metal stud framing ballooning to the roof deck. CMU exterior walls are also a solution, and for the added cost would add a level of robustness to the new addition. Schematic framing is shown in the appendix: New DPW Garage Addition Schematic Framing.

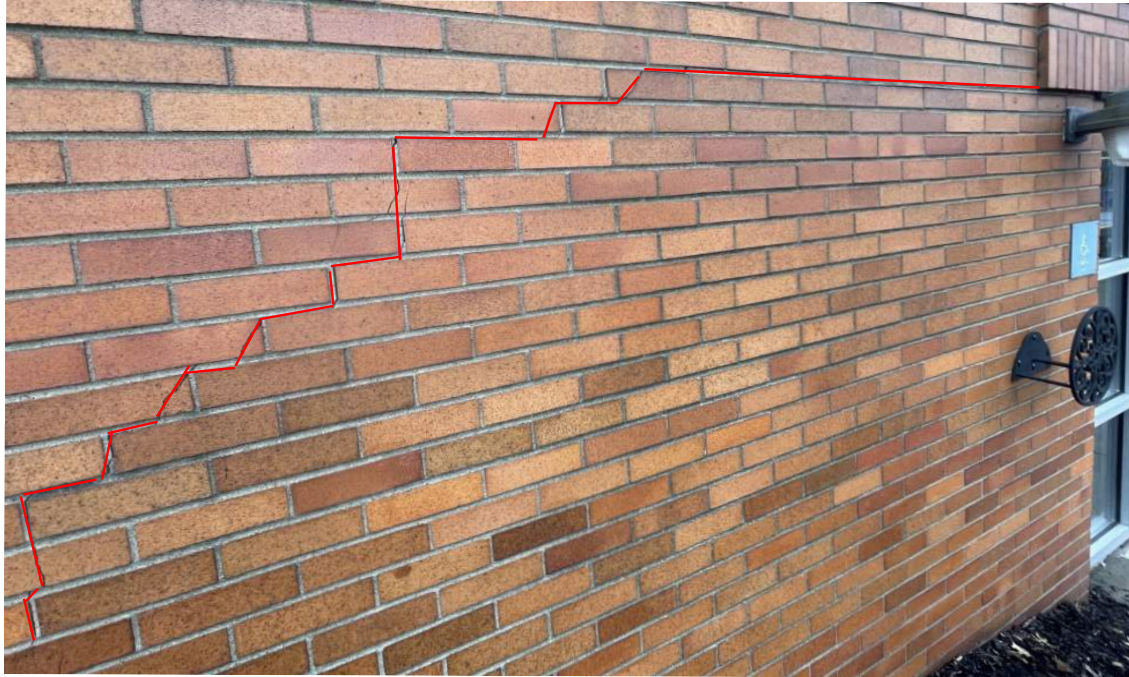
1957 East wall Near Stair Entrance.

The exterior walls have cracks on most walls in varying degrees of concern which we assessed to be from the settlement event. When the building's interior wall settled the roof and floor diaphragm pulled the walls inward causing an exterior cracking. These are typically horizontal cracks on the north and south walls, while are diagonal and vertical cracks on the east and west walls. To repair these cracks a mason or masonry restoration contractor needs to rake and repoint the walls. Some of the cracks may be from expansion and contraction, and should be addressed by the same mason by cutting vertical control joints into the brick and caulking the open joint with a high grade sealant. We recommend vertical joints to be between 7 and 15 feet from a corner and up to 25' thereafter.

Horizontal and stepping crack (highlighted in red).  
This cracking is an example of the building being dragged during settlement event

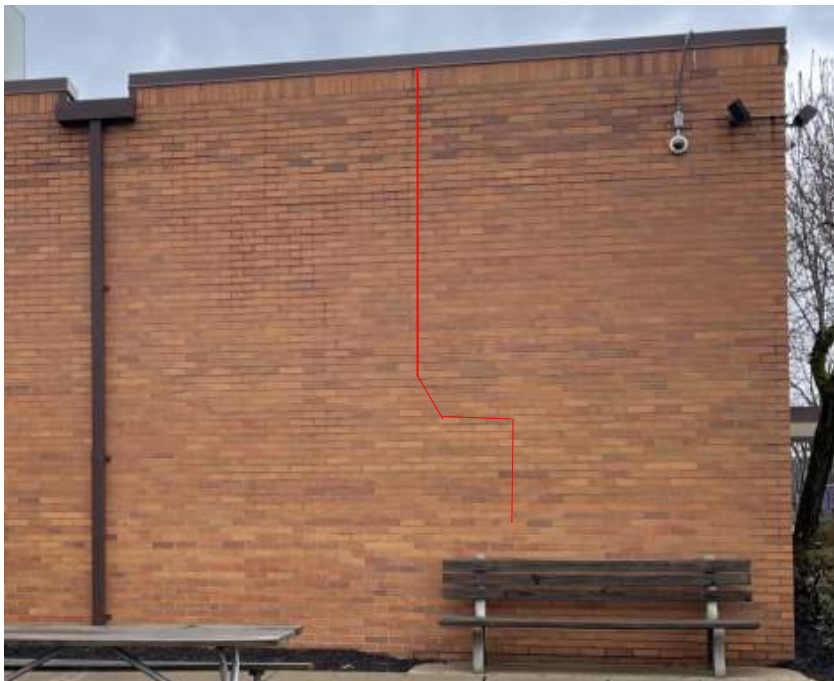
1957 West wall at NE corner and community Room.

Vertical and stepping crack  
(highlighted in red).  
This crack likely occurred  
during the settlement event.

The crack now acts as an  
expansion control joint.

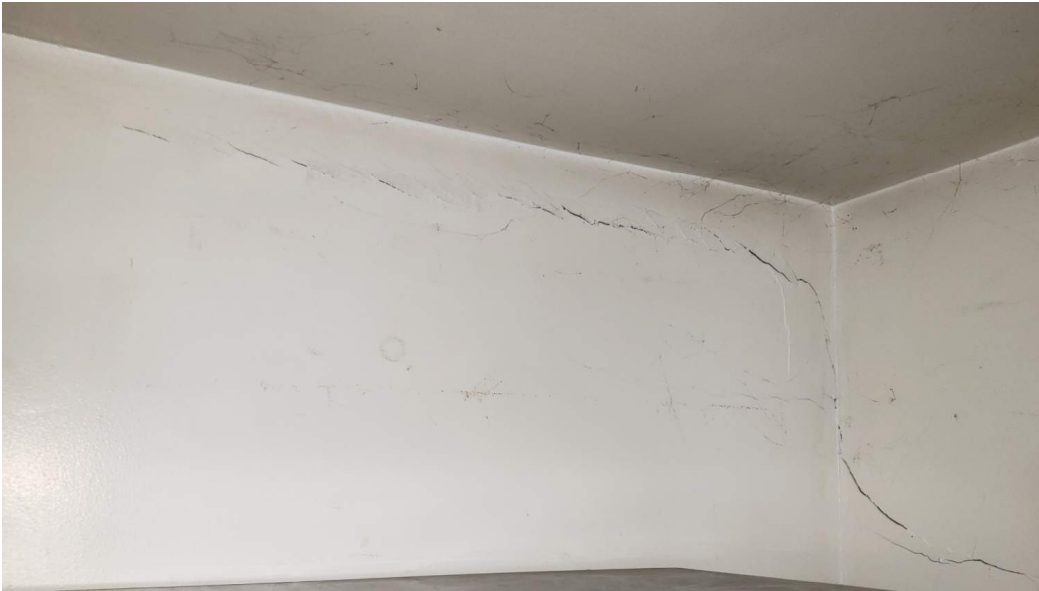
1957 First Floor - Storage room off Community room

Un-repaired Horizontal cracking.  
Another example of the building walls being dragged during settlement event.

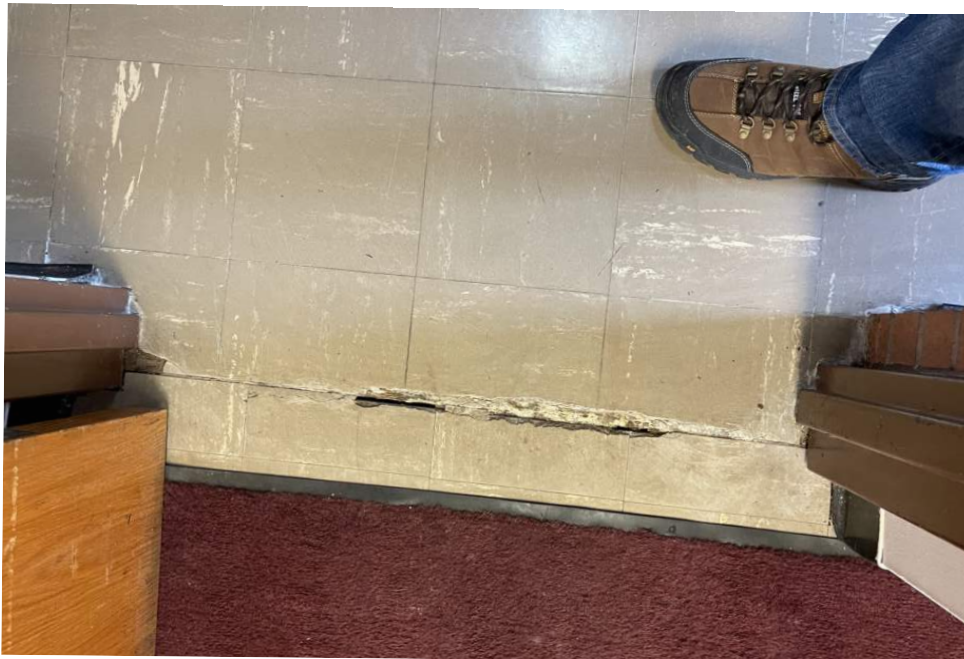
1957 First Floor -Police Chief Office door

- The 1st floor slab has some large cracking through the floor covering which we attribute to the building movement event. These should be addressed in future renovations.

Un-repaired floor cracking.  
Crack is an occurred during settlement event.

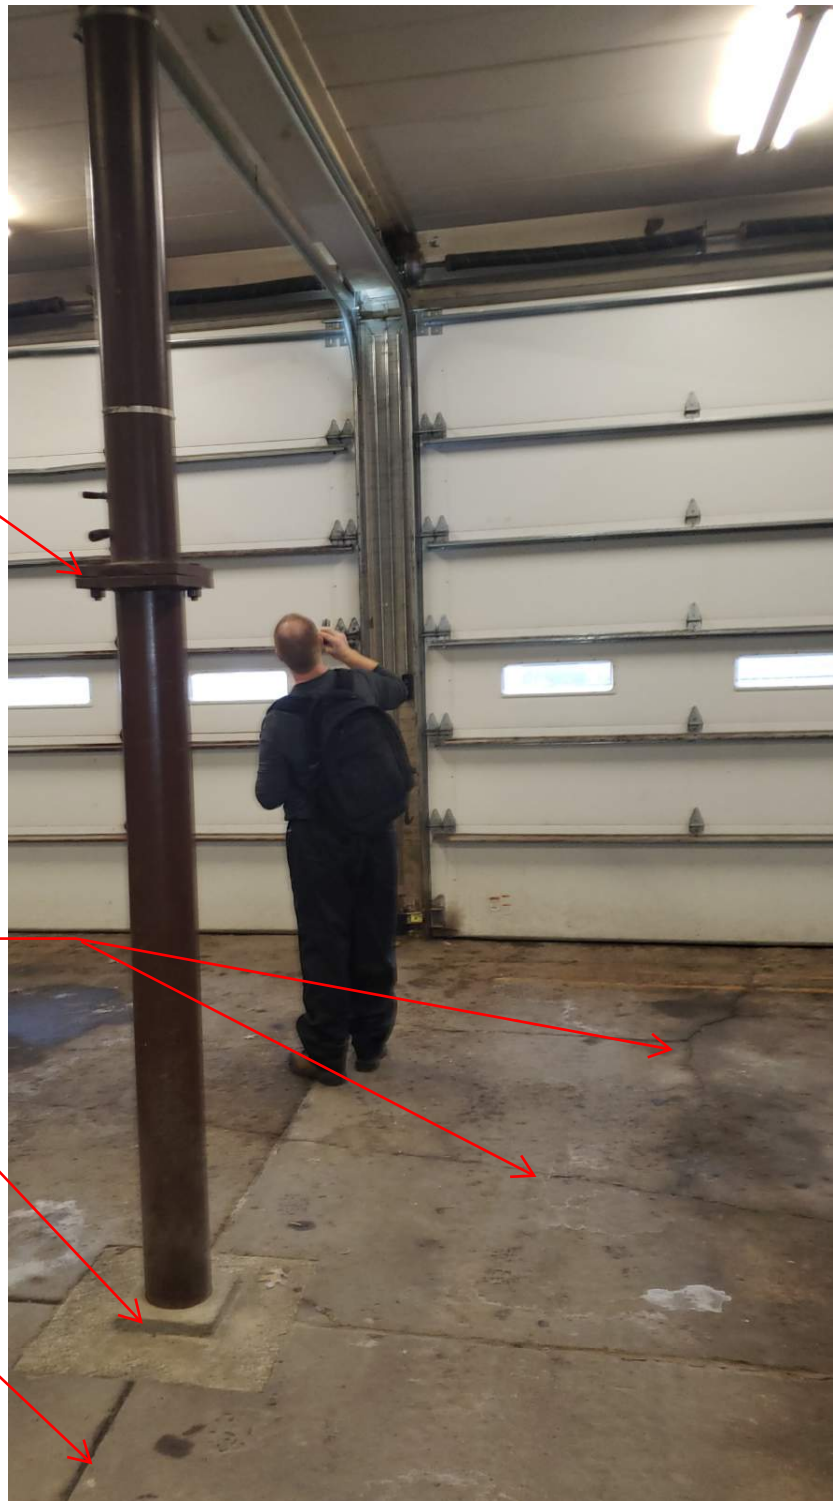
1957 Ground Floor - DPW Garage bay at column repair

The building interior bearing walls are supported to ground or in the case of the south office area on steel framing to posts in the lower level. Two of the original columns corroded to the point of buckling. The repairs appear to be quality work and the building was returned to an acceptable point of level.

Column replacement/  
repair.

Slab on grade cracking  
from heavy traffic

Foundation repair and  
slab house keeping  
pour to keep water  
away from column

Open slab joints

We recommended remediation to the lower level DPW parking bays. The slab is undersized and at the end of its service life. The drains are in poor condition, and it is understood water infiltrates the slab through floor joints deteriorating the sub-base. Removing the existing slab, repairing the sub-base, and replacing the slab with a heavy reinforced 8" concrete slab with new trench drains appropriate for multi-axle vehicle loads will better serve the space as a garage for multi-axle vehicles.
