SIDEWALK REPAIR GUIDE

Attached are examples of sidewalk deficiencies as defined by Chapter 136 of the Altoona Code of Ordinances. Included with each example is a repair suggestion. Some examples may have more than one method of repair, while others may have only one. If you have received a letter to repair your sidewalk, you will notice that the deficiency has an alphabetical identifier assigned to it. Match that identifier to the correct one below for guidance.

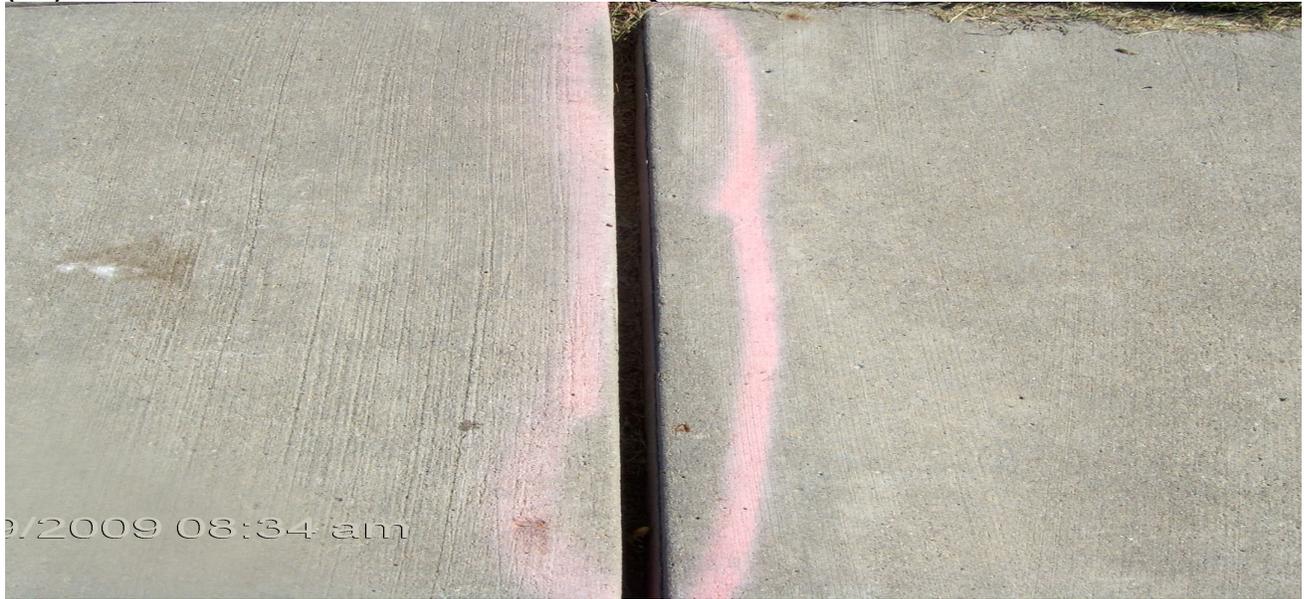
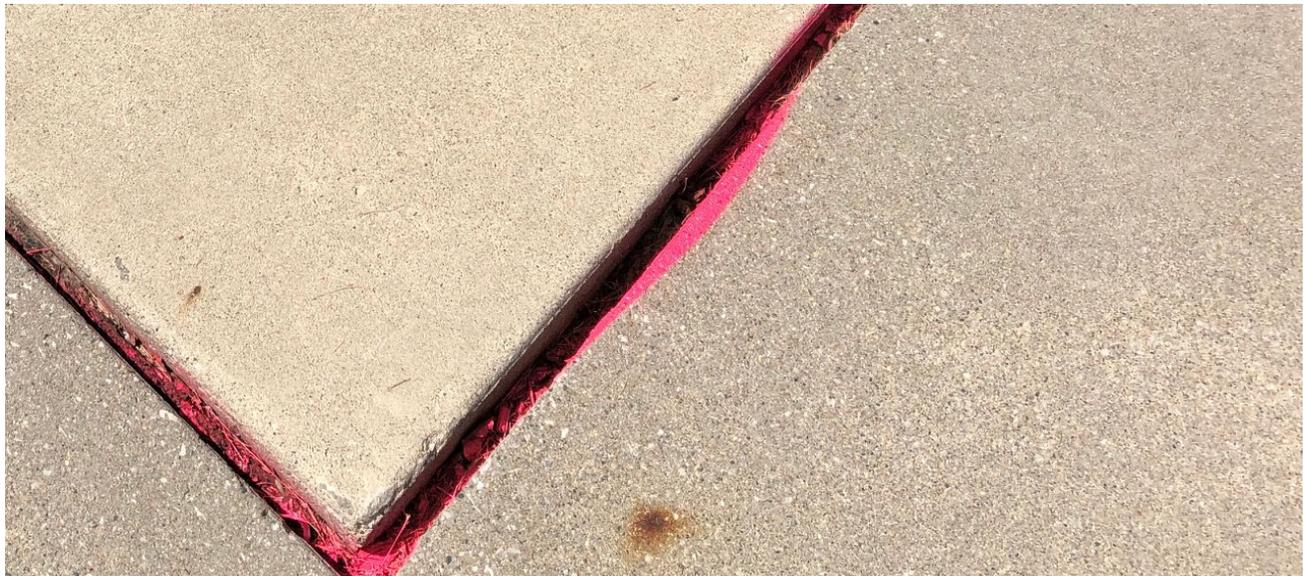
(B.) HORIZONTAL SEPARATIONS EQUAL TO 1" OR MORE

The appropriate repair for this scenario is typically filling in the gap between the two panels. Many times this is caused by deterioration of the expansion joint over time.

Repair Suggestions for Deficiency (B.):

- Fill in the gap
- Replacing the panel – PERMIT REQUIRED IF THIS OPTION IS CHOSEN

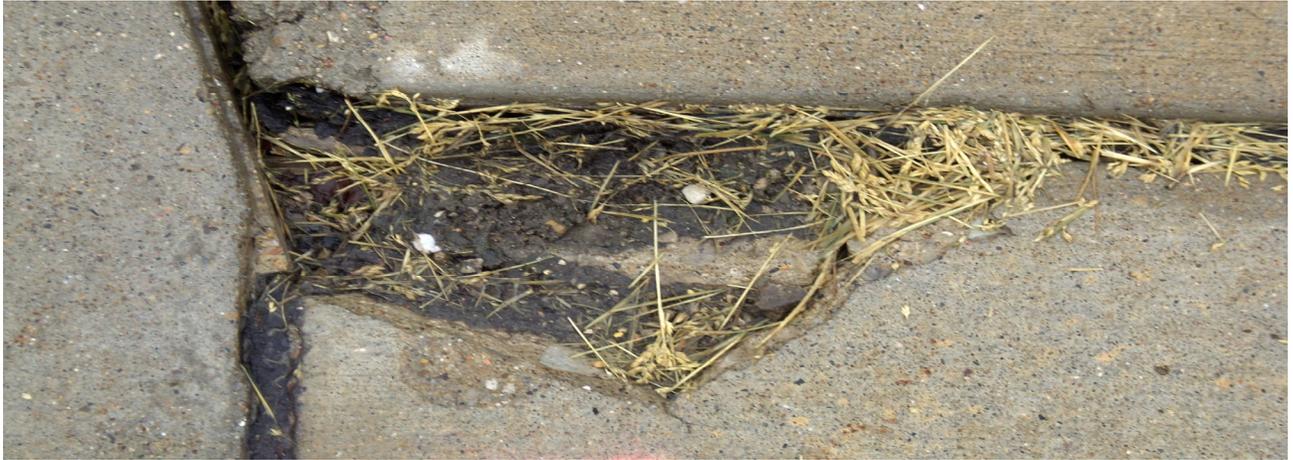
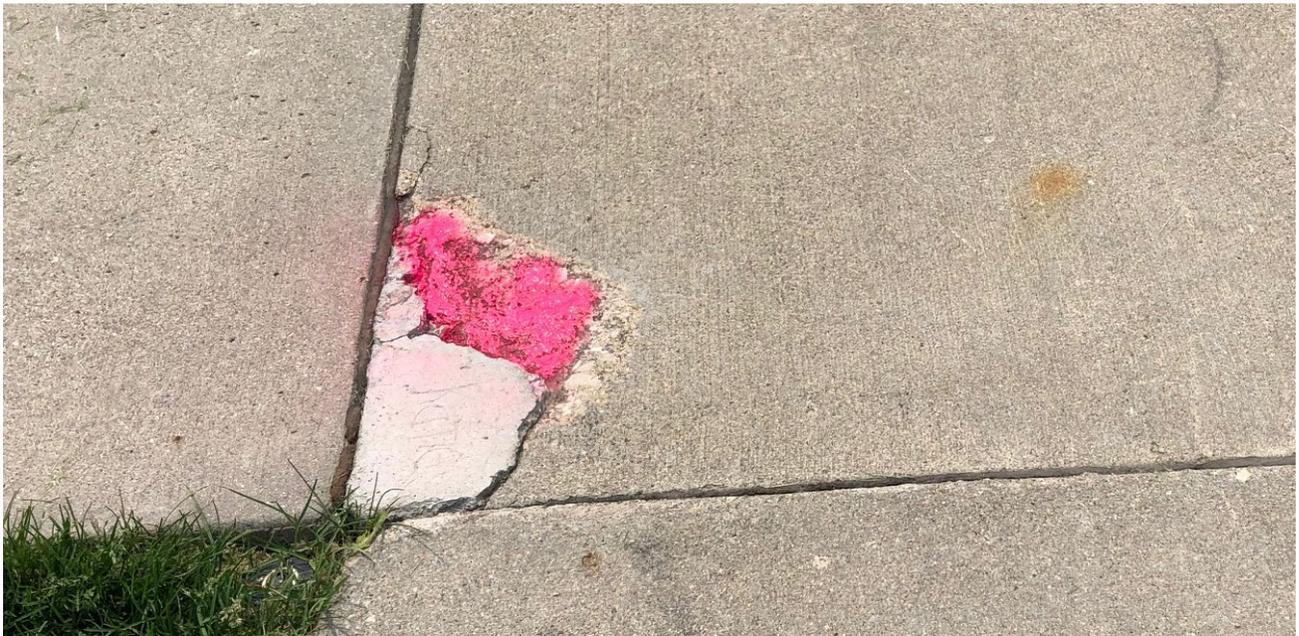
(C.) HOLES OR DEPRESSIONS EQUAL TO ¾” OR MORE AND AT LEAST 4” IN DIAMETER

The appropriate repair for this scenario is replacing the panel. Patching or filling in the depression(s) IS NOT an acceptable repair.

Repair Suggestions for Deficiency (C.):

- Replacing the panel – PERMIT REQUIRED

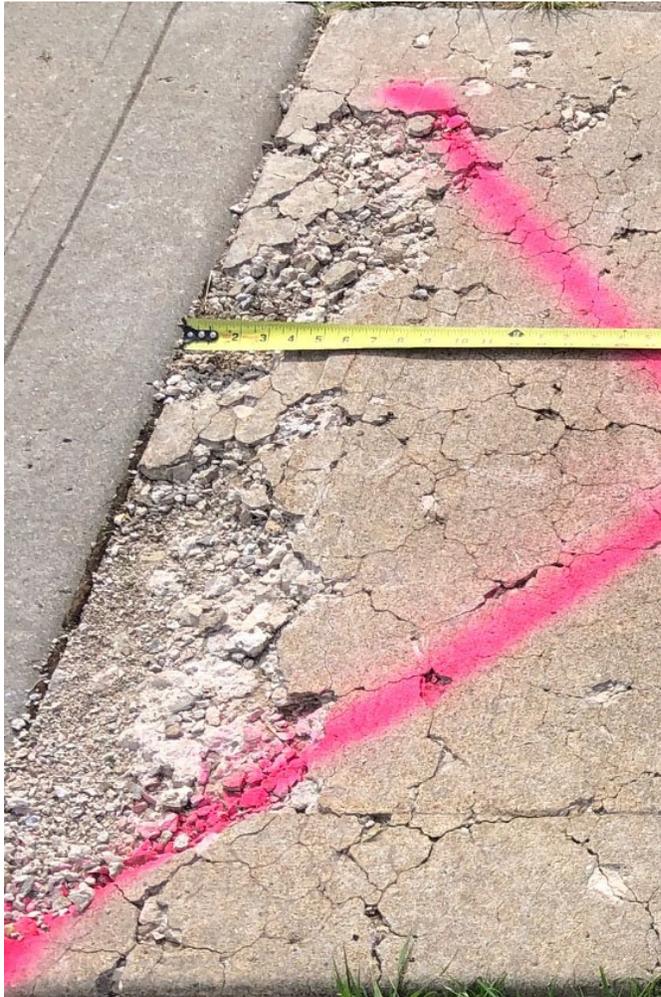
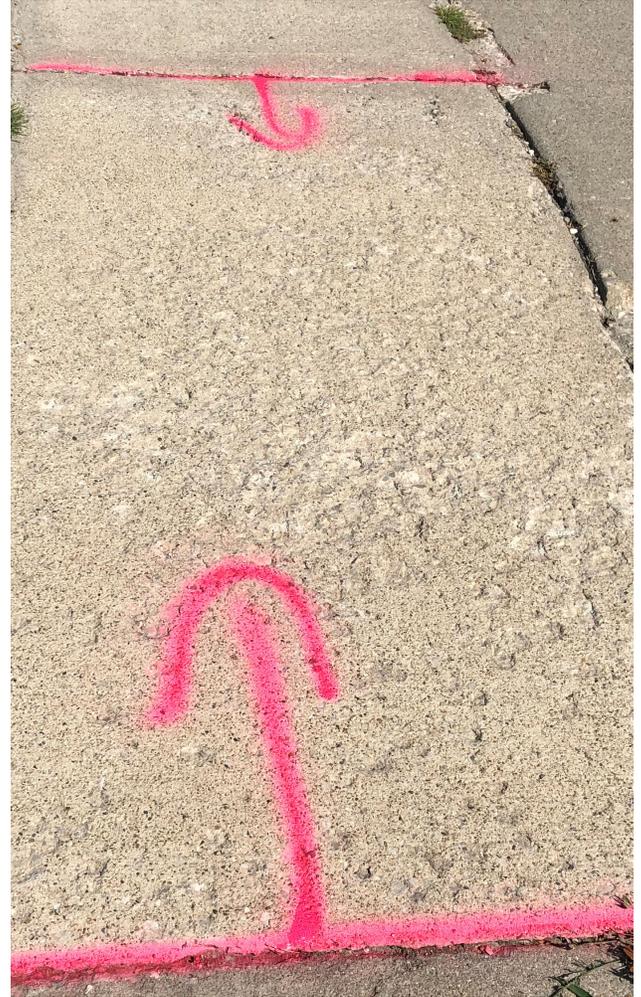
(D.) SPALLING OVER 50% OF A SINGLE SQUARE OF THE SIDEWALK WITH ONE OR MORE DEPRESSIONS EQUAL TO ½” OR MORE

(E.) SPALLING OVER LESS THAN 50% OF A SINGLE SQUARE OF THE SIDEWALK WITH ONE OR MORE DEPRESSIONS EQUAL ¾” OR MORE

The appropriate repair for this scenario is replacing the panel. Spalling is a condition in which the top portion of the concrete starts to pop off in pieces. There are two common reasons for this. First is the placement of salt and/or de-icing chemicals on the concrete during the winter months. The salts and chemicals actually eat away at the concrete surface, leaving it pitted. The second is that the concrete was finished in a manner that doesn't provide an effective seal. Adding salt and chemicals atop this already weakened seal results in a rapidly deteriorating sidewalk surface.

Repair Suggestions for Deficiencies (D. & E.):

- Replacing the panel – PERMIT REQUIRED

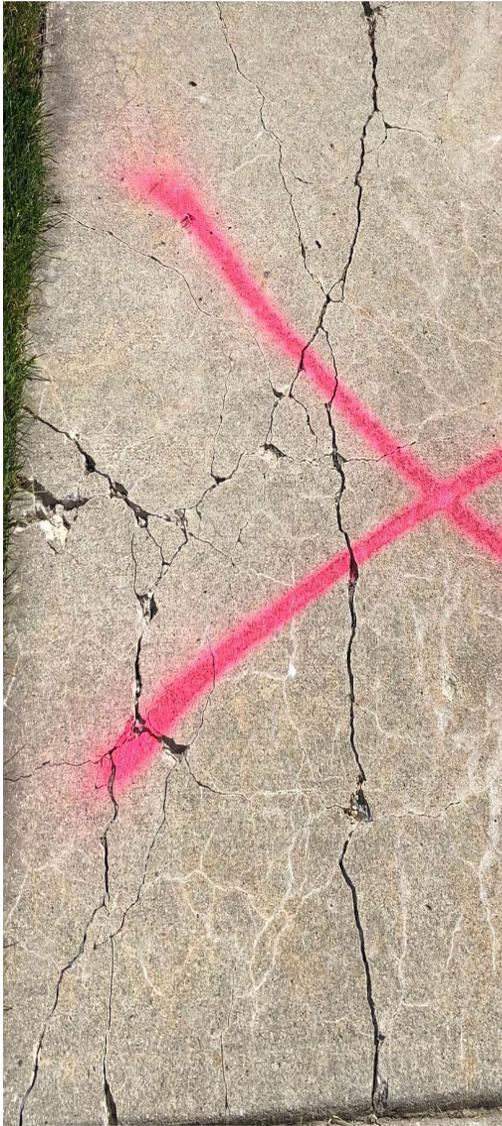
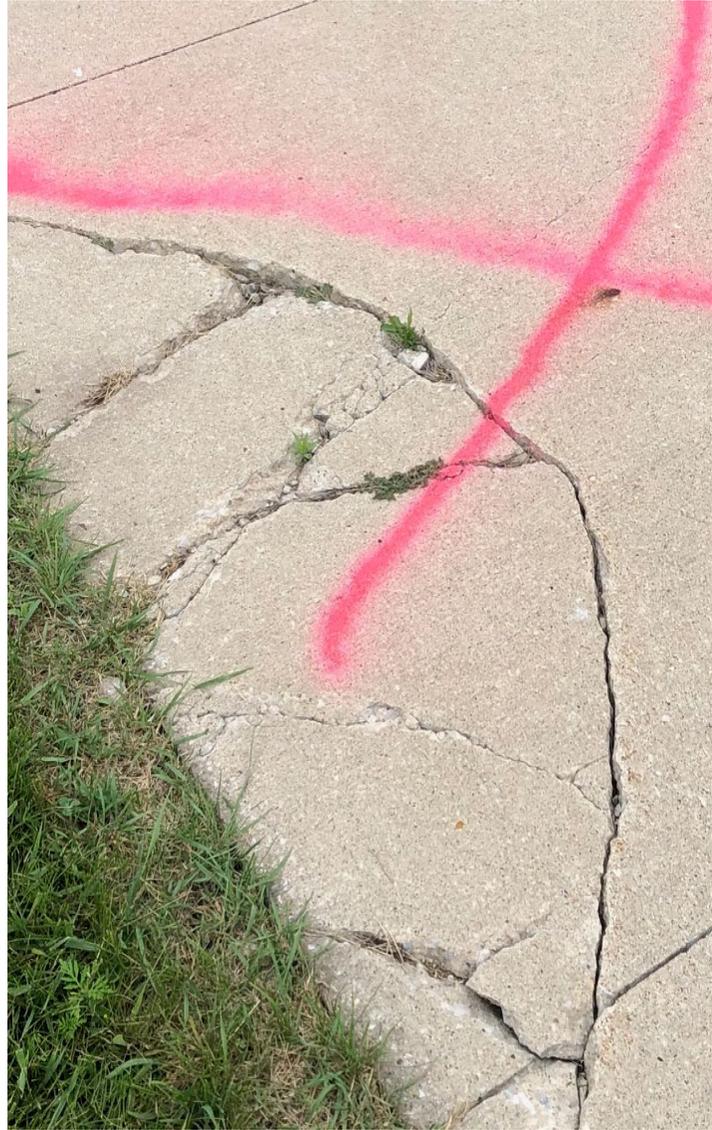
(F.) A SINGLE SQUARE OF SIDEWALK CRACKED INTO 6 OR MORE PIECES

The appropriate repair for this scenario is replacing the panel. Many times this scenario is caused by a vehicle driving over the sidewalk.

Repair Suggestions for Deficiency (F.):

- Replacing the panel – PERMIT REQUIRED

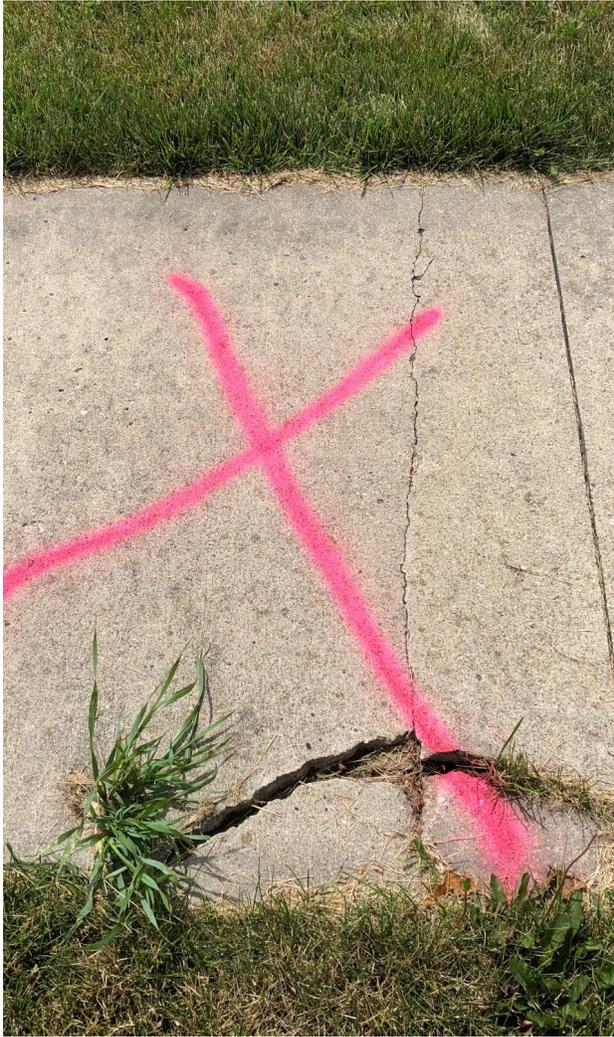
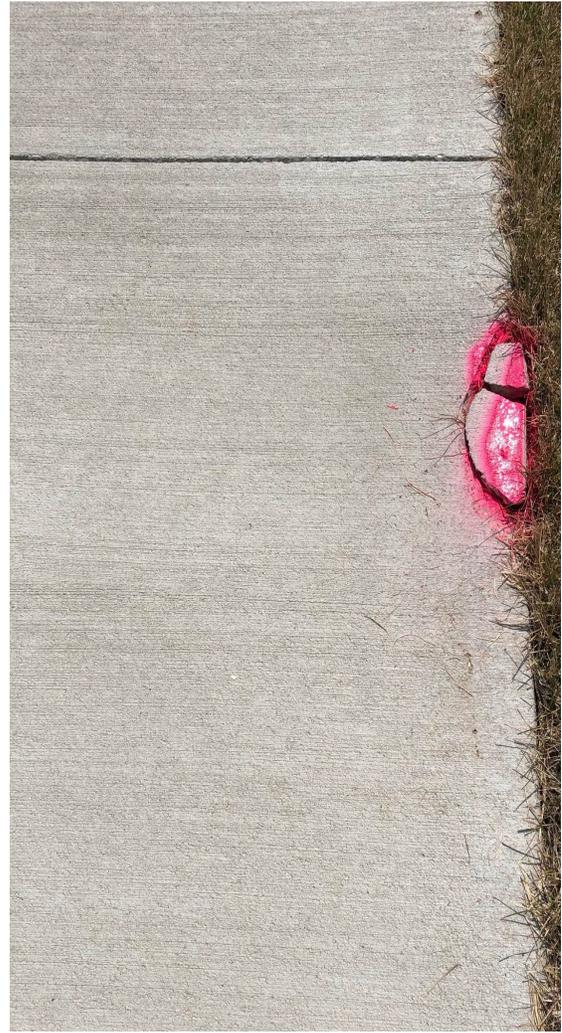
(G.) A SIDEWALK WITH ANY PART THEREOF MISSING TO THE FULL DEPTH

The appropriate repair for this scenario is replacing the panel. If ANY part of the sidewalk is missing in its entirety, Deficiency G applies.

Repair Suggestions for Deficiency (G.):

- Replacing the panel – PERMIT REQUIRED

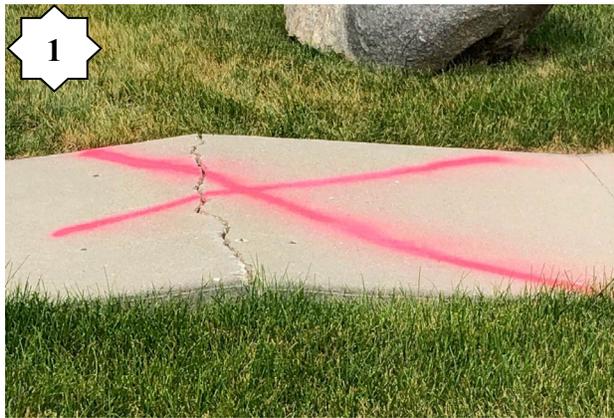
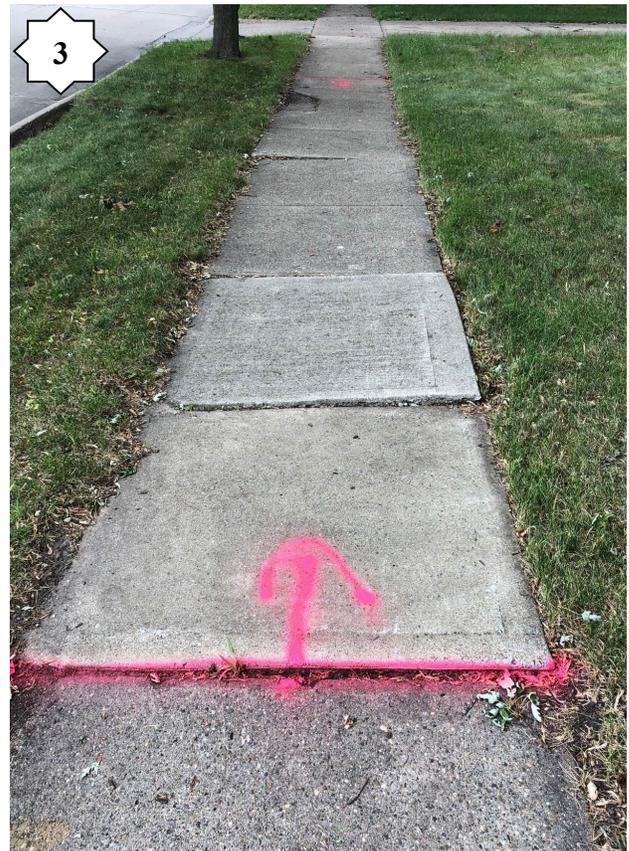
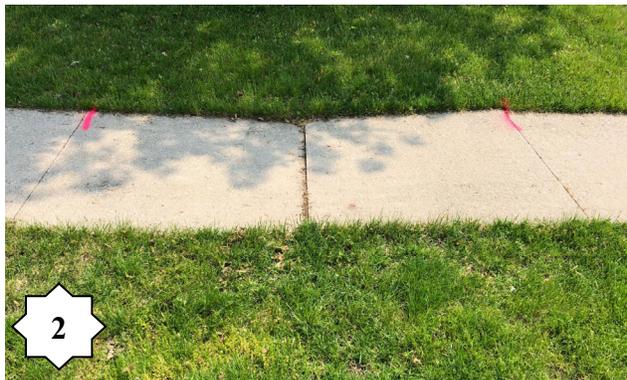
(H.) A CHANGE FROM THE DESIGN OR CONSTRUCTION GRADE EQUAL TO OR GREATER THAN ¾" PER FOOT

The appropriate repair for this scenario is on a case by case basis, as this condition may be caused by a couple different reasons. If the panel(s) have sunken as in photo (2) you may be able to mud jack or raise the panel(s). If the panel(s) have heaved (raised) as depicted in photos (1&3) then the only repair is to replace the panel(s).

Repair Suggestions for Deficiency (H.):

Sunken Panel:

- Mud jacking
- Raising the panel
- Replacing the panel – PERMIT REQUIRED IF THIS OPTION IS CHOSEN

Heaved (Raised) Panel:

- Replacing the panel – PERMIT REQUIRED

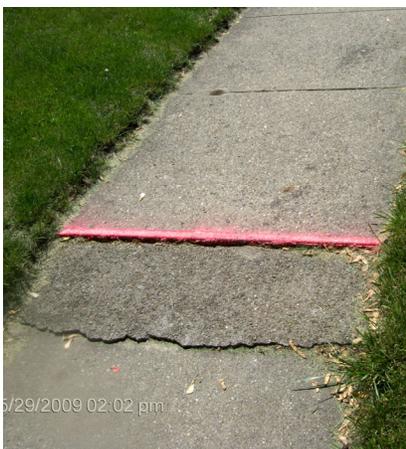
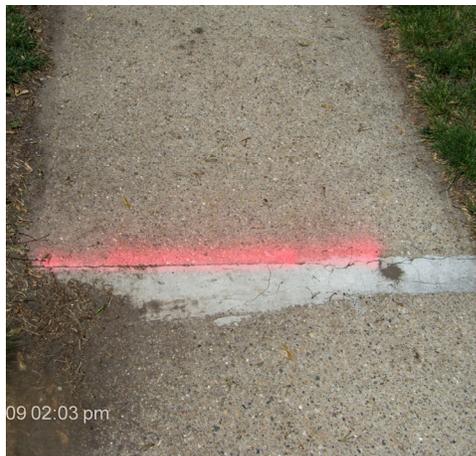
PATCHING:

*The City of Altoona does **NOT** recognize patching as an acceptable sidewalk repair.*

Below are photographs with examples of this specific “fix”.

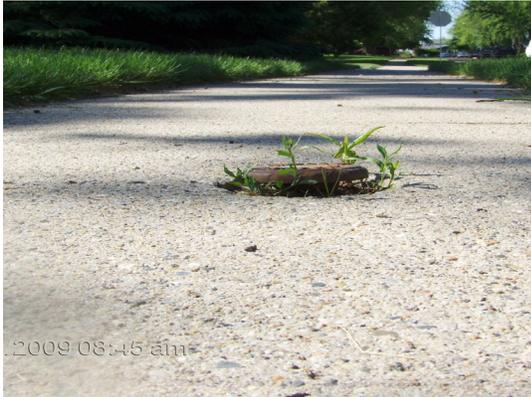
The above picture depicts a water shutoff service cap, commonly known as a “stop box” raised above the surrounding concrete surface. This situation may occur when the ground freezes in the wintertime and thaws in the spring. If you have a stop box located in the sidewalk that abuts your property, please check to see if you have this scenario. Most of the time a raised stop box can be set flush with the surrounding concrete by using a rubber mallet and gently tapping it back down. If you don’t feel comfortable making the proper adjustment to the stop box, please contact the Water Department at 515-967-2454.

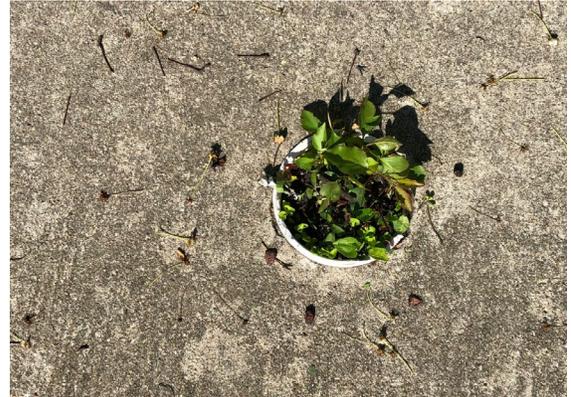
The above picture depicts a water shutoff service cap, “stop box” that is lower than the surrounding concrete surface. This situation may occur when the ground freezes in the wintertime and thaws in the spring. If you have a stop box located in the sidewalk that abuts your property, please check to see if you have this scenario. If your stop box is too low special tools may be needed to raise it. If you don’t feel comfortable making the proper adjustment to the stop box, please contact the Water Department at 515-967-2454.

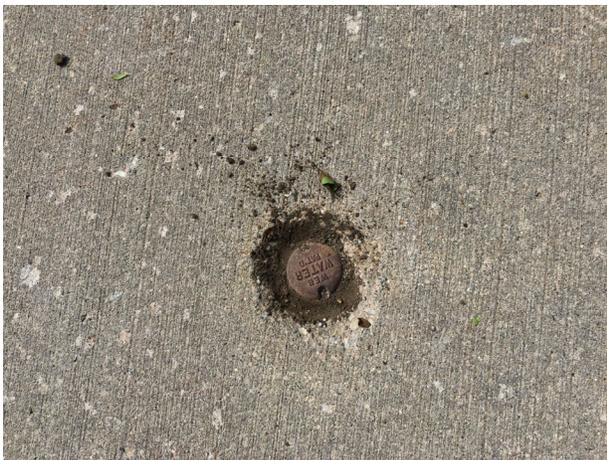
TEMPORARY PLUGS:

The picture to the left depicts a temporary plug. If you have a temporary plug instead of a service cap please contact the Water Department at 515-967-2454 to get a permanent service cap installed.
