TOWN OF BERWICK WATER DEPARTMENT

**Environmental Review**

Water Treatment Plant Upgrades

Berwick, Maine

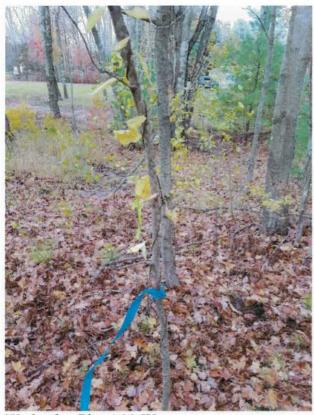
Wetland at Plot A11-W

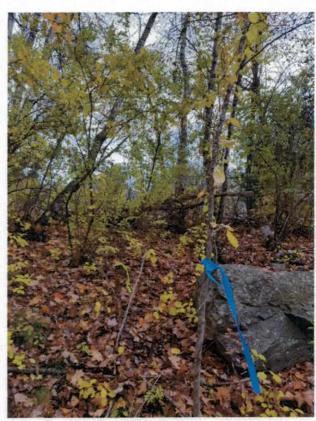
Upland at Plot A11-U

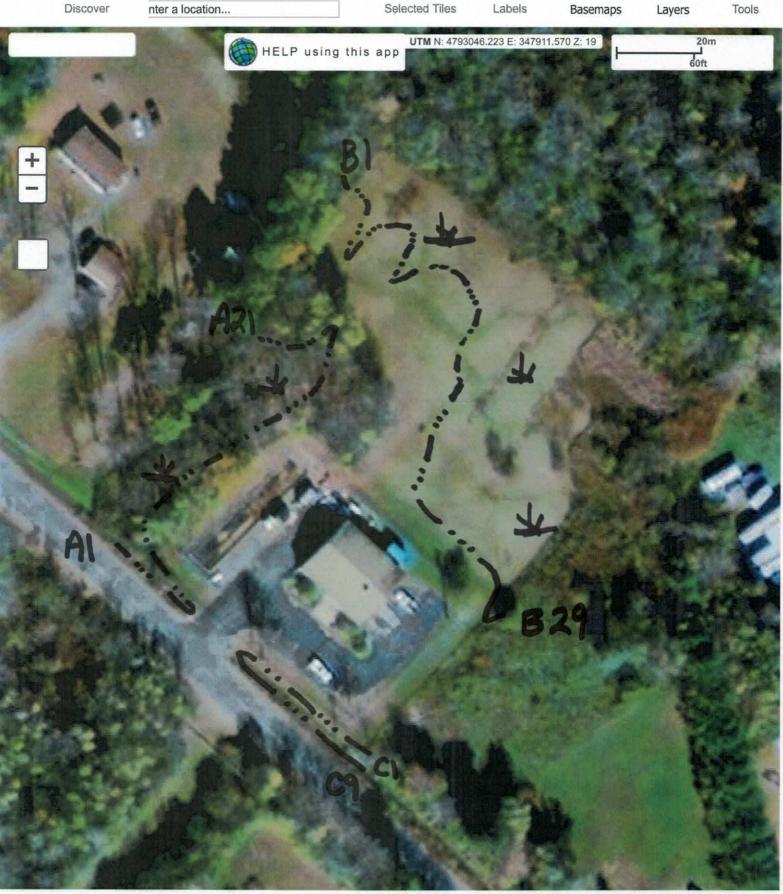
Sketch of Wetlands -- Locations Approximate -

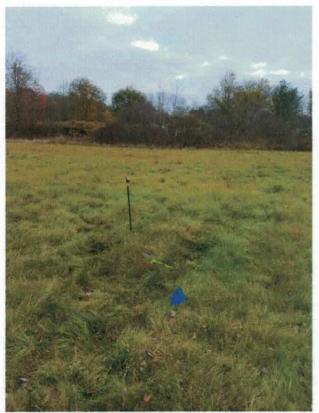
Wetland at Plot B18-W

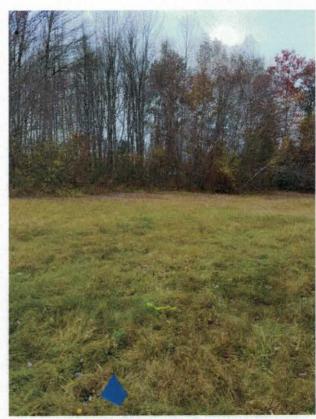
Upland at Plot B18-U
