**2006 EAST END BEACH RESTORATION PROJECT
KIAWAH ISLAND SOUTH CAROLINA**

Survey Report No 11

March 2018

BEACH MONITORING PROGRAM
SURVEY REPORT NO 11
Annual Beach and Inshore Surveys

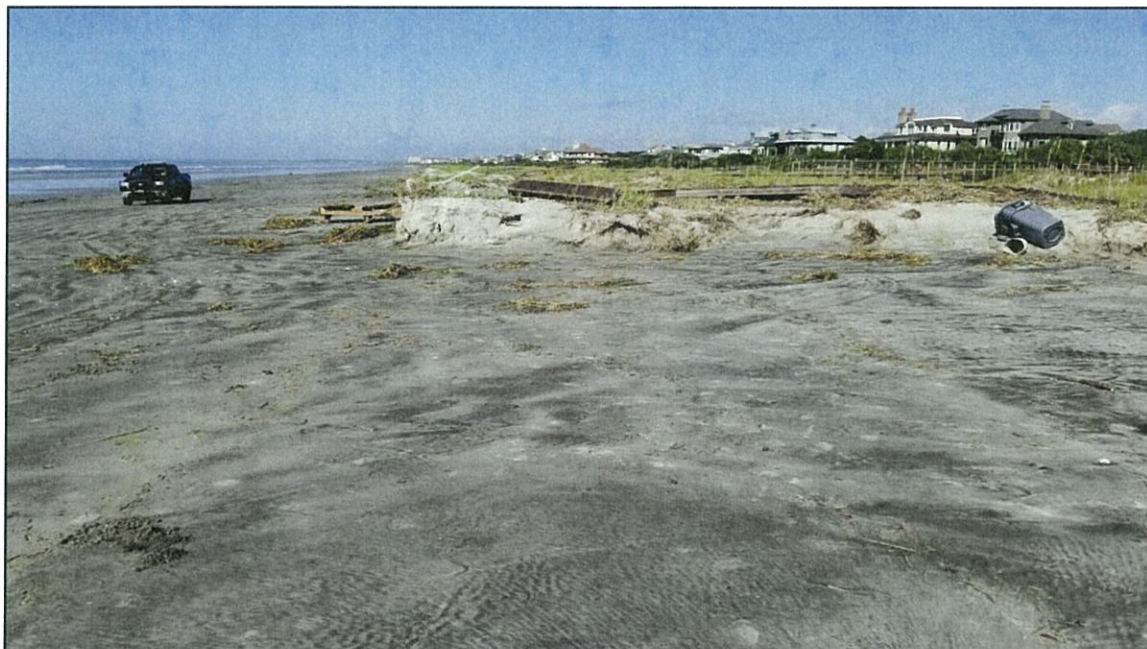
By February 2017, the entire island showed significant recovery of the dry-sand berm and some dune growth; however, Hurricane *Irma* caused additional damage to the dune field. *Irma* resulted in another 10–20 ft of dune loss beyond what was lost with Hurricane *Matthew*; however, overall sand volume loss was lower (Fig A). With the additional dune loss, some areas along the golf courses were within OCRM's definition of an emergency condition, and other areas had insufficient setbacks from the high-tide line. The Town conducted a dune restoration project along these areas after securing state and federal authorization. Figure B shows the dune position change since 2012 over the island. Figure C shows an example of the dune position change from Eugenia Avenue.

FIGURE A. September 2017 post-storm photo of the area near Beach Access 32 showing the eroded dune following Hurricane *Irma*.

CSE recommends the Town regularly assess the recovery of the dune area through photographs or dune-line GPS surveys. CSE does not believe additional emergency-type action is required; however, if the Town or other parties desire to restore the dune system beyond what was accomplished by the Town's restoration efforts, upland sand can be used for minor nourishment. CSE does not believe sand fencing is warranted; however, if sand fencing is installed, it should be installed as close to the primary dune as possible. The next monitoring event will occur in fall/winter 2018–2019.

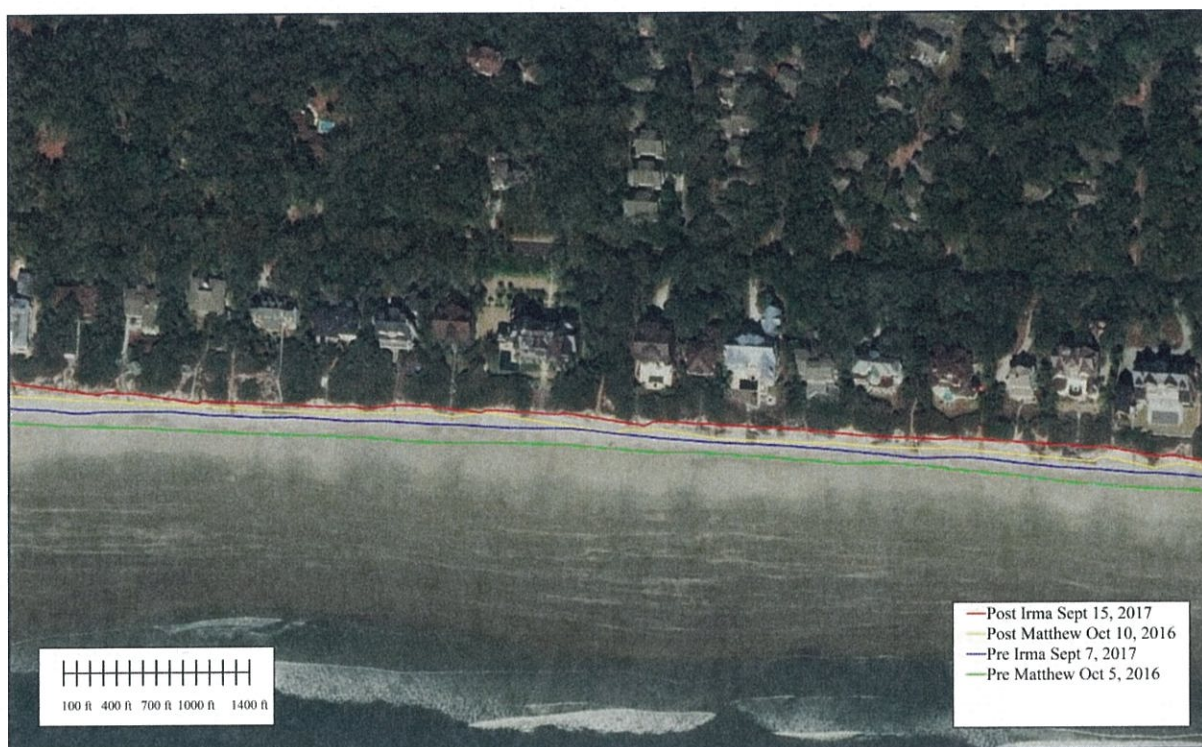
FIGURE C. Example of dune position change since October 2016 along Eugenia Avenue.

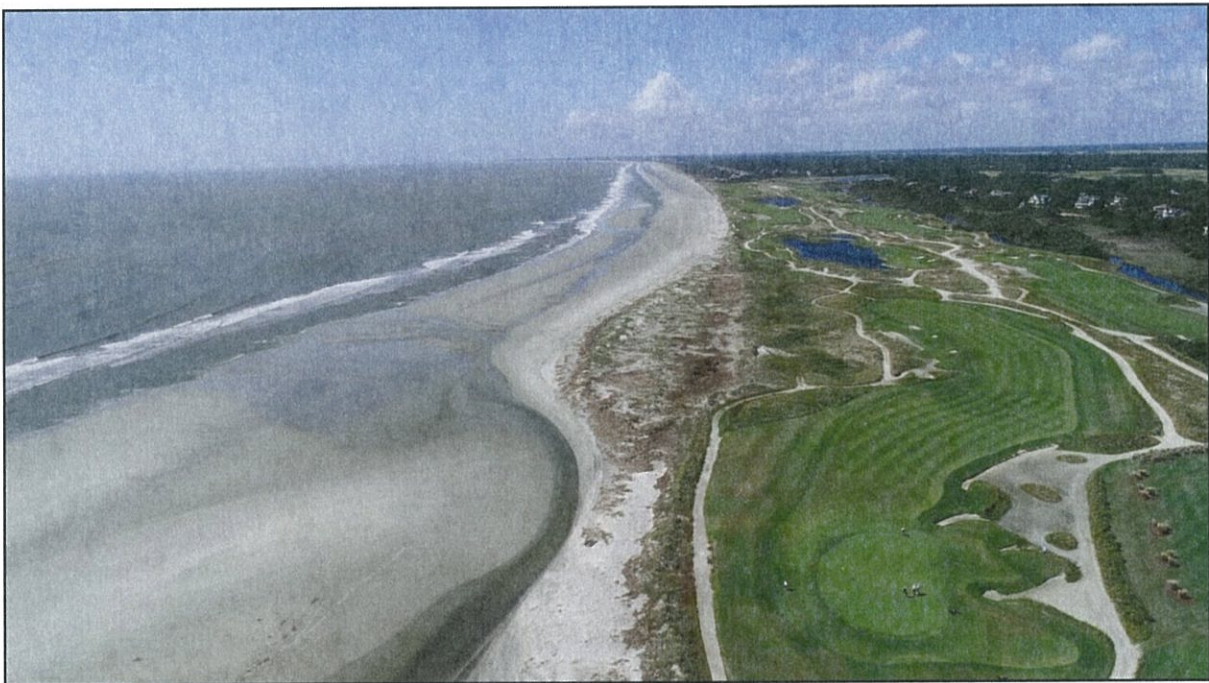
FIGURE 2.1. Kiawah Island in October 2017. Sand from Stono Inlet attaches to the island at the eastern end then migrates west, nourishing the beach.

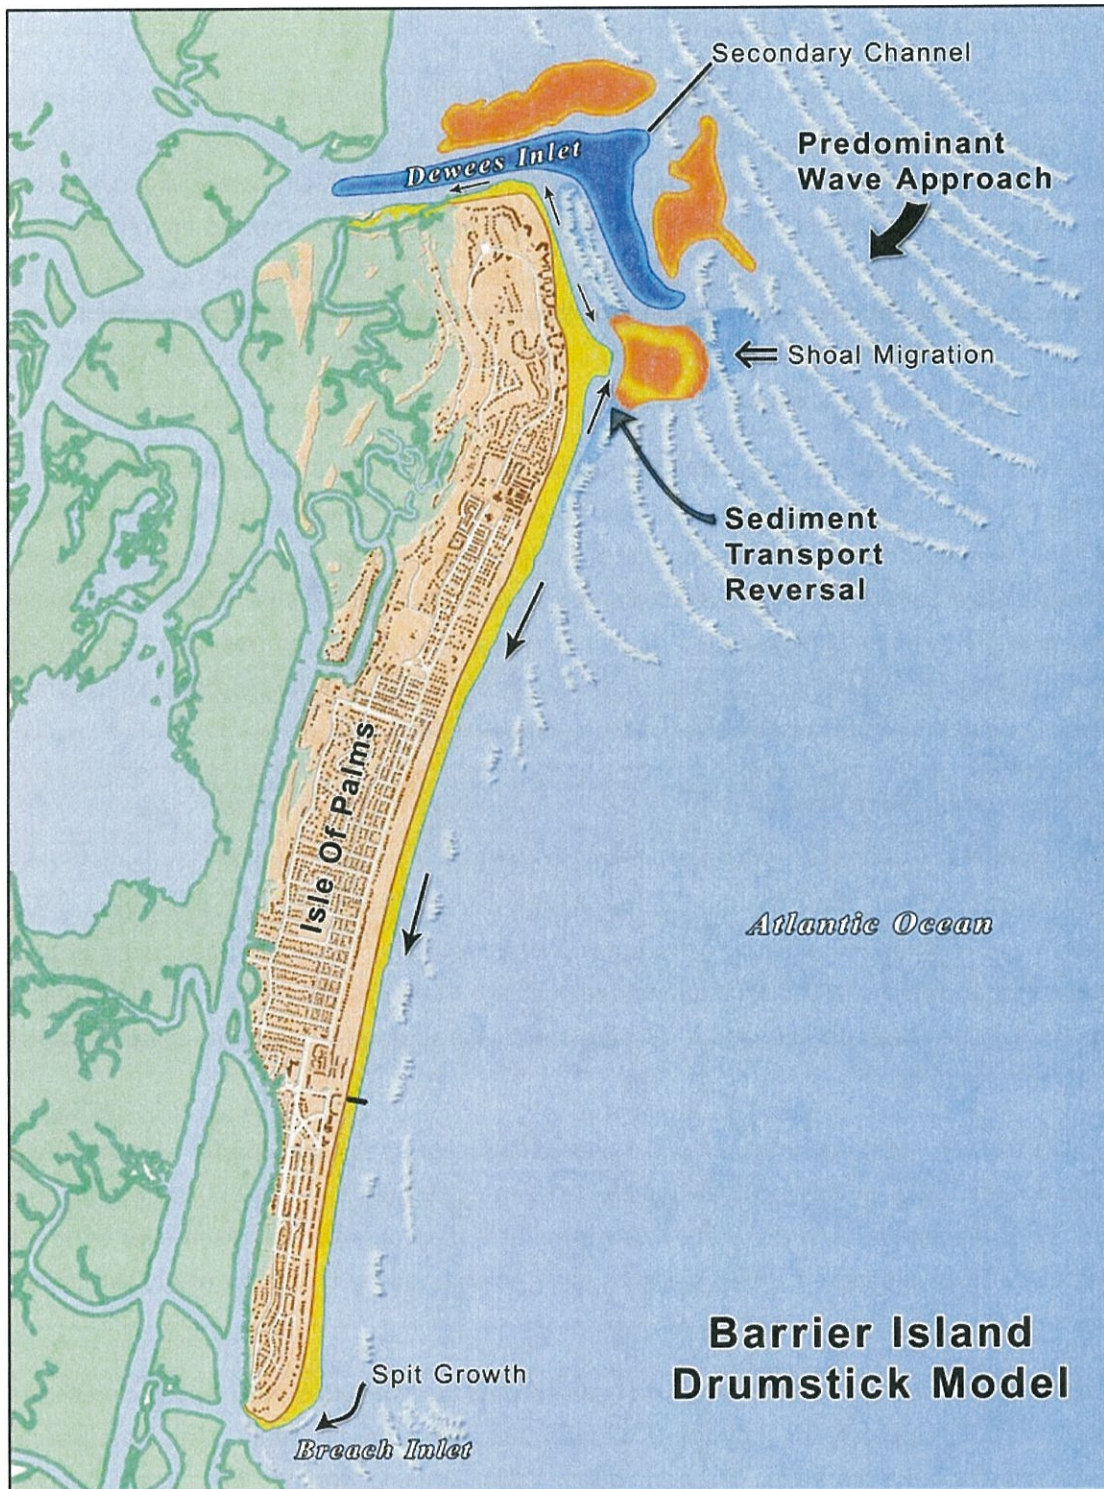
FIGURE 2.2. Barrier-island drumstick model (after Hayes 1977) using Isle of Palms as an example. The upcoast end is wider due to additions of sand from shoal-bypass events in the inlet. Net transport to the south builds a spit at the downcoast end of the island.

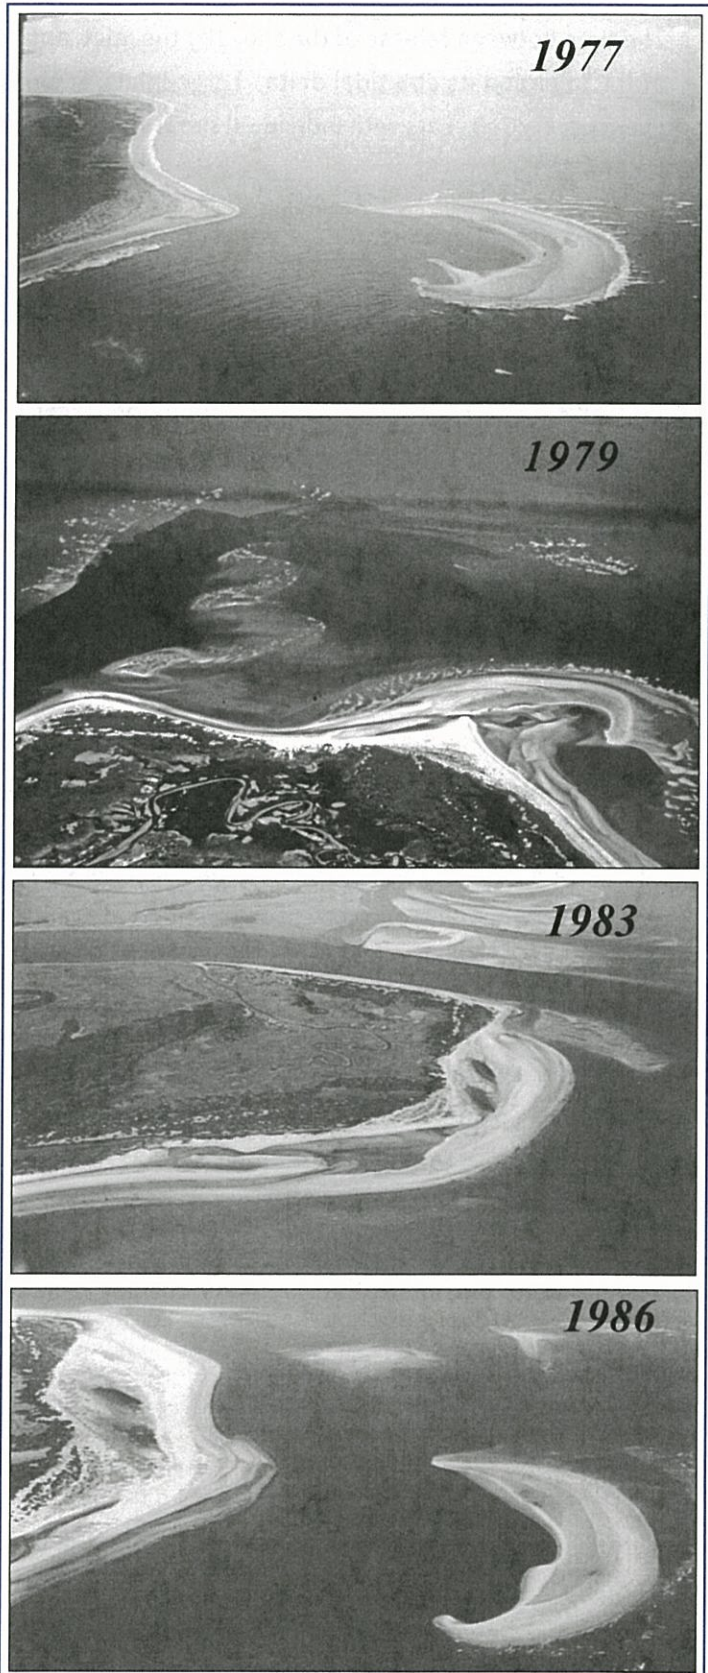
FIGURE 2.6.

Stage 1 in 1977 (upper). Stage 2 in January 1979 (upper middle) (courtesy of Research Planning Institute Inc). Stage 3 in 1983 (lower middle). Stage 1 in 1986 (lower). Note the similarity between the 1977 shoal and the 1986 shoal, but the additional sand accumulated on Kiawah in 1986. [After Kana et al 1999]

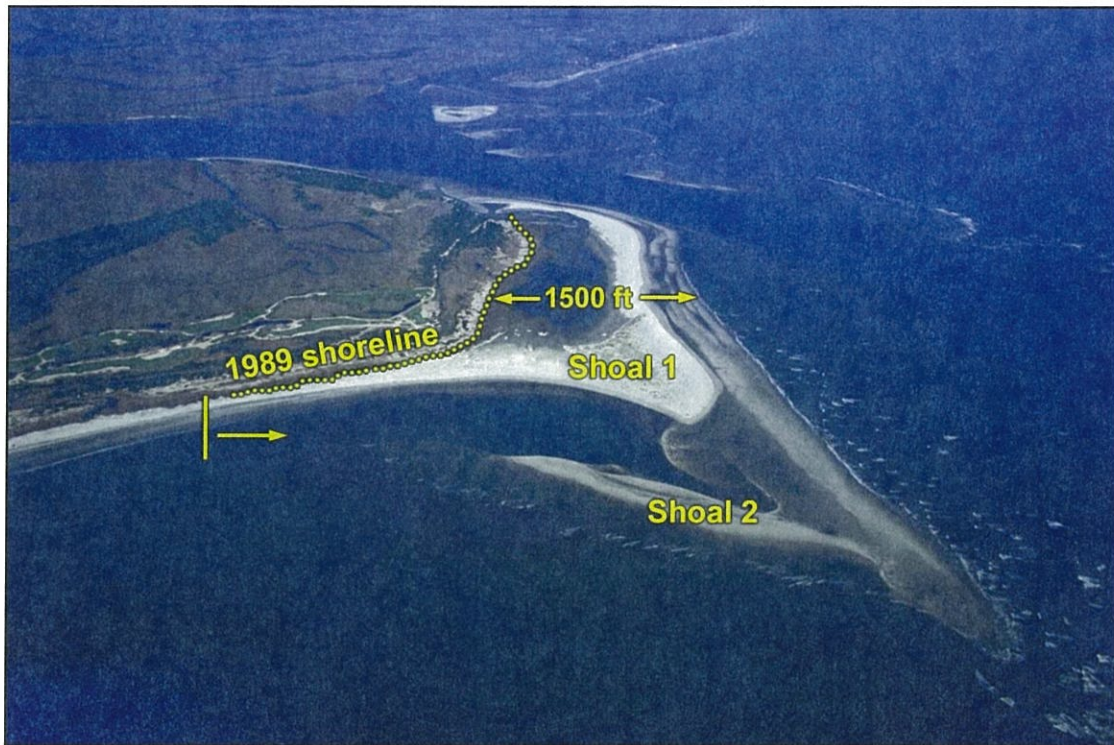
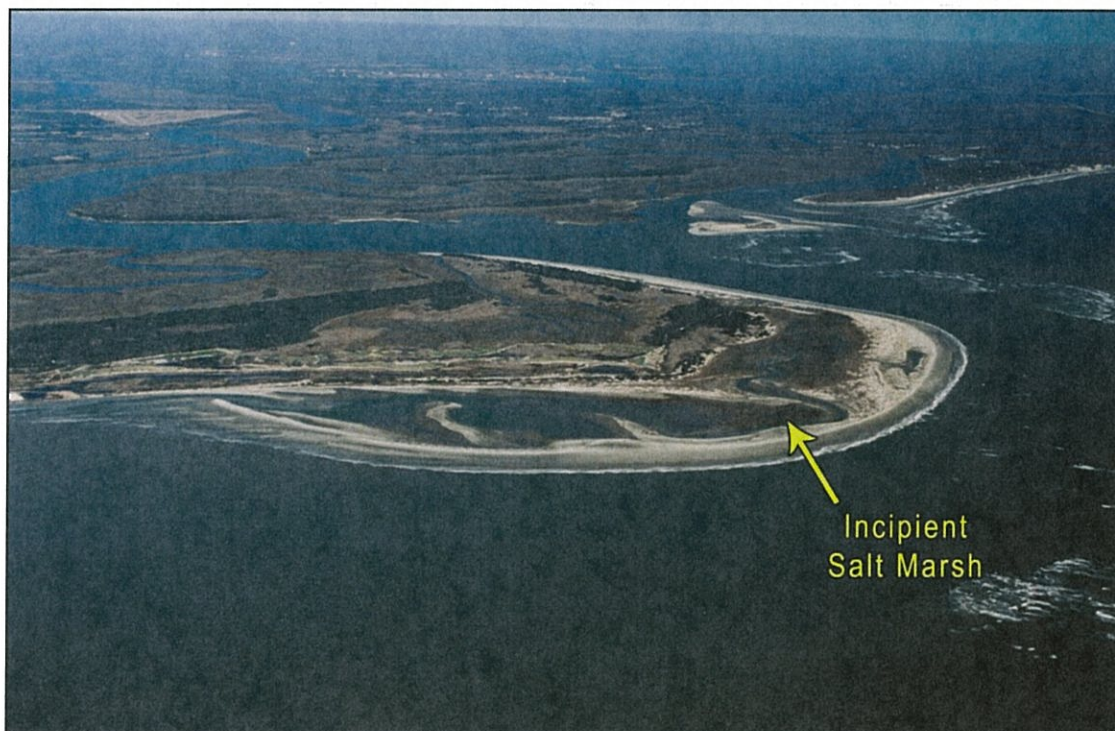
FIGURE 2.7. The eastern end of Kiawah Island in December 1998 (upper) and February 2005 (lower). Note the 1989 shoreline situated well inland from the outer beach. Shoals 1 and 2 added upward of 5 million cubic yards to Kiawah in the 1990s. As waves pushed the new sand shoreward, an incipient barrier island/lagoon/marsh formed. The new lagoon was flushed via a channel at the western end of the accreted beach. [From CSE 2007]

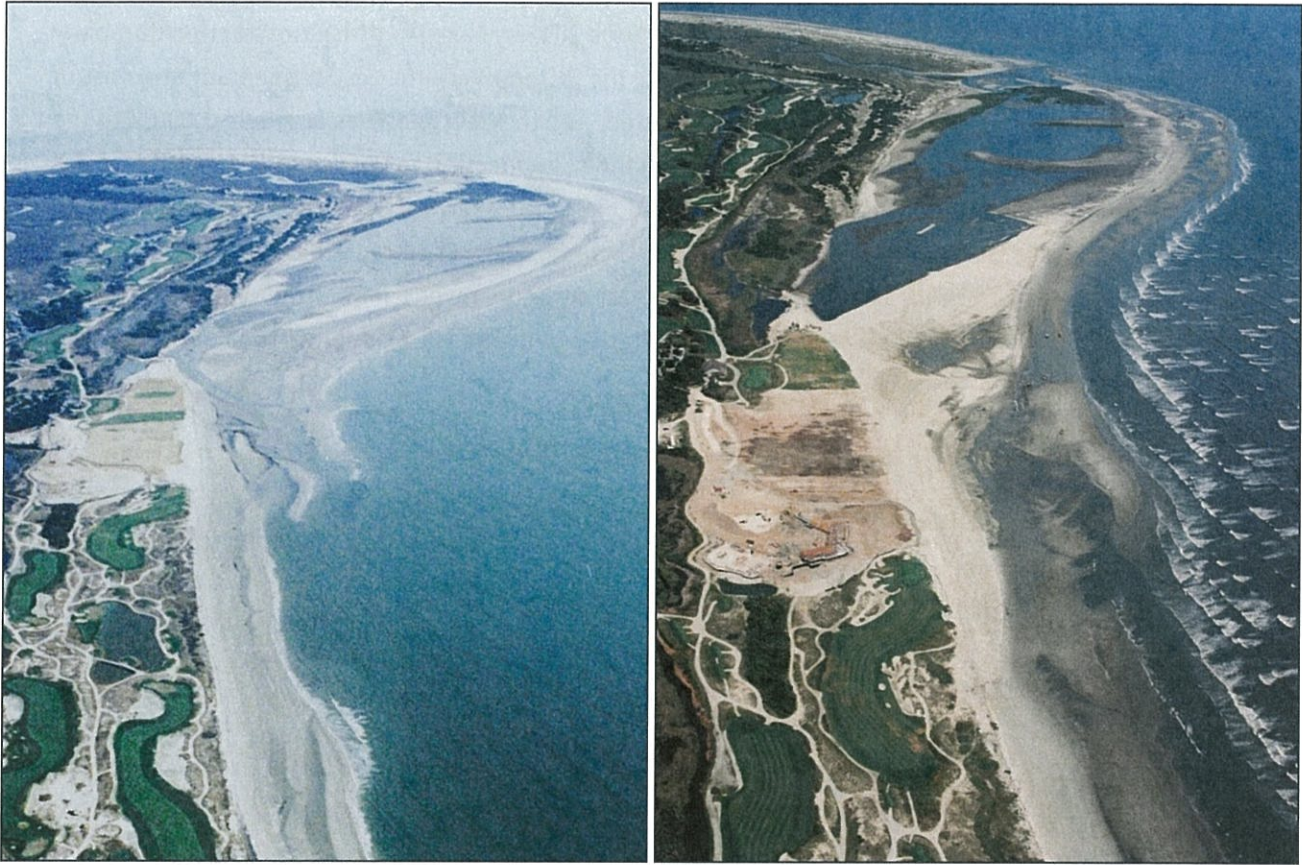
FIGURE 2.8. Before (February 2006) and after (July 2006) aerial photos of the 2006 East End beach restoration project.

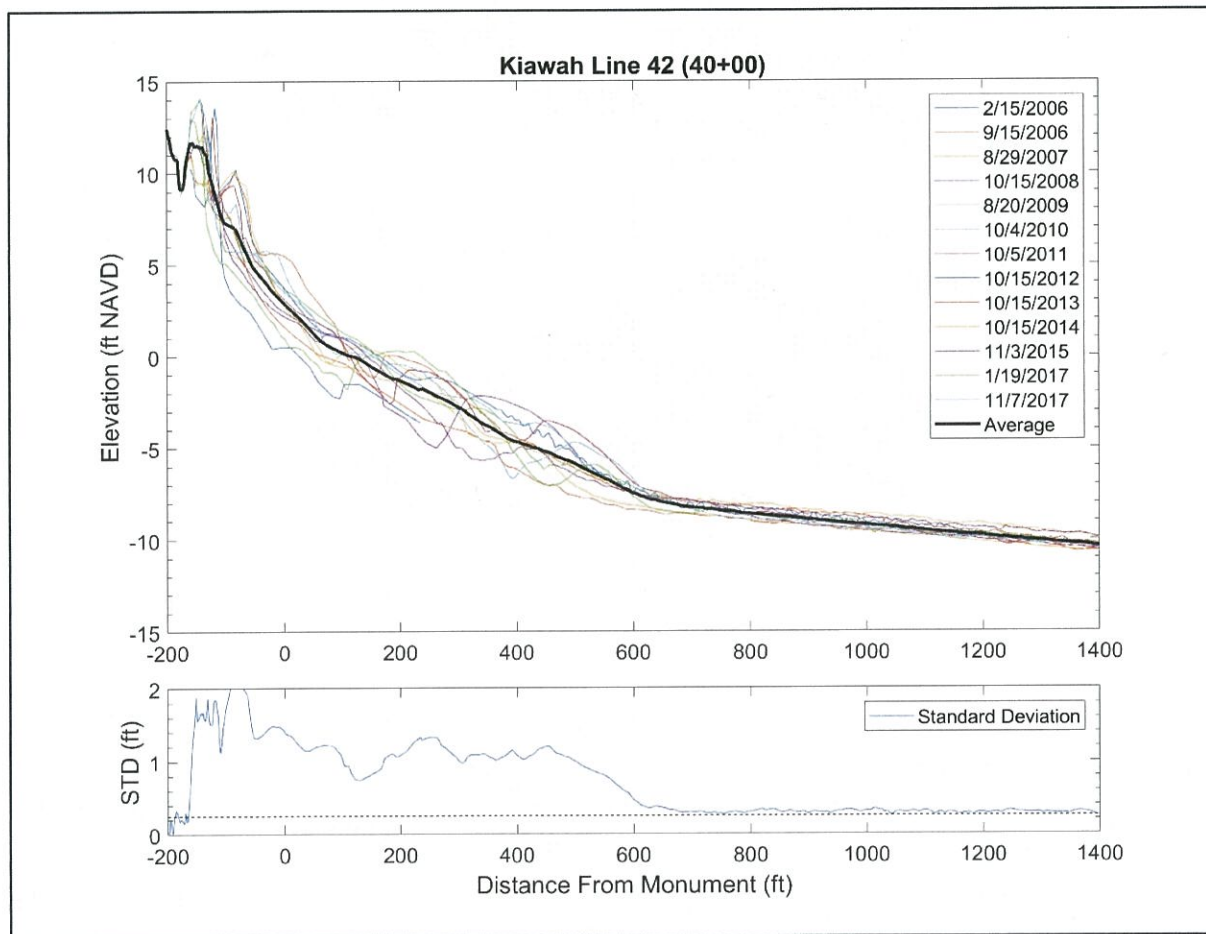
FIGURE 3.5. Comparison of repetitive profiles at a monitoring station along Kiawah Island and computation of standard deviation. Where the profiles converge, the standard deviation is low and is an indicator of little sediment exchange (approximate closure depth).

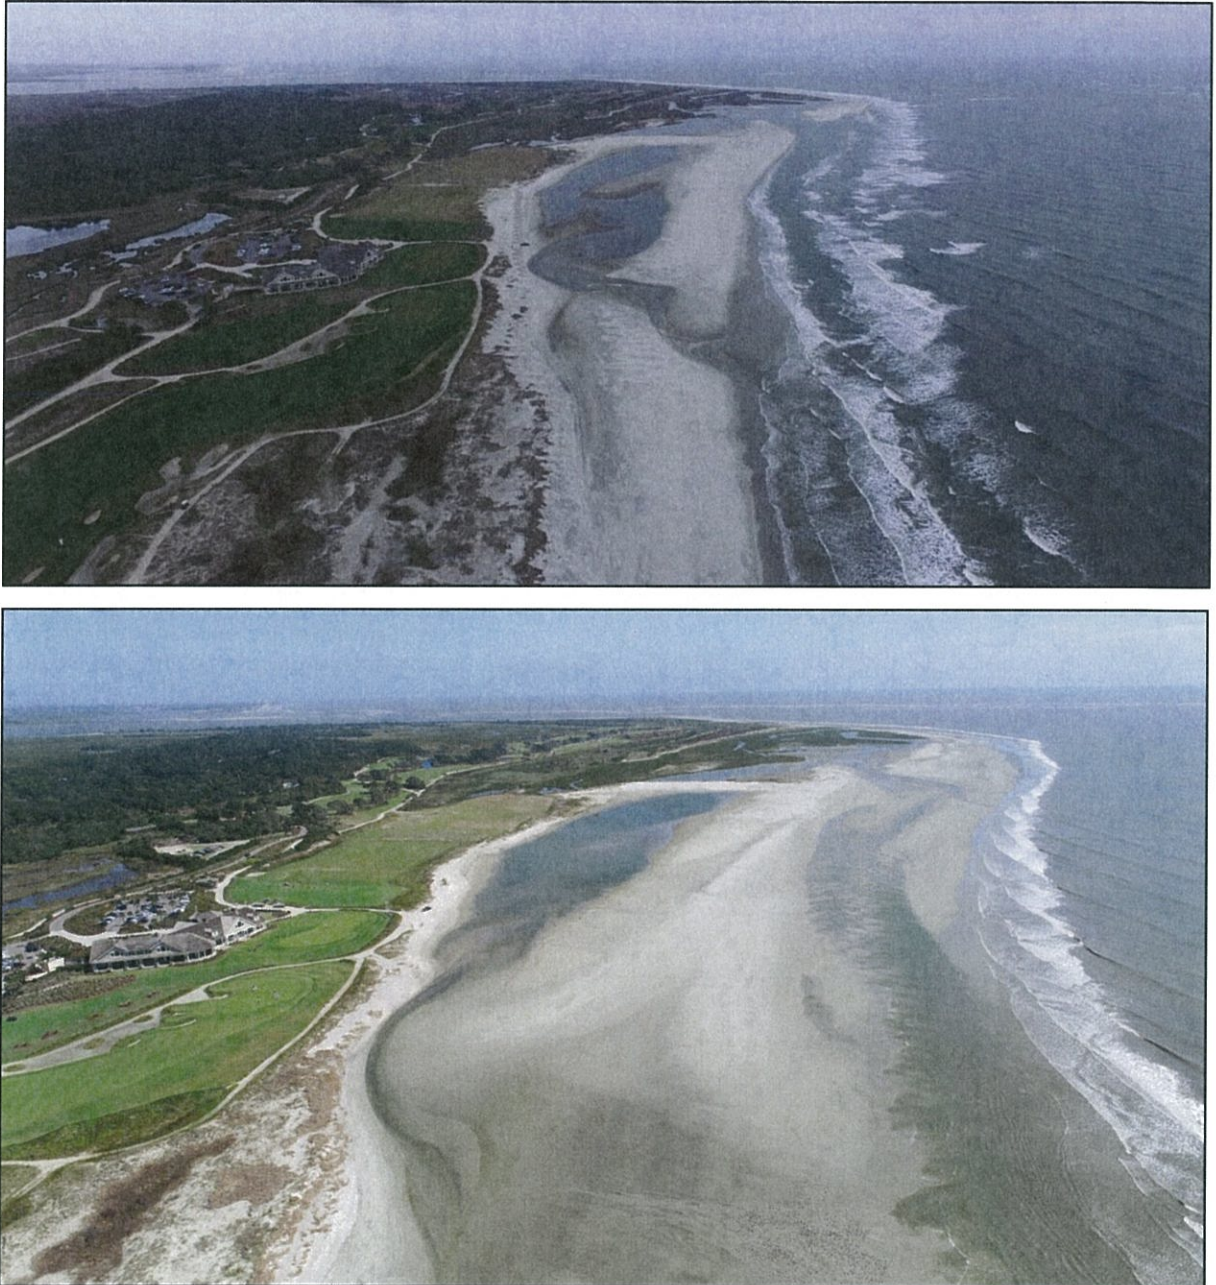
has also decreased in size as the pond has infilled. There is presently more sand in the upper beach profile seaward of the practice green (near the small channel), although there is a lower overall beach volume when considering the entire profile.

FIGURE 4.1. Aerial images of the 2015 project area in February 2017 (upper) and October 2017 (lower).

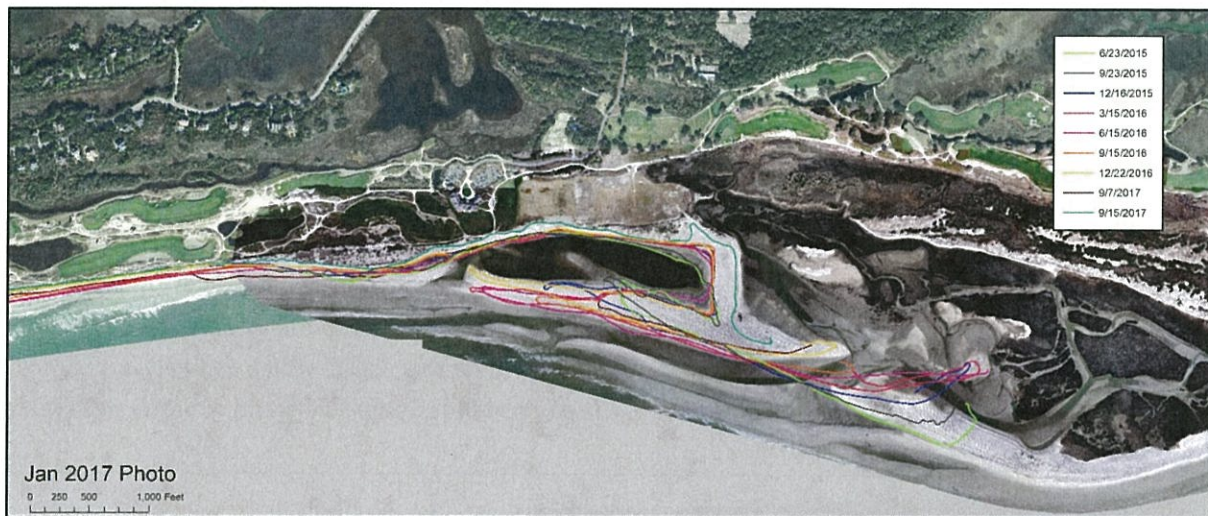
The Town has been collecting quarterly dune-line surveys since project completion. Figure 4.3 shows the position of the dune line (or line of stable dry sand not regularly wetted by spring tides) from June 2015 to September 2017 (post-*Irma*). Since June 2015, the dune line, which represents the boundary of the inlet, has moved ~1,900 ft to the west. The western boundary of the inlet is also migrating landward, which is similar to evolution of the previous inlet from 2010 to 2014. The westward growth and extension of the outer berm from 2015 to December 2017 is also evident in the dune-line surveys; however, in 2017, the dune line on the outer bar shifted landward and retreated further east. Again, this survey defines the limit of vegetation, and much of this was lost during Hurricane *Irma*. It is likely to extend again to the west under normal weather conditions.

FIGURE 4.3. Position of the dune line or line of stable dry beach from June 2015 to September 2017. Data were collected by Town staff. The inlet has migrated over 1,400 ft to the west.

Overall, the 2015 channel realignment project is performing nearly as expected, and has withstood well the impacts of two major hurricanes. The area should continue to be monitored periodically by Town staff and if significant changes are observed, CSE should be consulted.

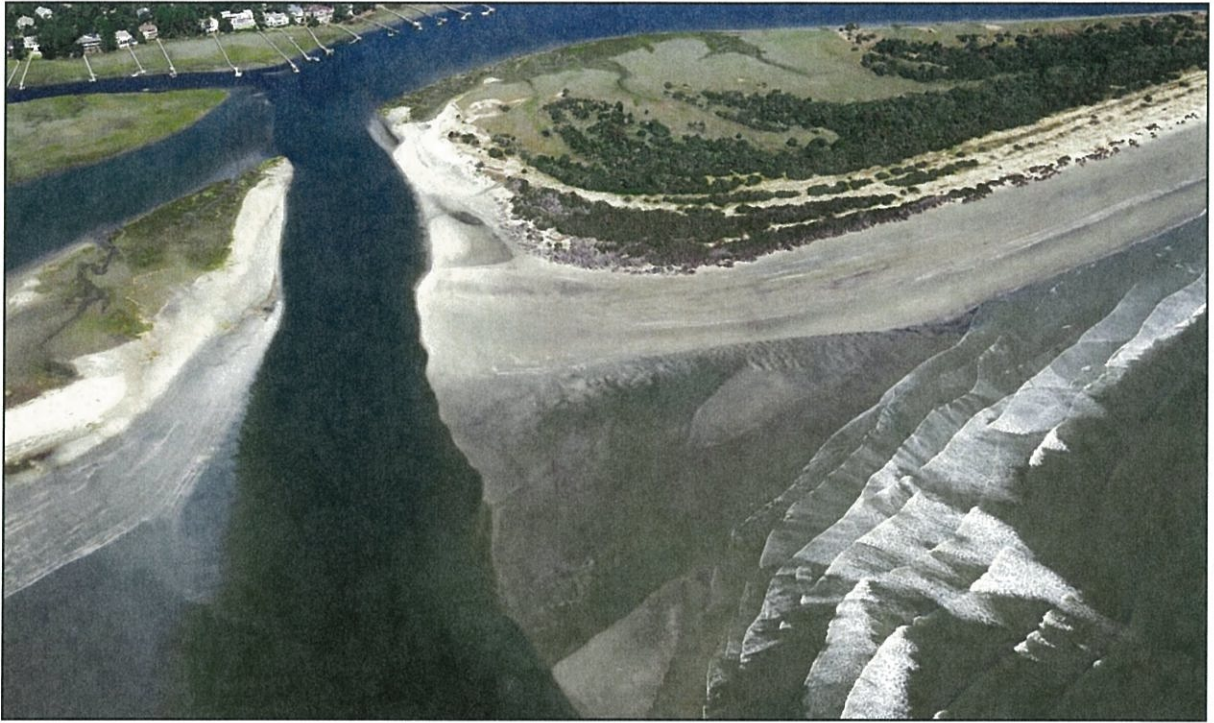
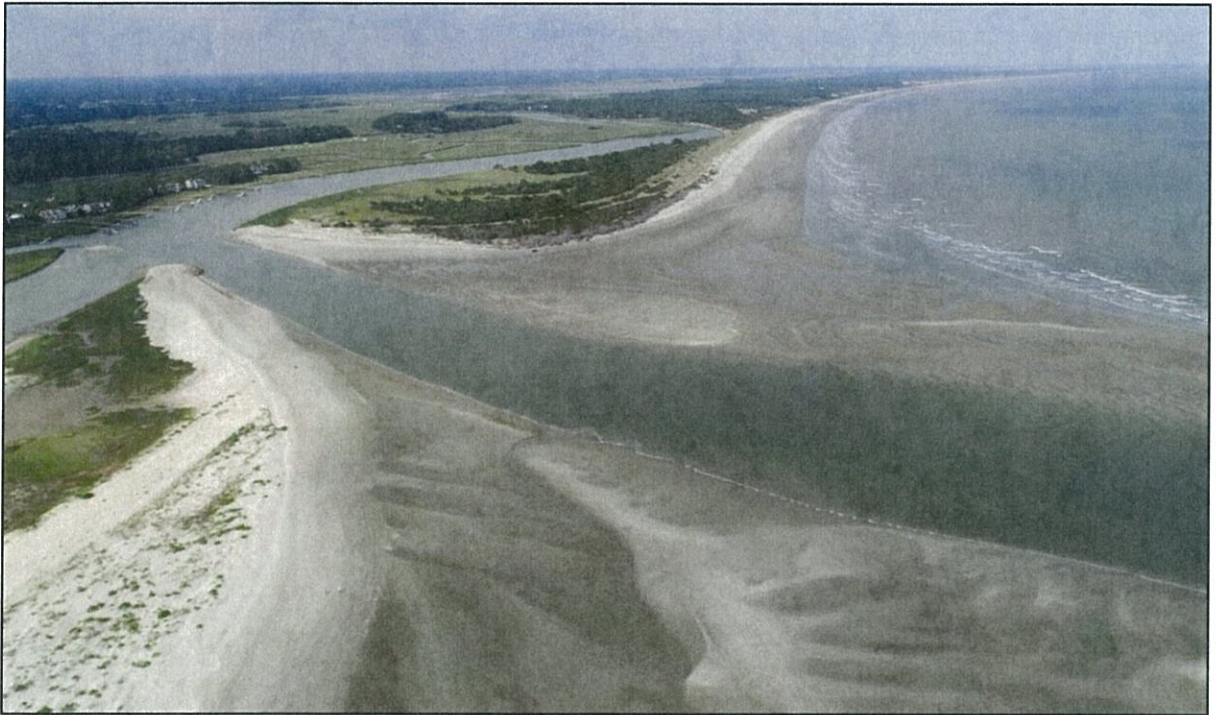
FIGURE 4.5. October 2016 (upper – post-*Matthew*) and June 2017 (lower) aerial images of Captain Sams Inlet, which was relocated ~3,000 ft to the east by SIPOA in May–June 2015.

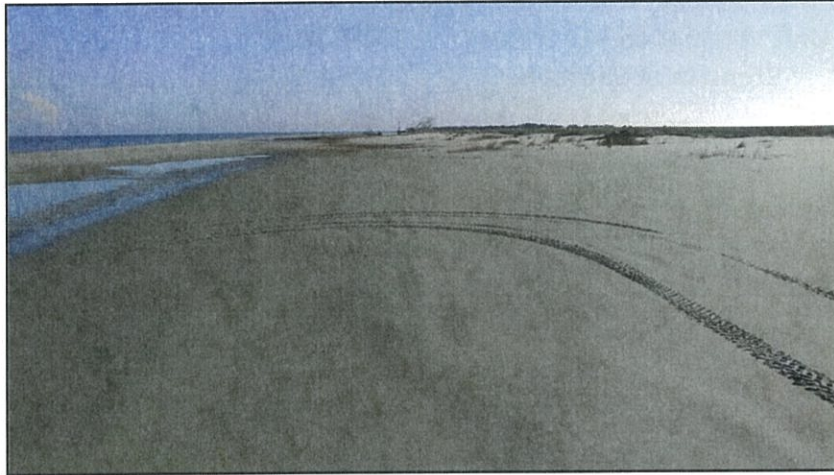
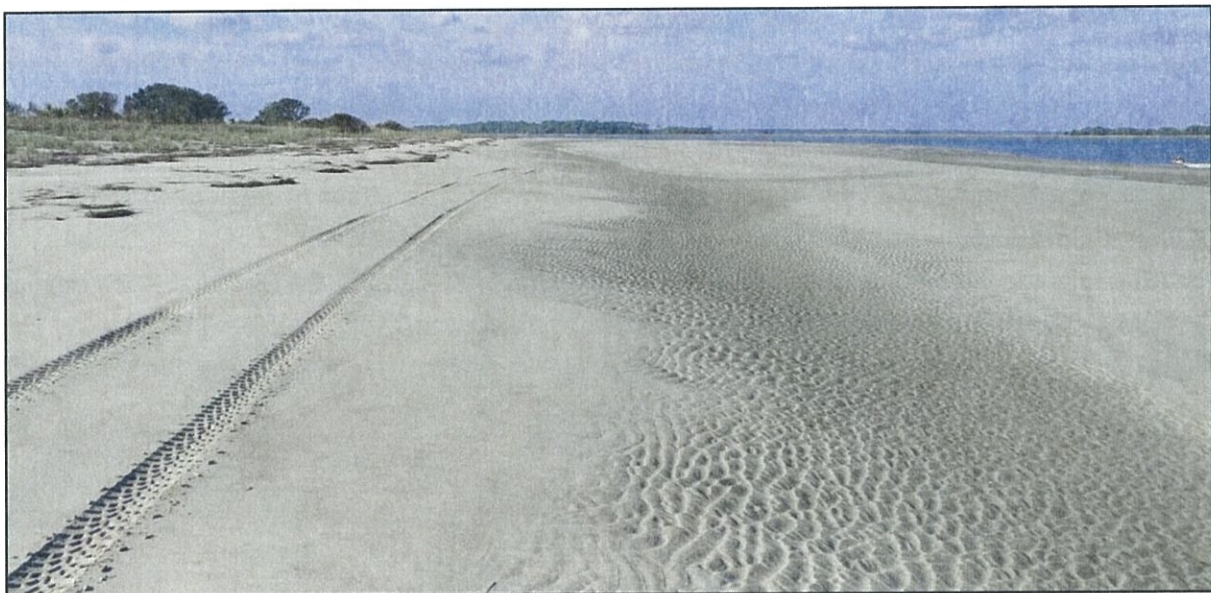
FIGURE 4.7.

Hurricane *Matthew* resulted in the washout of a significant dune area between Lines 56 and 58. This area was eroded further by Hurricane *Irma*, and multiple connections between the lagoon and ocean were present including one along the Stono Inlet Reach near Lines 56 and 57. Profiles for the reach show over 70 ft of beach recession from November 2015 to January 2017 (following Hurricane *Matthew*) and another loss of over 100 ft of beach for January to November 2017 (after Hurricane *Irma*). Ground photos (Fig 4.7) show the eroded beach condition and washover condition at Stations 56 and 57 (Fig 4.8). Further inland, the beach is still eroded; however, no marsh exists landward of the dunes, and the beach is migrating into upland area rather than overwashing. Since 2007, the reach has lost a total of 494,000 cy, which is an average annual erosion rate of 8.0 cy/ft/yr.

Middle) Line 58

Lower) Line 60

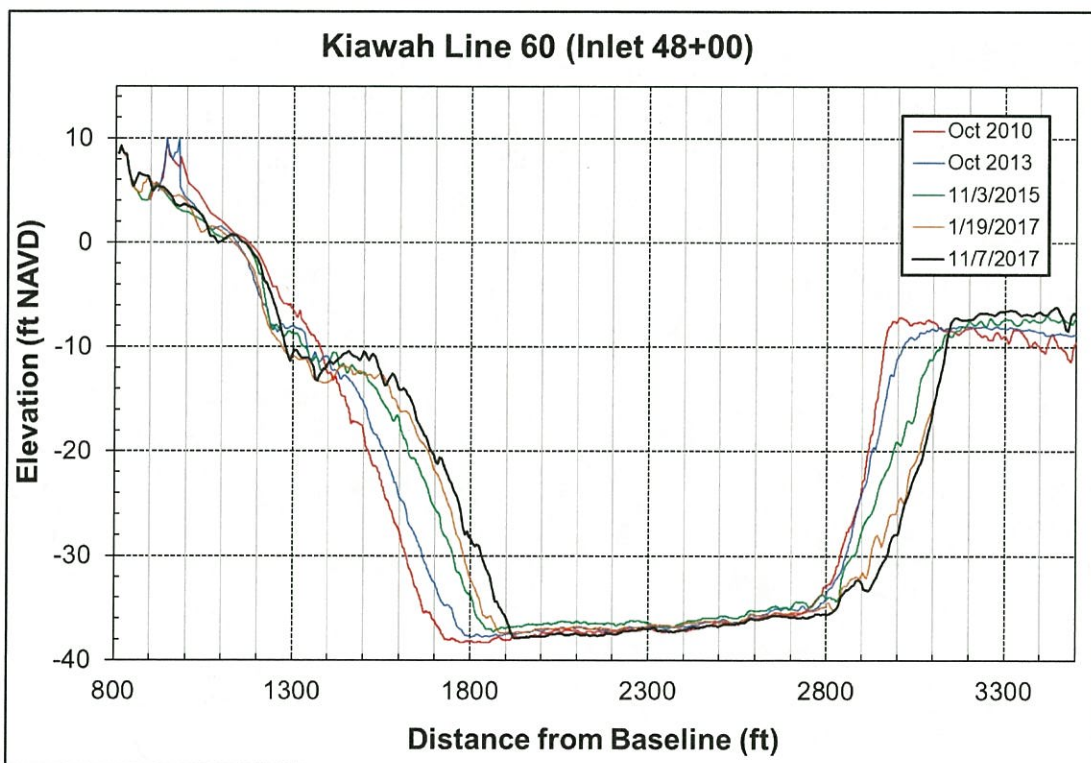
FIGURE 4.8. Profiles from Line 57 (upper) and Line 60 (lower) along the Stono Inlet shoreline. Hurricane *Matthew* eroded all of the remaining dunes in 2016. The berm shifted over 100 ft landward over the past year (due largely to impacts of Hurricane *Irma*). Of note is that the eastern slope of the channel has moved ~200 ft away from Kiawah Island over the past seven years.

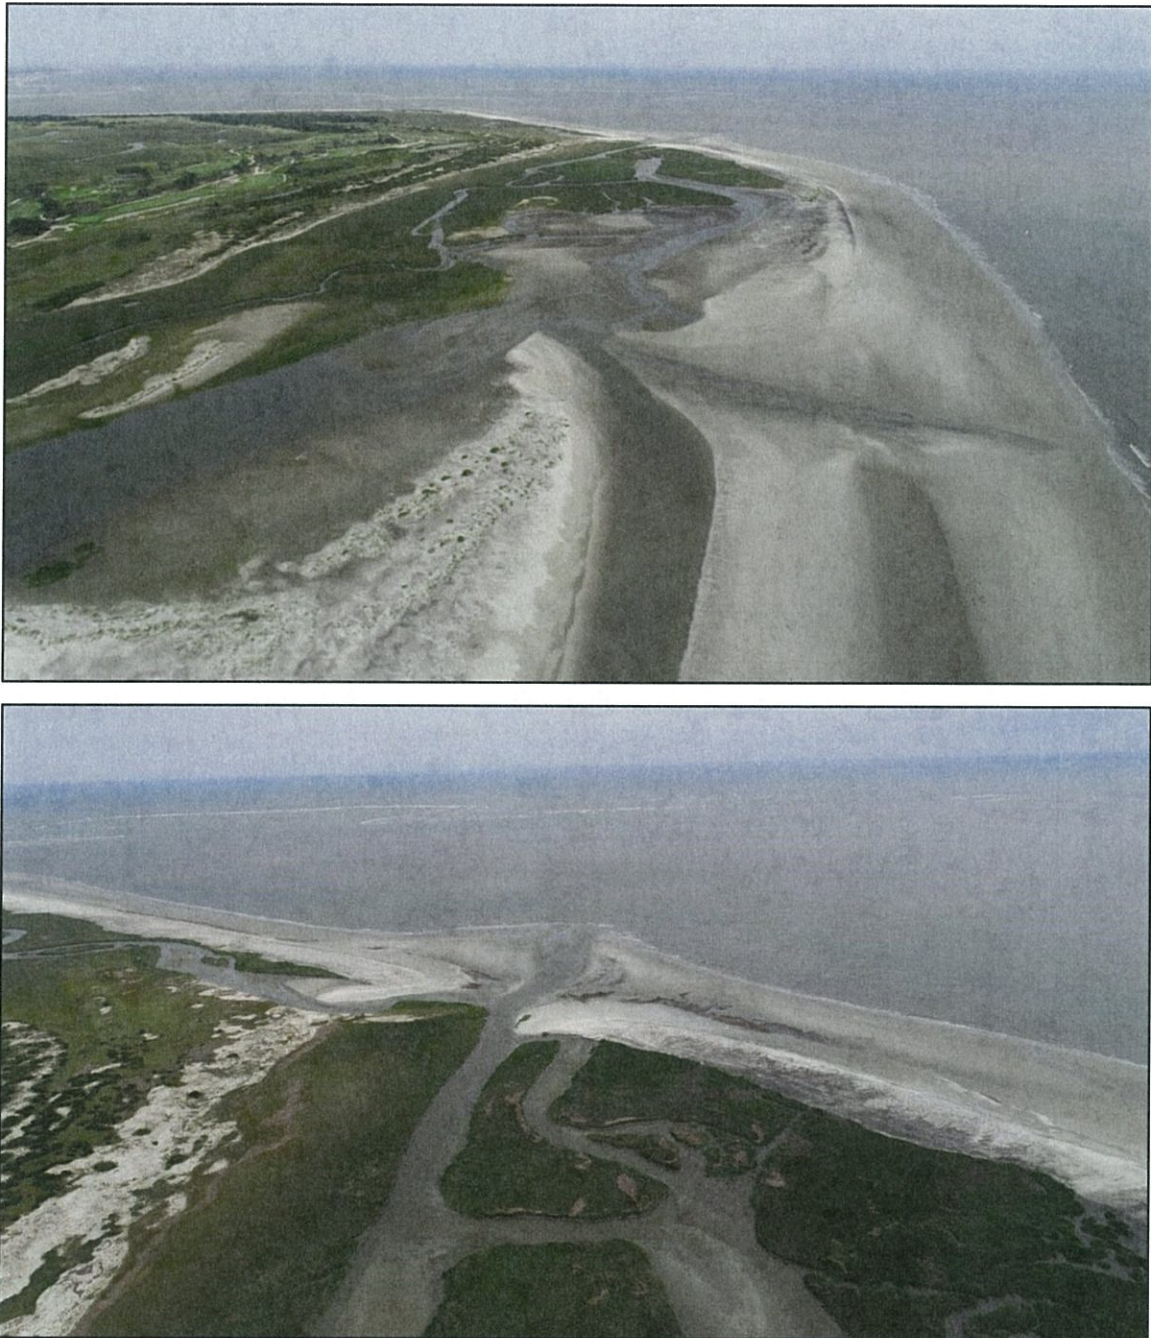
Figure 4.10. June 2017 aerial images of the Lagoon Reach. The 2015 constructed channel is visible in the foreground of the upper image, while the channel created during Hurricane *Matthew* is visible in the lower image.

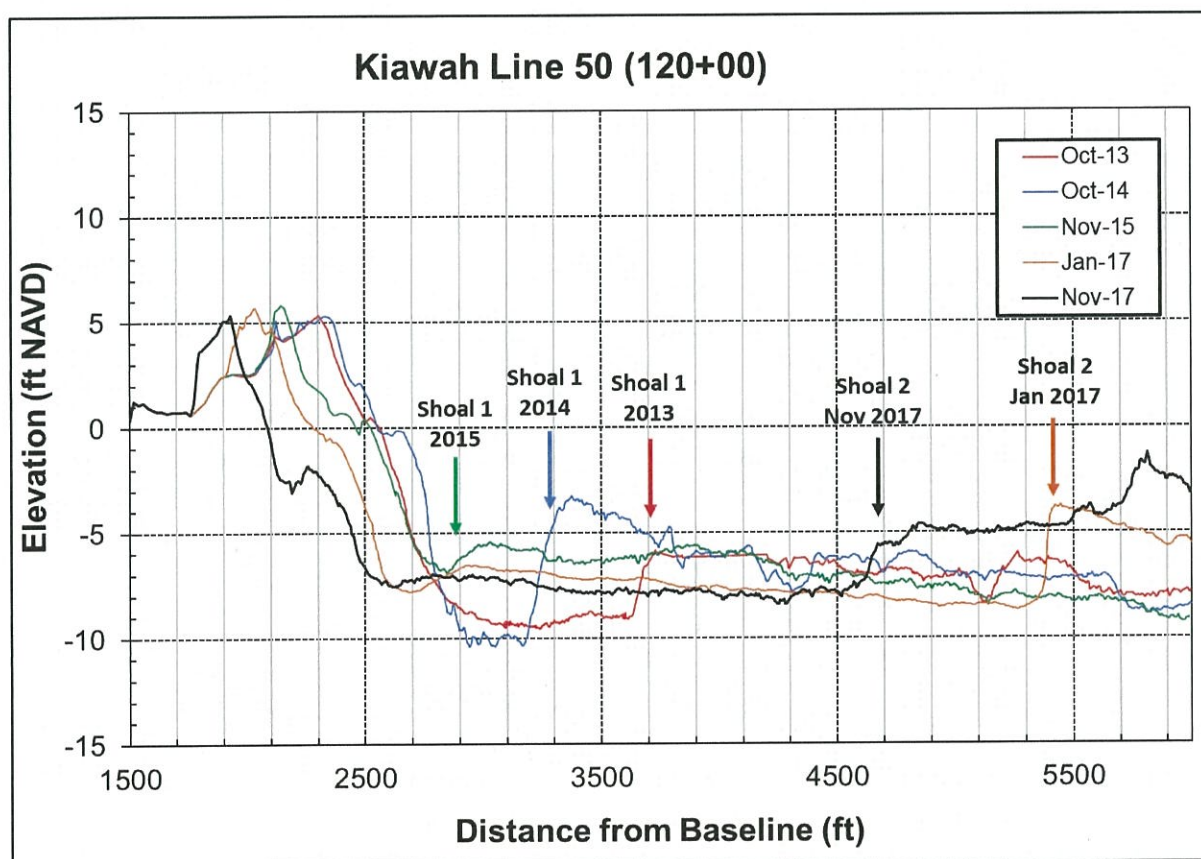
In 2012, the incoming shoal was positioned ~1,700 ft from the beach and was still far enough offshore to have only limited impacts to the beach. Between 2012 and 2014, the shoal migrated ~1,200 ft landward (Fig 4.11). More information and photos of the evolution of these shoal events were provided in previous monitoring reports to the Town (ie – CSE 2015). Between October and November 2015, the shoal continued to migrate landward, attaching to the beach at the -7 ft contour (low-tide wading depth). Interestingly, the shoal decreased in elevation, which may indicate that the sand is presently moving in a more alongshore direction rather than directly toward the beach. As of January 2017, the shoal had completely merged with the beach.

FIGURE 4.11. Profiles from Line 50 showing recent and ongoing shoal attachment events. Landward migration of the two shoals is visualized by the colored arrows on the plot.

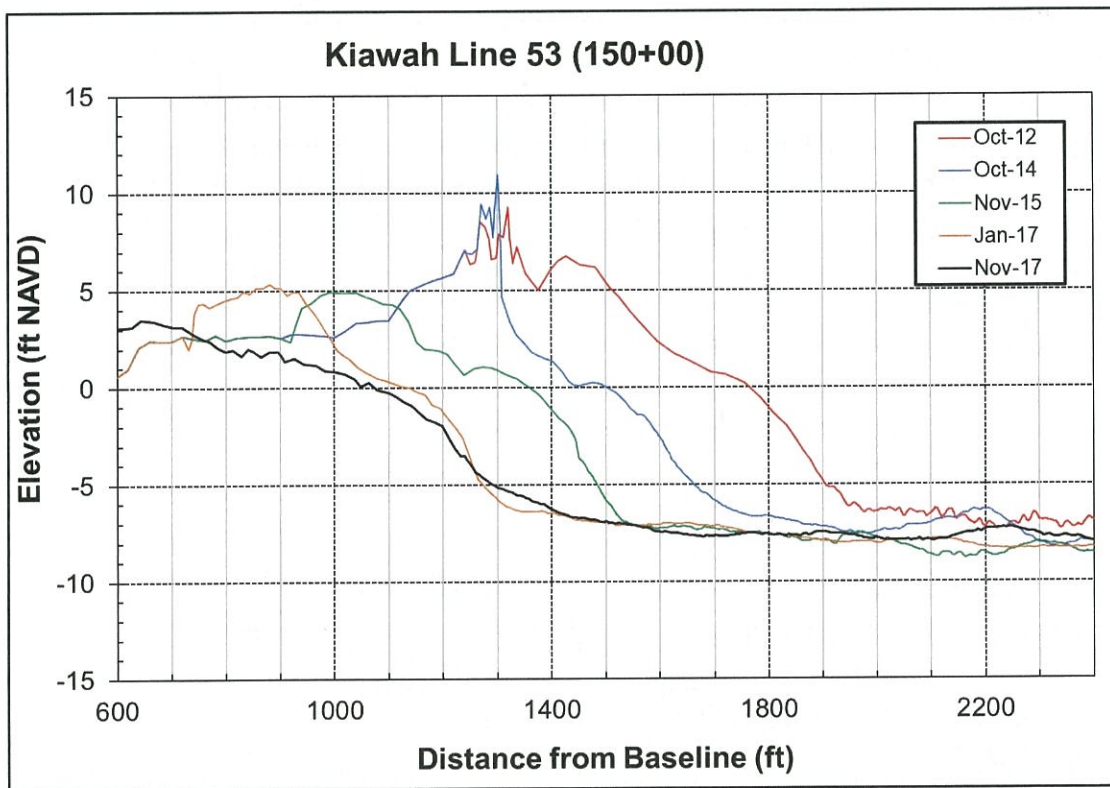
FIGURE 4.12. Profiles from Line 53 showing rapid shoreline recession and loss of dunes over the past five years. Peak elevations of 4–5 ft are insufficient to prevent overwash during storms and spring tides.

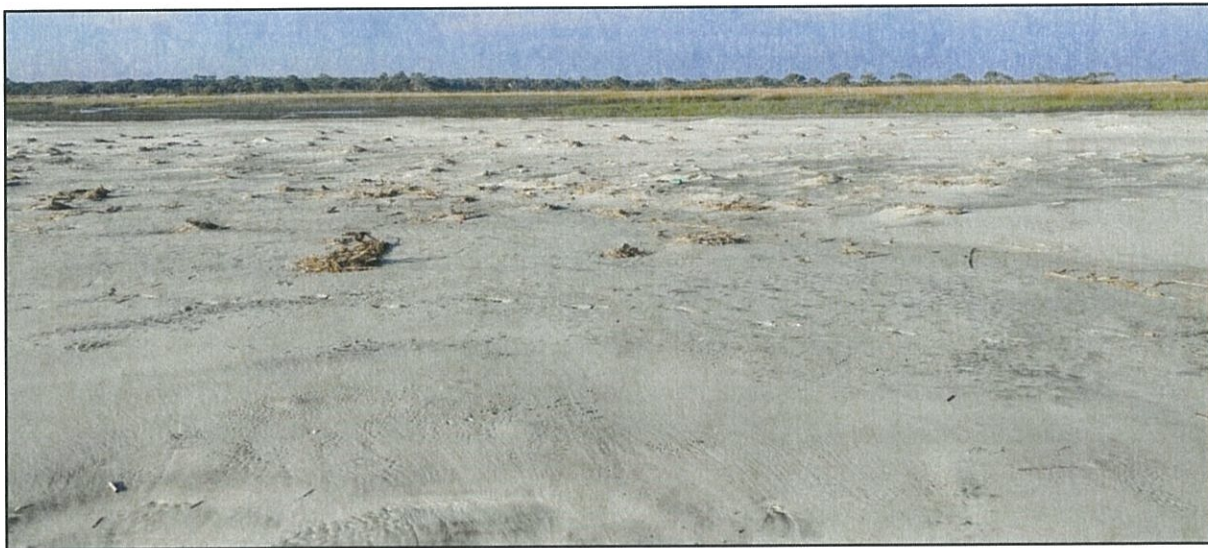
The erosional trend observed in the Lagoon Reach in recent years continued in 2017 due to a lack of new sand attaching via shoal events coupled with overwash of the outer berm. As of November 2017, the entire outer berm of the Lagoon Reach showed maximum elevations less than 6 ft NAVD (Figs 4.12–4.13). This elevation is too low to prevent overtopping during modest spring tides or small storm events. Overwash results in more rapid landward migration of the beach compared to typical along-shore sand losses.

FIGURE 4.13. November 2017 ground photo of Line 49 showing the low berm and evidence of recent washover.

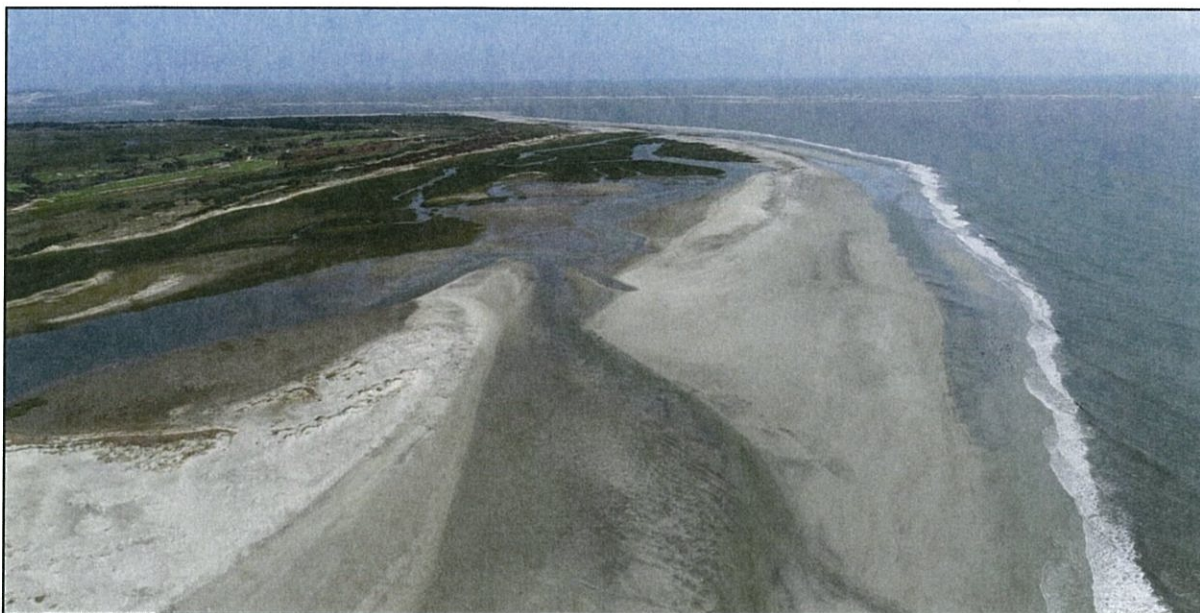
The most significant change in the lagoon area is the continued development of the channel created by Hurricane *Matthew* and the gradual infilling of the 2015 constructed channel. CSE observed the 2015 channel completely closed to flow in March 2018; however, it may reopen during any higher-than-normal tide event. Figure 4.14 shows an aerial image from October 2017 (post-*Irma*) in which the 2015 channel is visible. These channels should be monitored throughout the upcoming year to document migration and potential changes to the tidal prism through either channel.

FIGURE 4.14. October 2017 aerial of the Lagoon Reach showing the mostly infilled 2015 channel.
