**2006 EAST END BEACH RESTORATION PROJECT
KIAWAH ISLAND SOUTH CAROLINA**

Survey Report No 11

March 2018

BEACH MONITORING PROGRAM
SURVEY REPORT NO 11
Annual Beach and Inshore Surveys

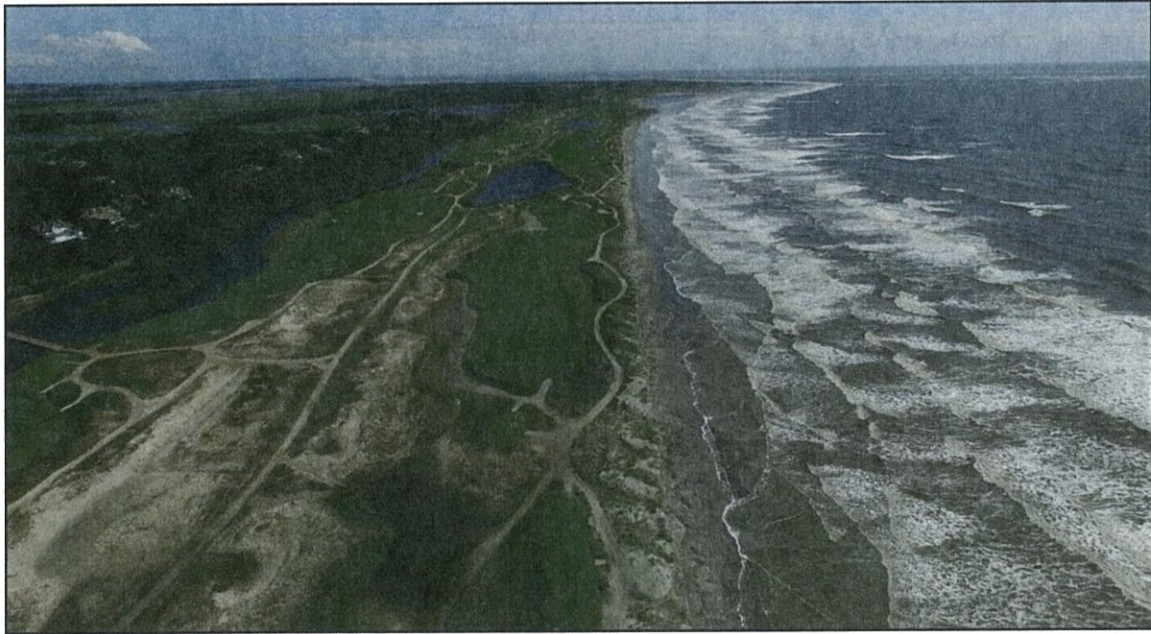
FIGURE 4.15. September 2017 aerial image of the Ocean Course Reach following Hurricane *Irma*. The storm eroded dunes along the course and, in one location, reached the cart path.

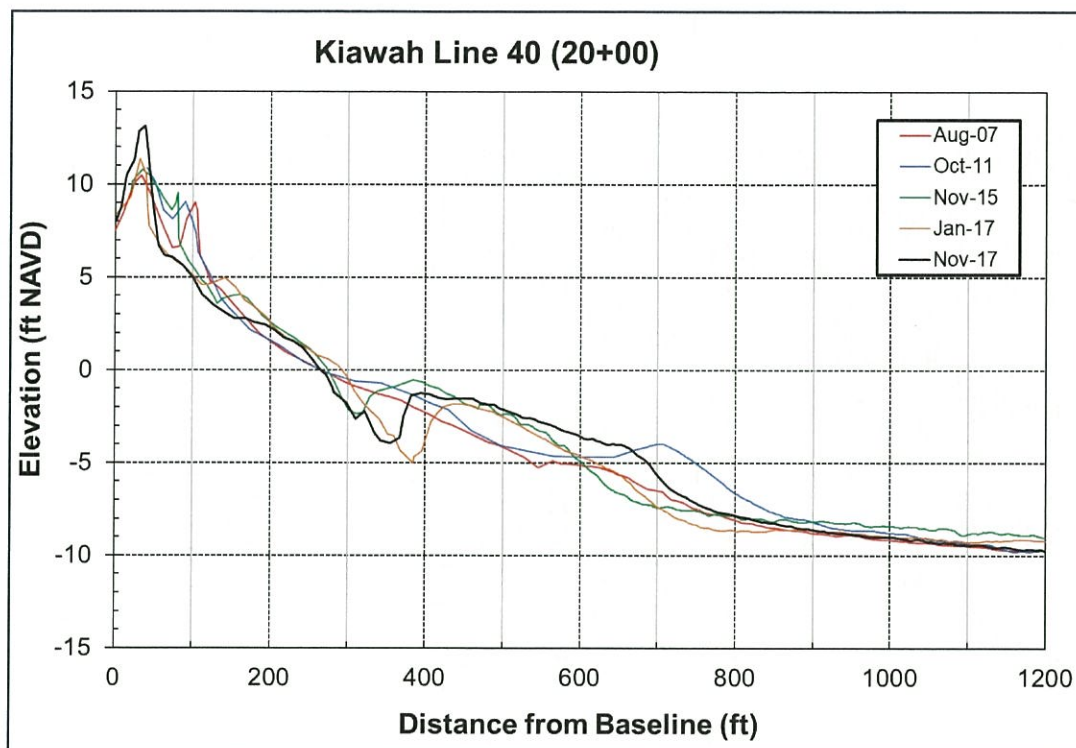
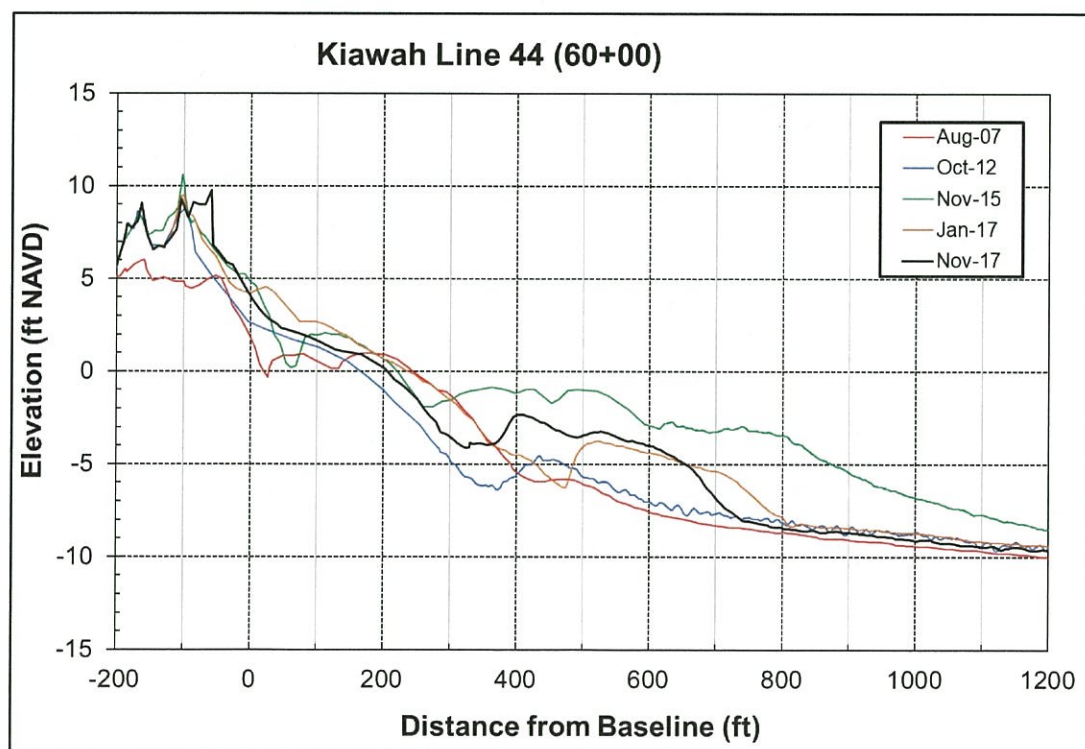
FIGURE 4.17. Profiles from Lines 40 (upper) and 44 (lower). At both lines, the November 2017 dune is healthier than the January 2017 condition, despite no dune restoration occurring at Line 44.

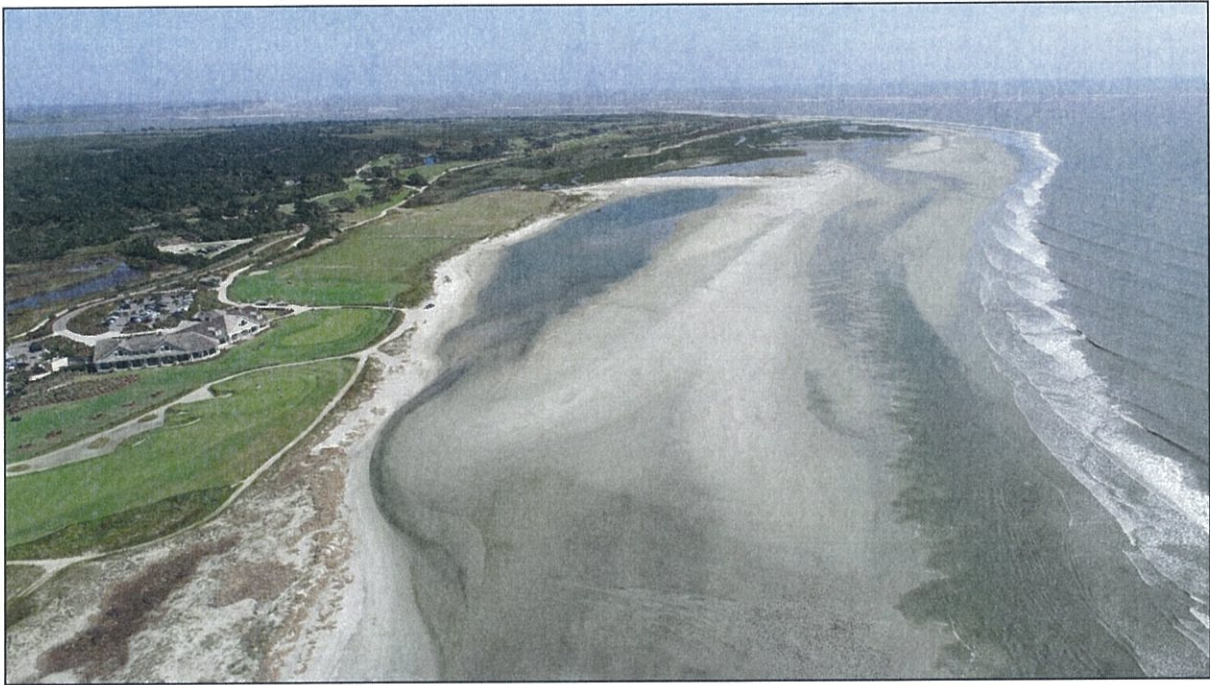
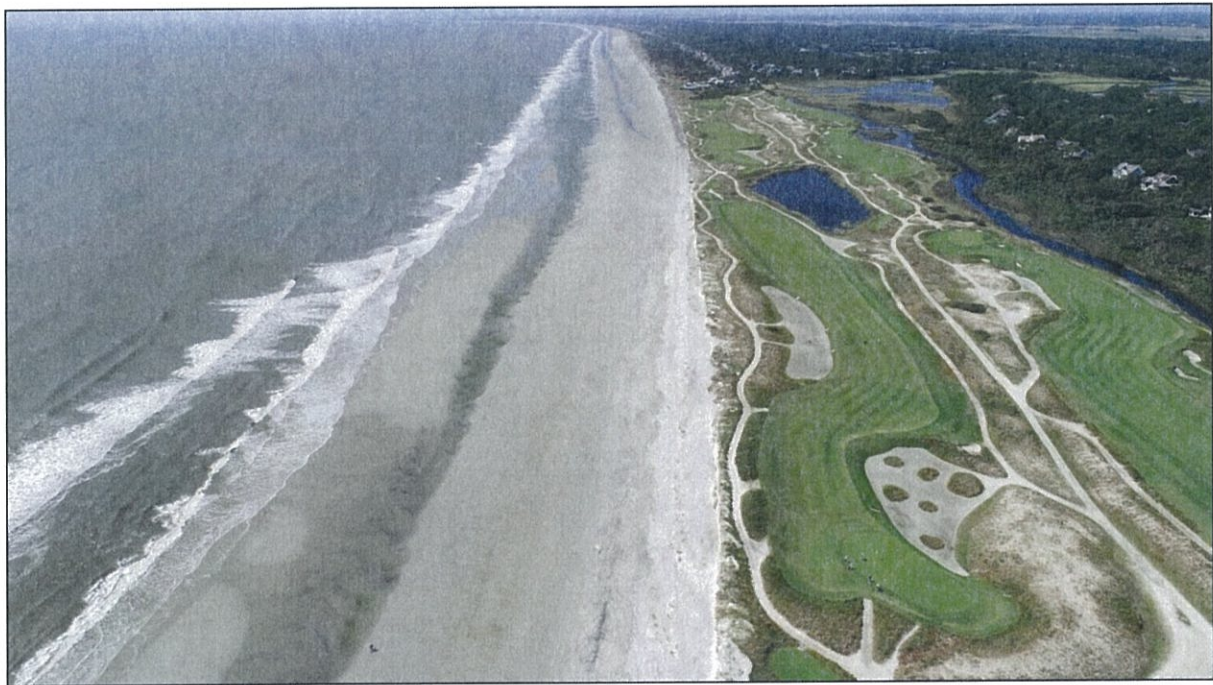
FIGURE 4.18. October 2017 aerial images of the Ocean Course Reach.

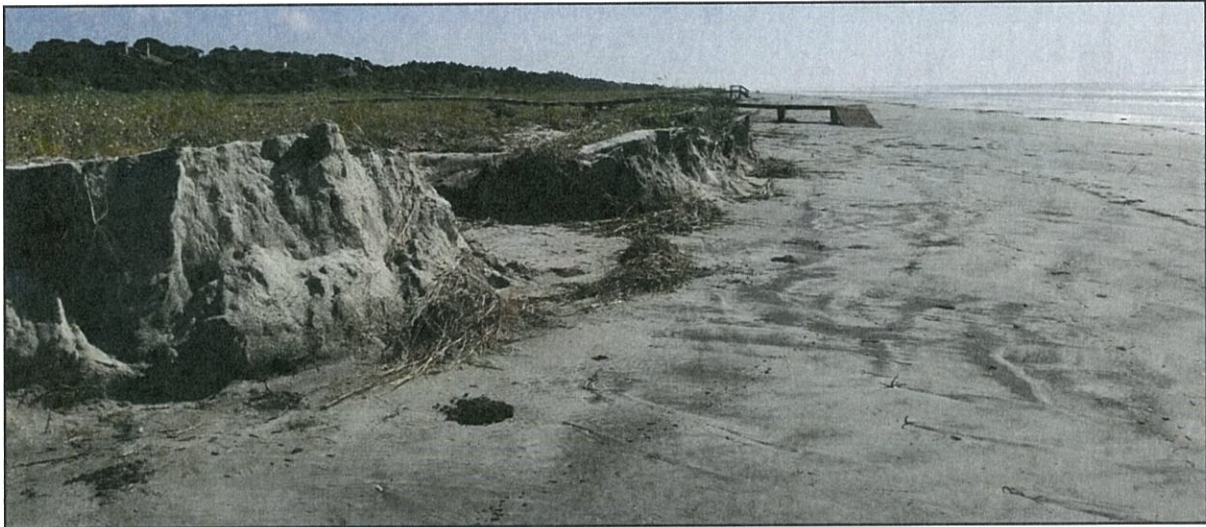
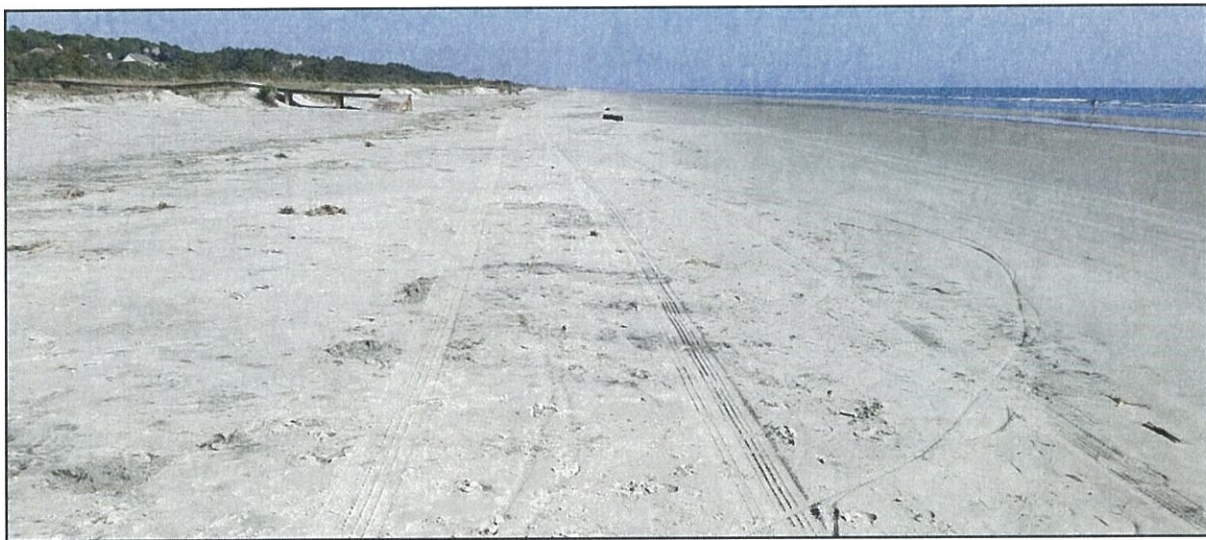
In some locations, the dune eroded nearly 50 ft during Hurricane *Irma* (ie – Line 32 in Fig 4.21). Ground photos (Fig 4.22) show an escarpment present along most of the reach following Hurricane *Irma* with some recovery by November 2017. In areas where the dune breached, ponding may be present in areas during extreme tides. As the beach recovers and a new dune line forms, the frequency of any ponding is expected to decrease. A dune was reconstructed along the Turtle Point Golf Course prior to the November survey, because this area was within the state's definition of an emergency condition following *Irma*.

FIGURE 4.22. Ground photos from Line 28 post-*Irma* September 2017 (upper) and November 2017 (lower).

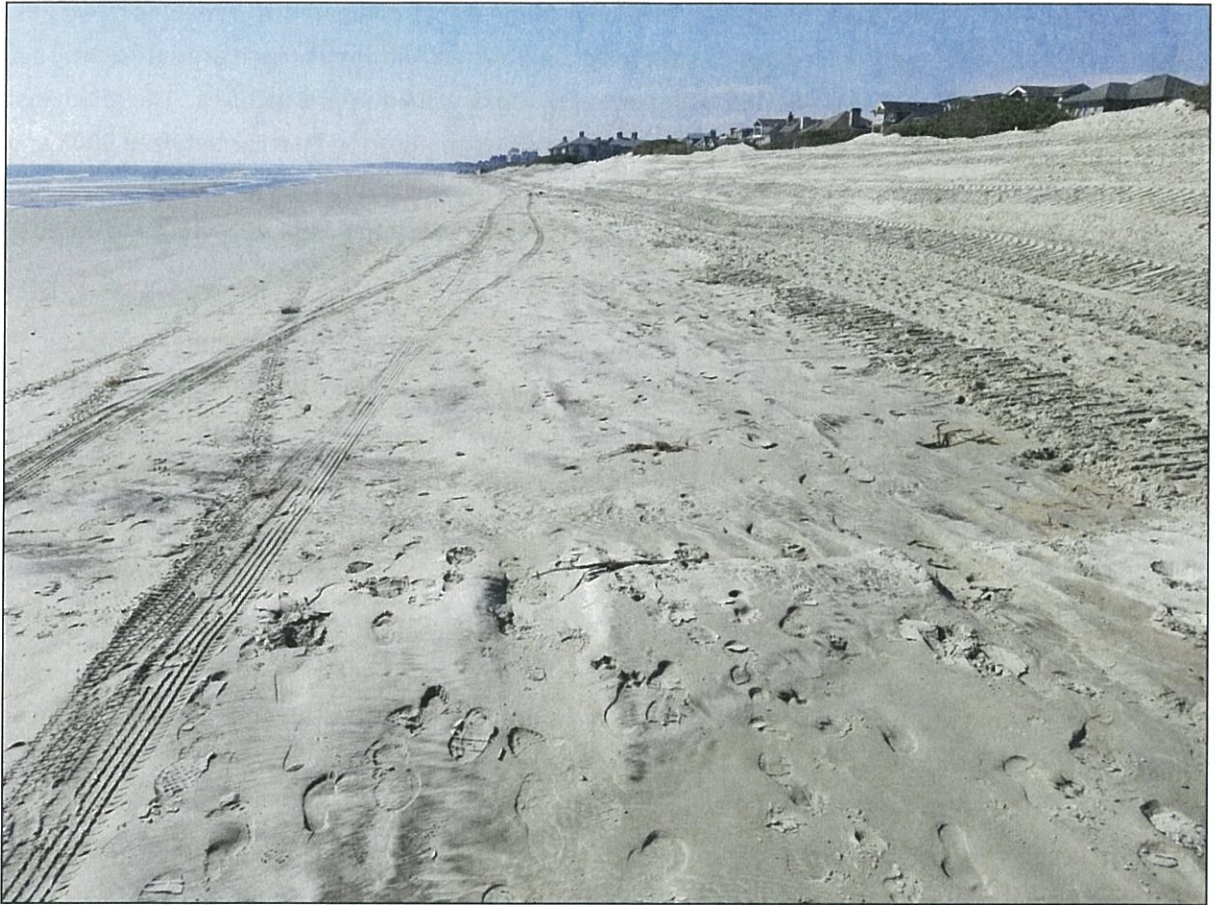
FIGURE 4.23. Post-scraping photo of the area seaward of the Turtle Point Golf Course in November 2017.

Post-storm beach scraping was completed in the areas of Eugenia Avenue, the Sanctuary, Turtle Point, the Beach Club, and the Ocean Course. This effort restored the dune that was lost during *Irma* and offered immediate protection for these properties. Work was completed under emergency authorization from OCRM and the USACE, as well as a permit modification to the East End project permit. CSE generally recommends that sand scraping only be considered immediately after storm events, such as was accomplished by the Town. Under normal circumstances, CSE generally recommends any sand for dune restoration be brought in from an outside source since this adds sand to the beach profile rather than redistribution of existing sand.

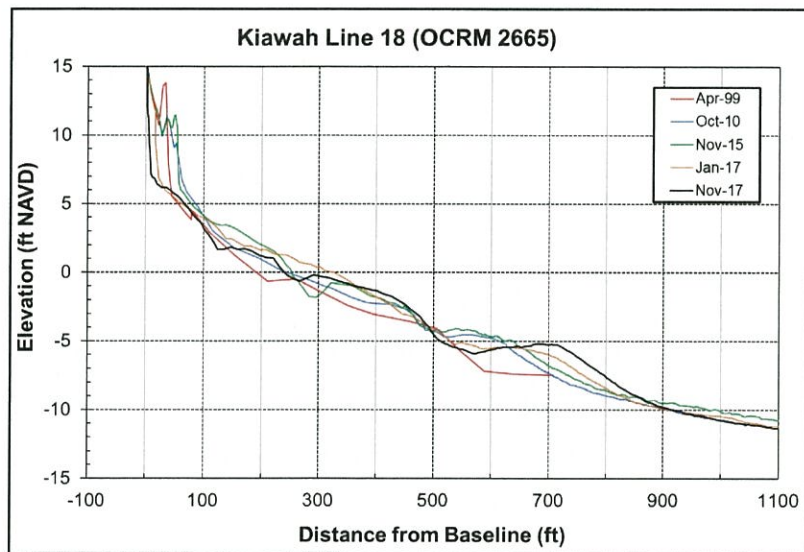
FIGURE 4.24.

Profiles from the reach (Fig 4.24) show a consistent pattern of erosion of the primary dune, leaving a significant escarpment. As shown in Figure 4.20, the dune receded ~20 ft along the reach. With the combined effects of Hurricane *Joaquin*, Hurricane *Matthew*, and Hurricane *Irma*, and the pre-existing narrower setbacks of structures in the reach, several of the properties were left vulnerable to damage. The Town obtained a permit for beach scraping to rebuild the dunes along Eugenia Avenue and seaward of the Sanctuary. This effort restored the storm protection offered by the primary dune and also improved recreational access along the shoreline. CSE generally recommends sand scraping only after significant storm events, because these efforts do not add sand to the system; rather, they simply restore sand that was lost from the upper profile and accelerate natural recovery.

Representative profiles from West Beach Reach. The eastern end of the reach (Lines 18–21) have been the least accretional areas of Kiawah over the past two decades. Line 20 is the only line showing less volume than the 1999 condition.

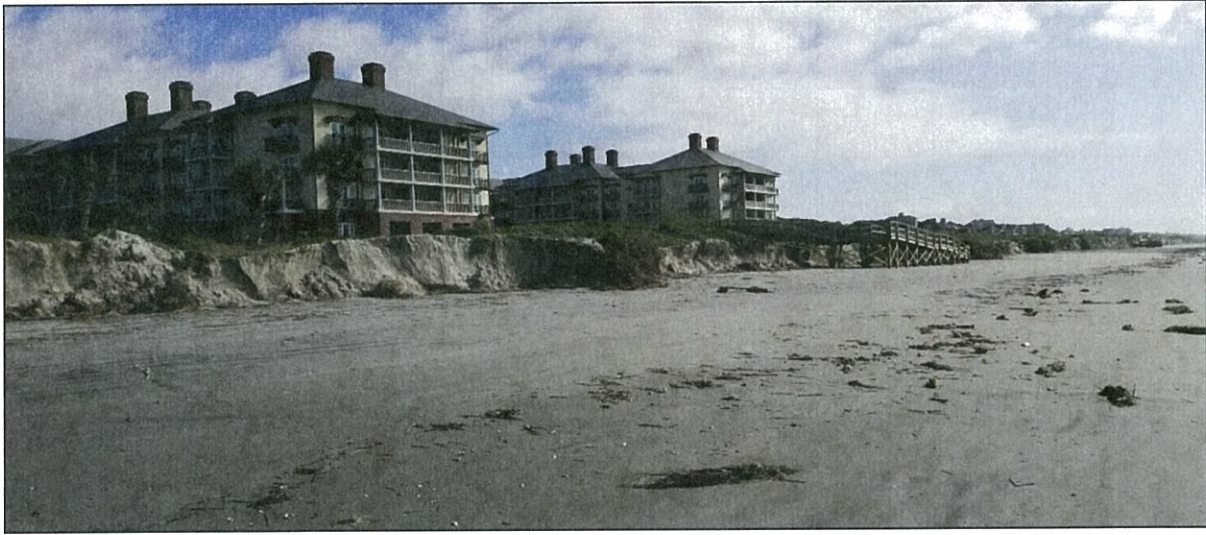
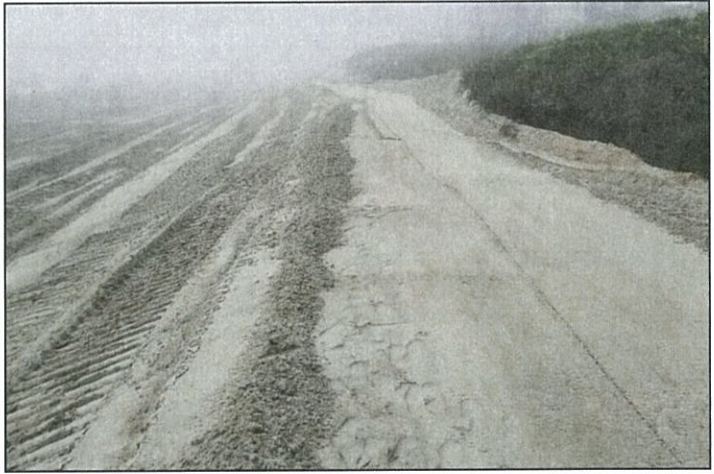
Photos in Figure 4.25 show the post-storm (September), November 2017, and post-restoration condition along the West Beach Reach. The oceanfront homes along Eugenia Avenue have the narrowest setback of any area on Kiawah. CSE believes that the scraping project completed in the winter of 2017–2018 restored a sufficient dune for moderate storm events such as Hurricane *Irma*. CSE expects additional recovery to occur this spring and summer due to the relatively low erosion rate observed over this past year.

FIGURE 4.25. [UPPER] Post-Hurricane *Irma* photo from the Sanctuary. [MIDDLE] November 2017 image (left) and December 2017 (right) from near Line 18 at the eastern end of Eugenia Avenue. [LOWER] November 2017 photo from Line 12 near the Sandcastle.

CSE is aware that some owners along Eugenia Avenue are considering additional dune restoration via minor nourishment using upland sand. If such a project is conducted, CSE recommends that the owners coordinate so that all sand is added during one effort, and that efforts be made to make a continuous dune line rather than sporadic mounds at individual properties. This will create a dune with more integrity during storm events and will produce a more aesthetic vista.

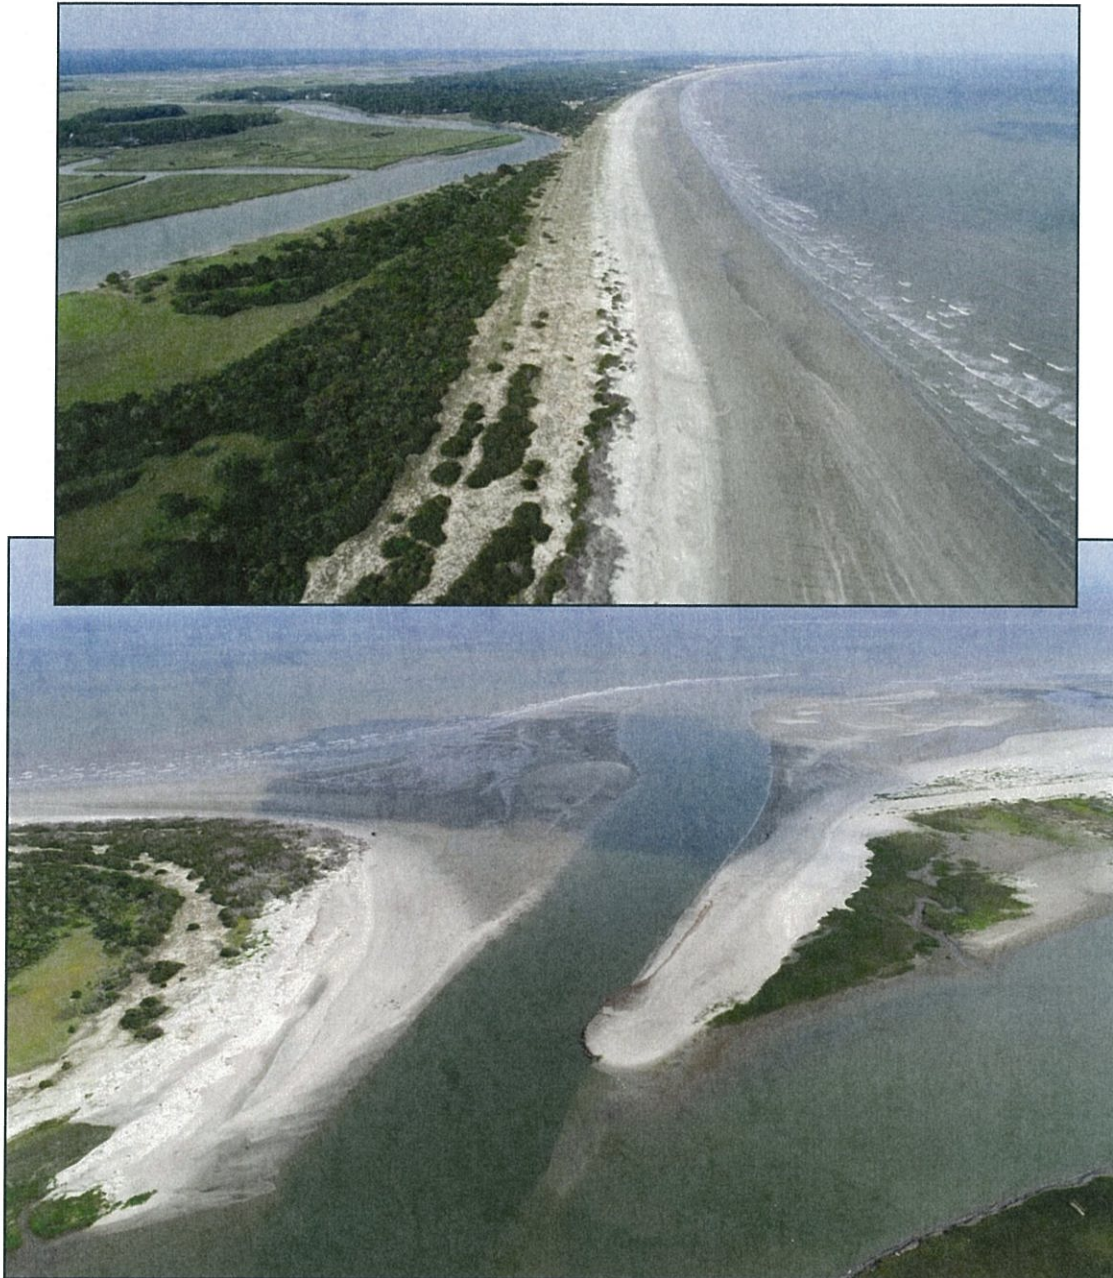
FIGURE 4.26. June 2017 aerial images of the Kiawah Spit Reach.

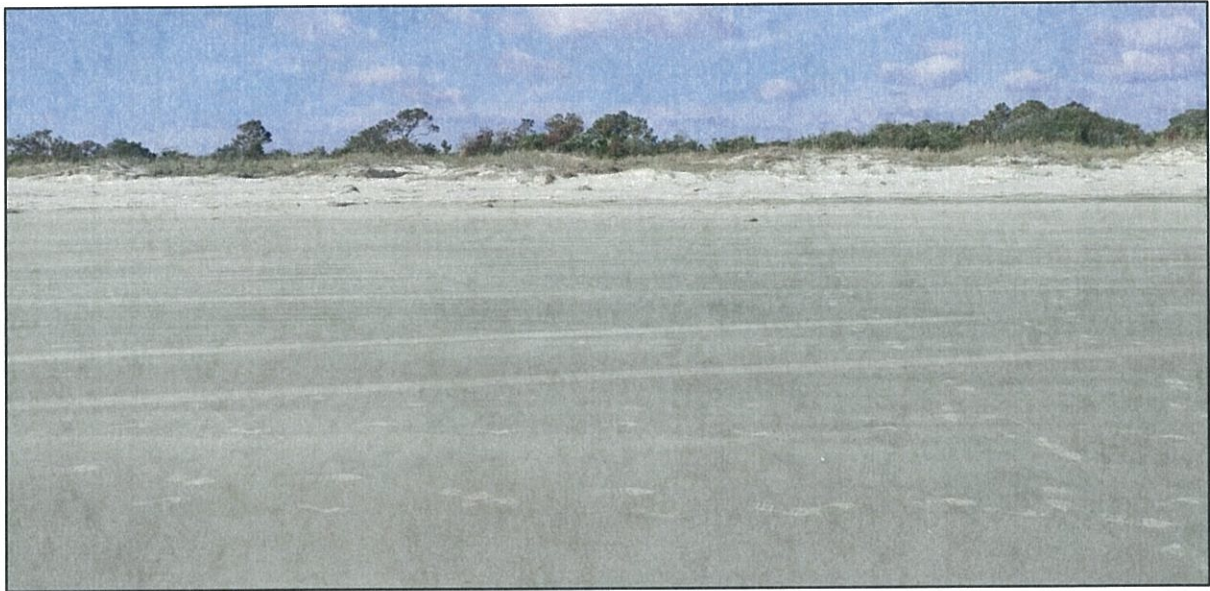
FIGURE 4.28. Ground photos of the Kiawah Spit Reach (November 2017), approximately two months after Hurricane *Irma*.
