Kiawah Island 2017 Beach Monitoring

Steven Traynum

Coastal Science & Engineering

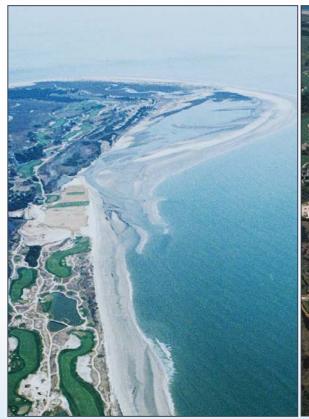
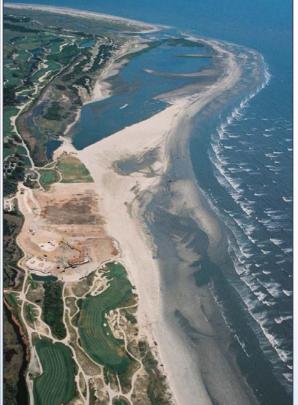
2006 Restoration Project

Moved ~550,000 cy

Inlet realignment plus beach restoration

Used land-based equipment

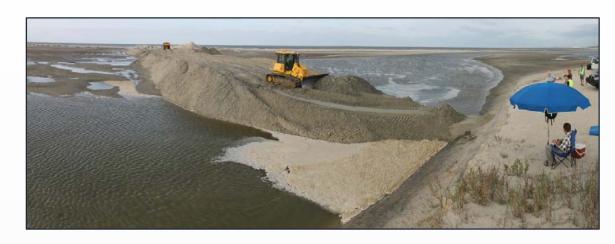
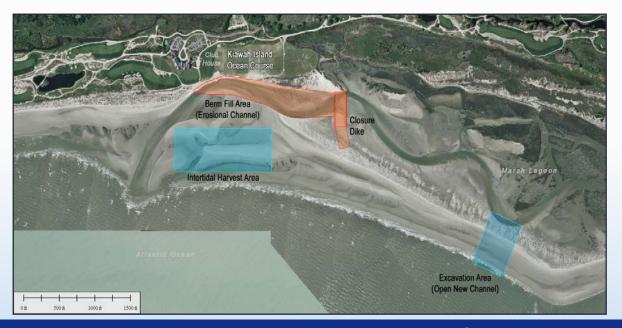
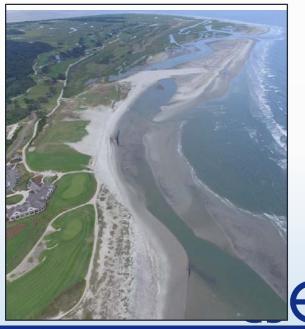
2015 Channel Realignment Project

- Moved 100,000 cy
- Limited beach restoration
- Focus on habitat conservation

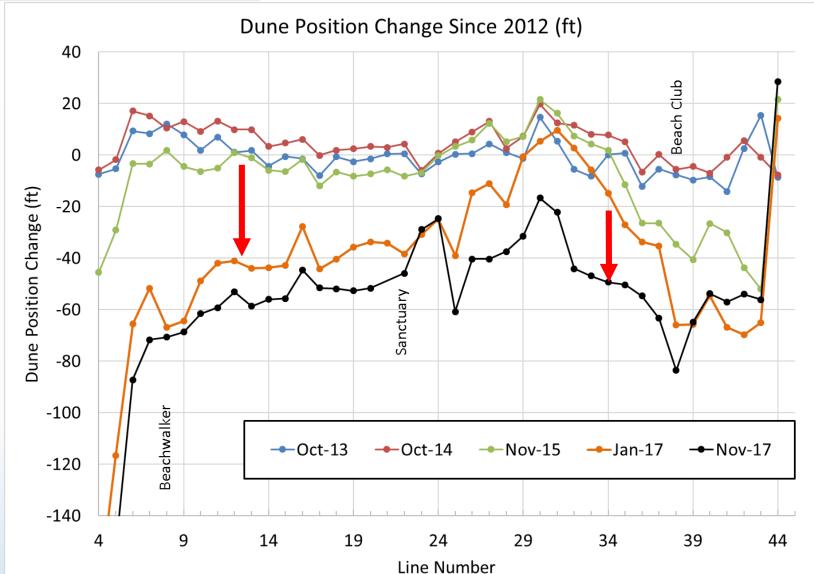
Dune Erosion

- Matthew impacted the beach around 8 October 2016 as a weak Category 2 storm. Winds in Charleston ~75 mph.
- Resulted in significant dune recession (20-60 ft typical), damaged walkovers, minor flooding
- Irma passed to the west, however, higher water levels that Matthew.
- Additional 10-30 ft of dune erosion

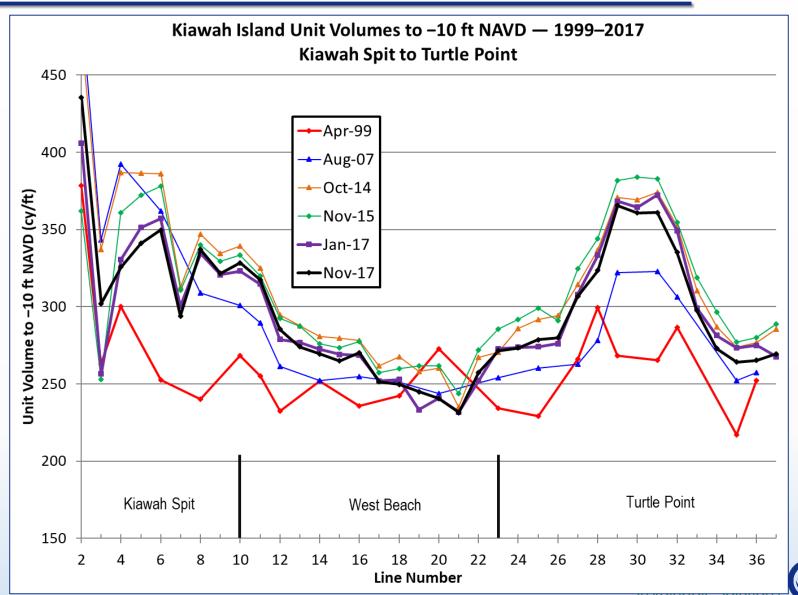
Residential Area Beach Volumes

- Overall the island lost ~210,800 cy of sand (compared to ~750,000 cy lost previous year)
- Erosion mostly restricted to area east of Ocean Course driving range
- Residential zone lost ~21,000 (compared to ~370,000 cy previous year)
- Erosion most severe along Flyway Dr.

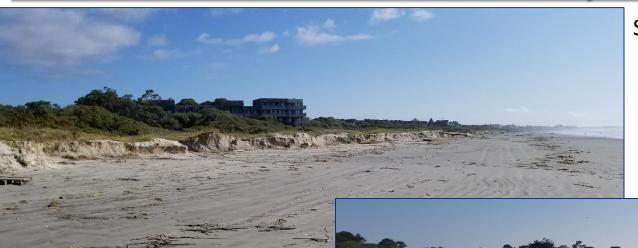
September 2017

Post Storm and Recovery Conditions

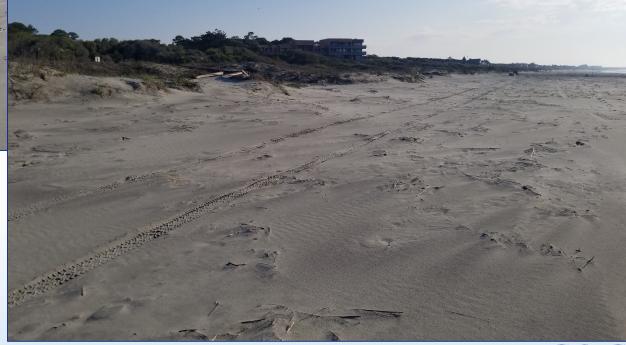
April 2018

- Calm weather promotes beach recovery.
- Sand moves from underwater bars to the dry sand berm and dune.
- Sand lost from system needs to be replaced by new sand from upcoast.
- Evidence of recovery in early 2018 and substantial by April 2018.
- Scraped dunes have remained stable, which is a positive sign that additional erosion is minimal.

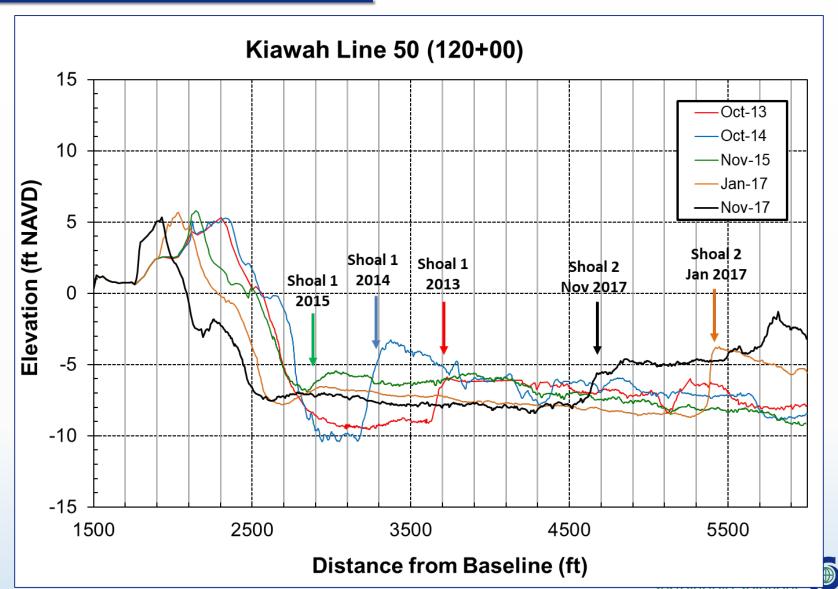
Shoal Attachment

- The east end project area continues to evolve as a washover attaching shoal
- Constructed channel has closed, lessening threat to Ocean Course
- Permit allows for another project to be completed, if necessary, but triggers are not met
- An additional survey can be obtained to document recovery of upper beach profile

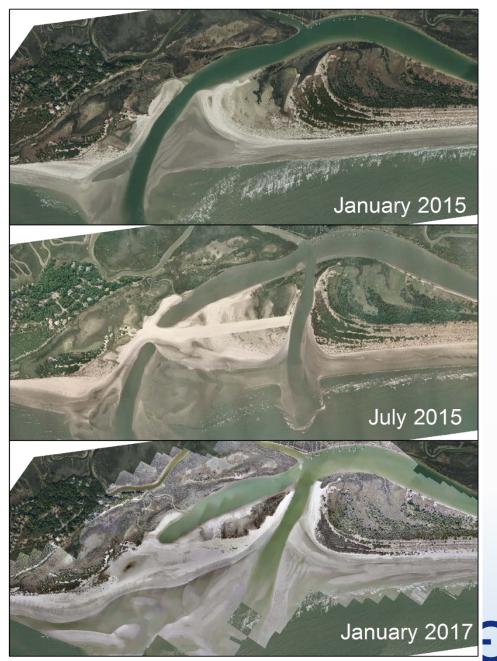
- Inlet relocated ~3,000
 ft east in 2015
- 140,000 cy removed from new inlet basin
- Migrated ~325 ft from July 2015 to Jan 2017.
- Historical rate 200-300 ft/yr
- End of spit is rebuilding normal shape
