DORRIS RANCH LIVING HISTORY FARM

MASTER PLAN REVISION

December 2019

WILLAMALANE PARK AND RECREATION DISTRICT
REYNOLD & EVA BRIGGS HOUSE REPORT

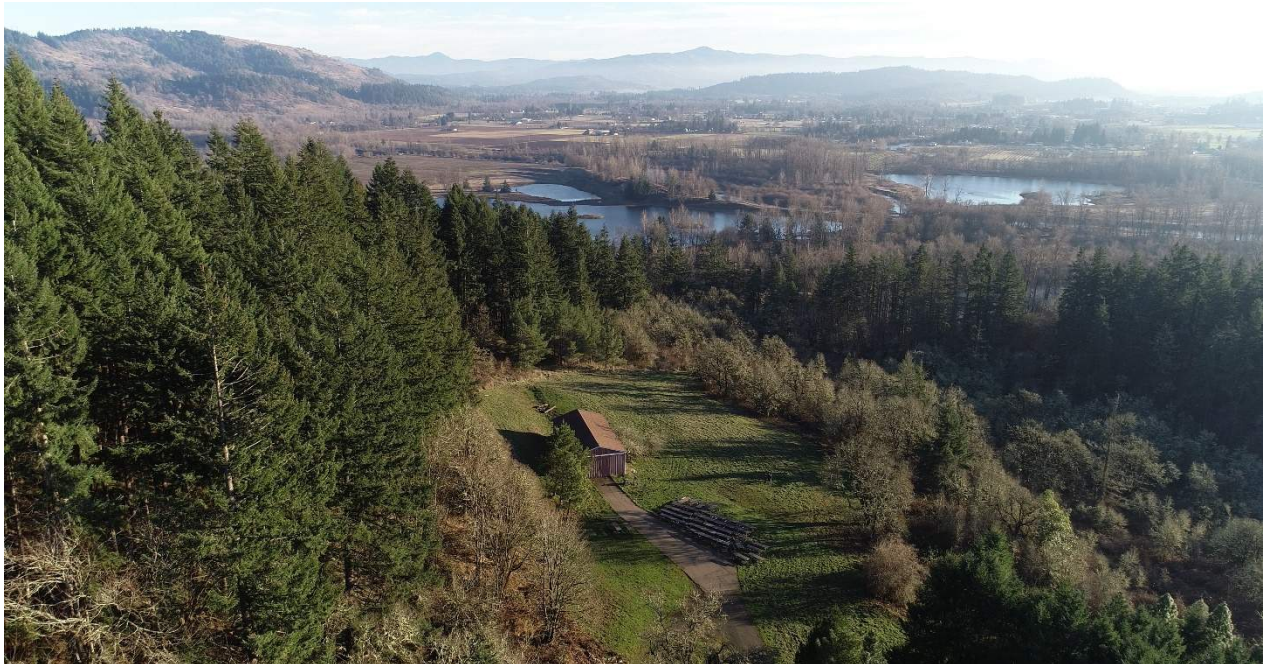
A bird's eye view of the new property. The large clearing with the metal workshop building is a key destination on the property.

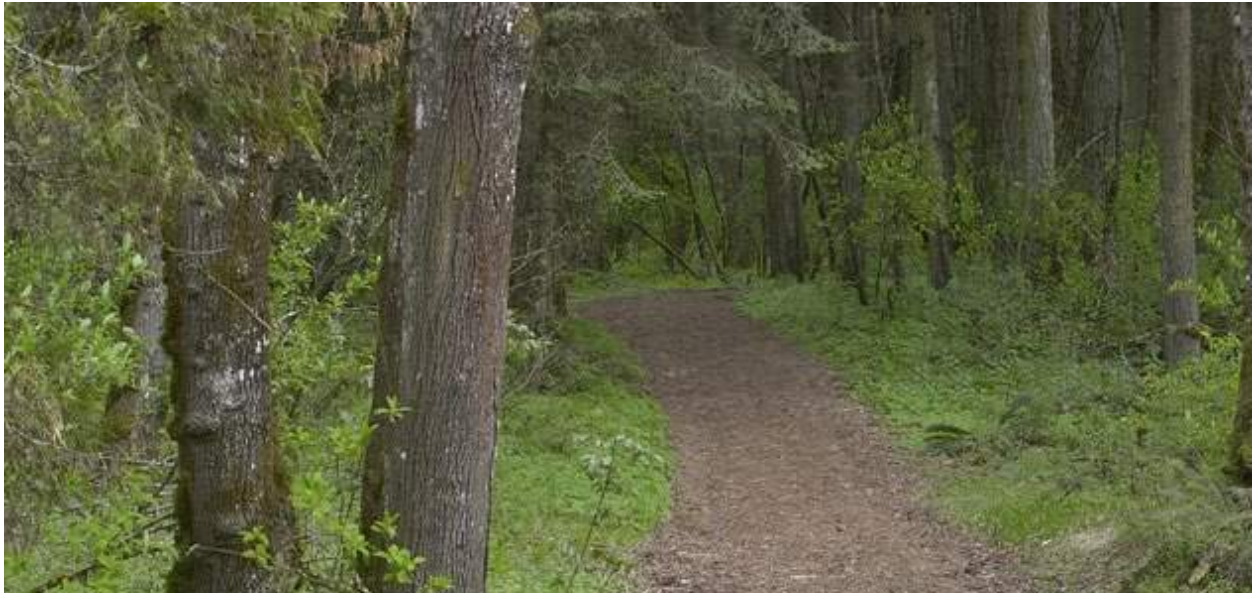
Existing paths at Dorris Ranch.

The largest addition to the park was the development of the Middle Fork Path, a multi-use path that extends from a new trailhead just north of the Living History Village, approximately $\frac{3}{4}$ mile to the southeast corner of the property, where it continues along the Willamette River and eventually connects to Clearwater Park. In addition, a new trail segment was built that continues from the terminus of the Oak Trail, through the restored oak woodland, and connects users to the Middle Fork Path approximately $\frac{1}{4}$ mi. further south than it previously did. This trail segment was built in coordination with restoration efforts occurring in the area.

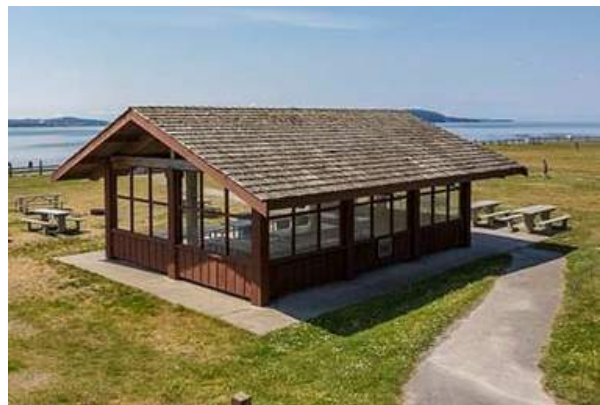
Example of an enclosed picnic shelter.

Provide water, shade, and seating for visitors to sit and enjoy the scenery at the main lookout. The shelter structure could be used for private rentals and would be sized to accommodate smaller group gatherings (30-60 people). Ideally the shelter would be designed to have the ability for it to be enclosed and locked (i.e. using sliding doors or removable panels) in order to minimize risk of it being a destination for un-programmed or after hours use.

The shelter is positioned so it does not block views for those picnicking in the open lawn area when the shelter is not in use. Minimal lighting and water access is proposed as part of this improvement.

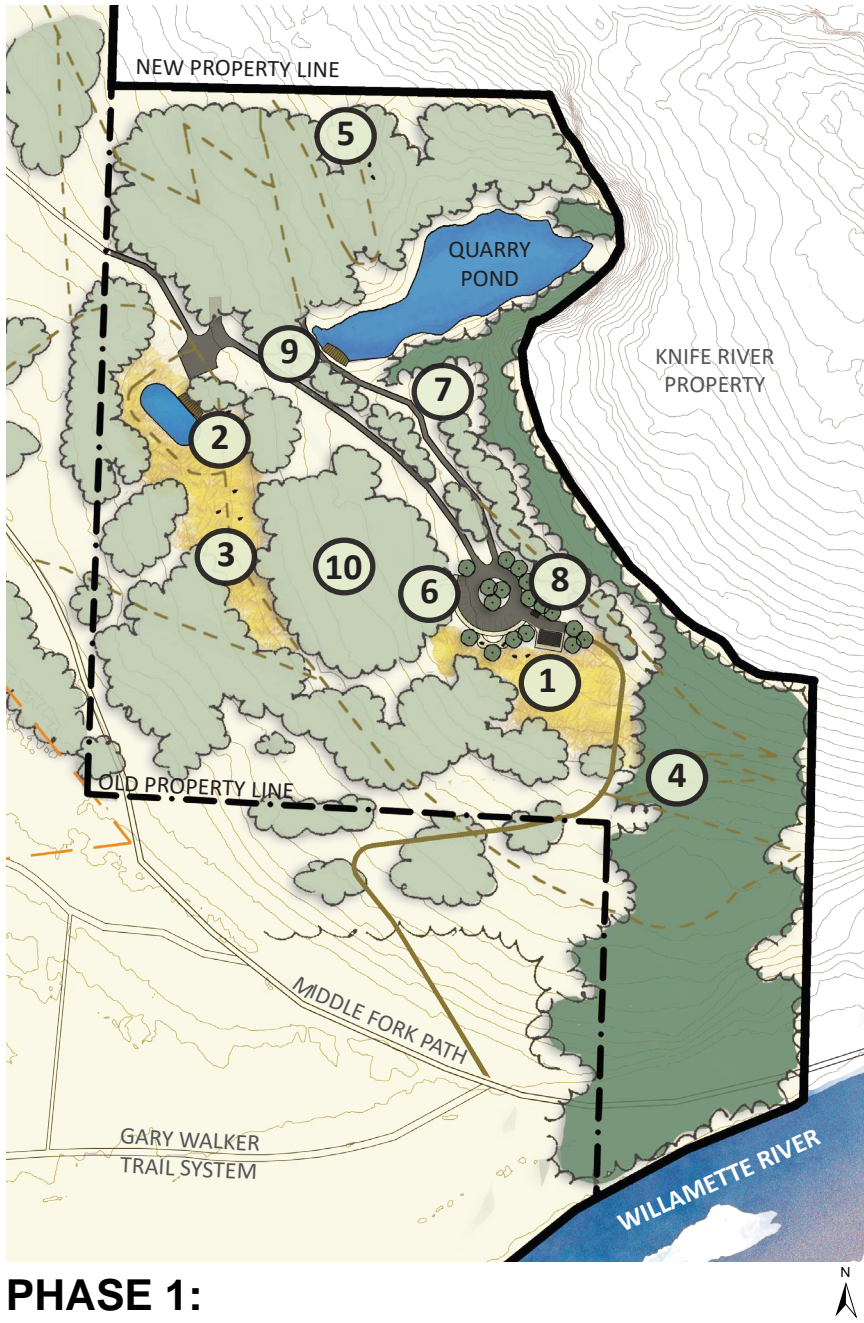
FIGURE 4:

- 1 - **PICNIC AREA AND SHELTER**
Provide water, shade, and seating for visitors to sit and enjoy the scenery at the main lookout.
- 2 - **HABITAT RETENTION BASIN**
Allow vegetation to encroach around edges of the pond with the goal of limiting public access and preserving habitat.

- 3 - **OPEN FIELD/PICNIC AREA**
Maintain as an informal gathering space for school groups, programs, and picnicking.
- 4 - **TRAILS**
Provide new trails throughout the property that connect to the existing Gary Walker Trail System.

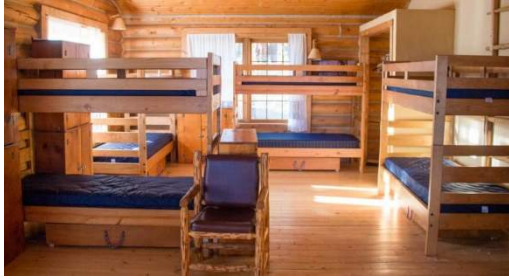
A multi-purpose room in the proposed utility building could provide space for bunk beds, tables for meetings, or space for event staging.

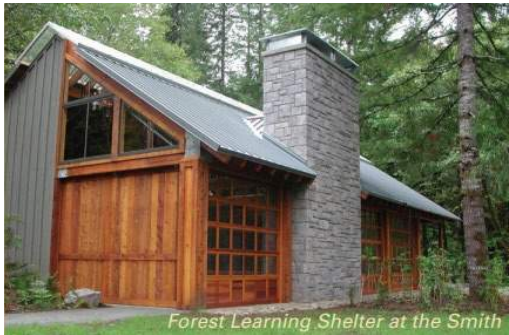
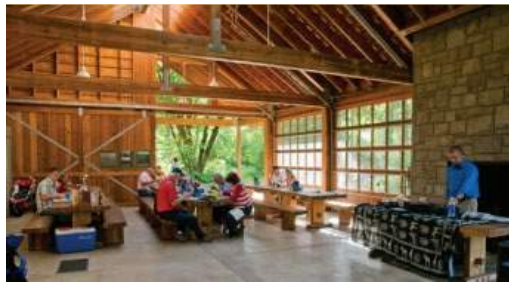
The Smith Homestead Forest Learning Shelter at the Tillamook State Forest in Oregon provides a rental space similar to that proposed at Dorris Ranch.

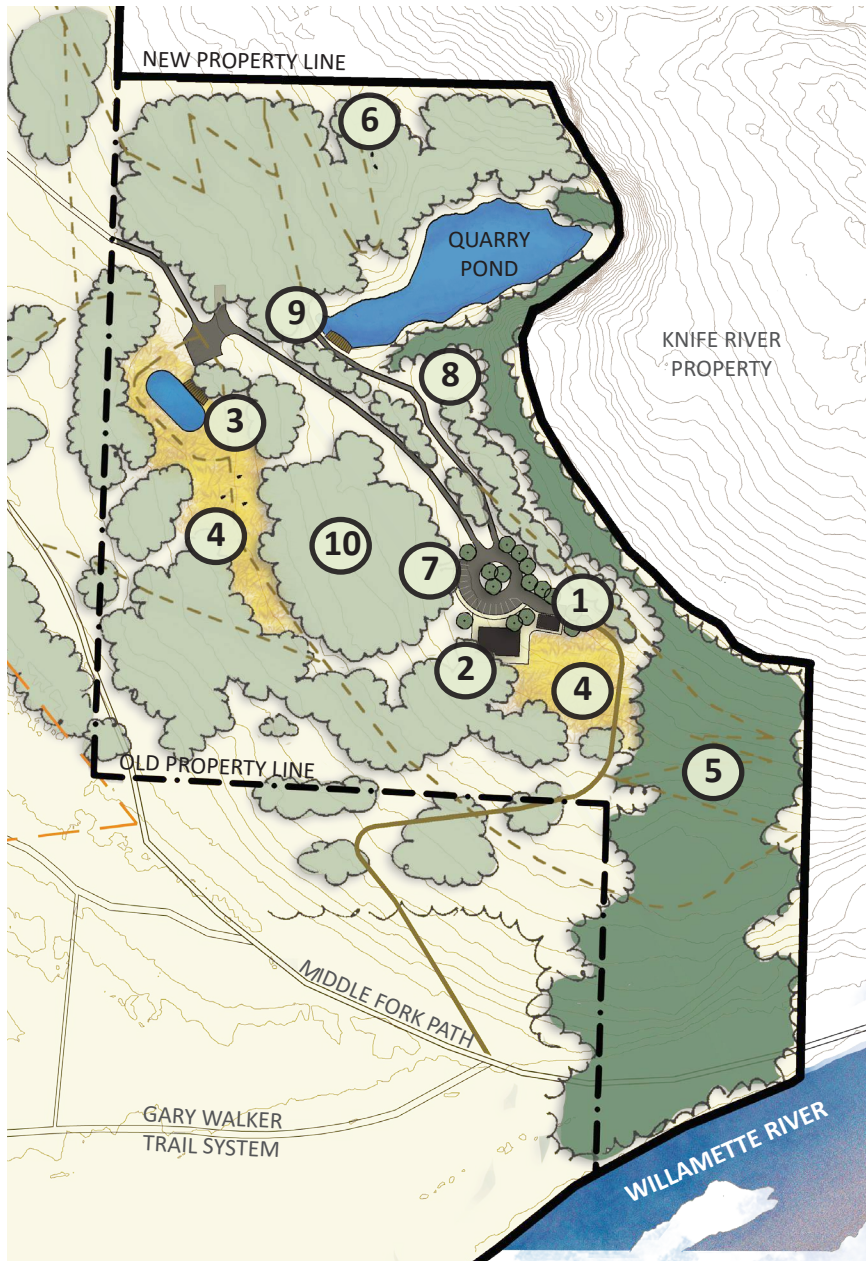
NEW PROPERTY, PHASE 2

- 1 - **UTILITY BUILDING**
Provide amenities that support large events (e.g. kitchen, restrooms, storage, or general multi-purpose room).
- 2 - **GATHERING BUILDING**
Indoor space for up to 200 people for programs and events.

- 3 - **HABITAT RETENTION BASIN**
Allow vegetation to encroach around edges of the pond with the goal of limiting public access and preserving habitat.
- 4 - **OPEN FIELD/PICNIC AREA**
Maintain as an informal gathering space for school groups, programs, and picnicking.

The second phase of development takes advantage of the scenery and privacy of the site for development of a community gathering space. This phase of development expands on what was completed in phase one and proposes a multifunctional design for additional structures that accommodate a multitude of different user groups and uses (e.g. weddings, community events, Willamalane programs, outdoor school programs, overnight camps, etc.). A market analysis and further assessment of local demand is recommended prior to design development to better define the target user groups for this site so the design can be refined accordingly. Regardless of the determined future target user groups, flexibility should be prioritized in the design so the space can accommodate as many interested user groups as possible. It should be noted that water and septic would be significant factors to consider in determining feasibility and project cost for this phase. New improvements proposed in this second phase of development are shown on Figure 5 and described in more detail below.

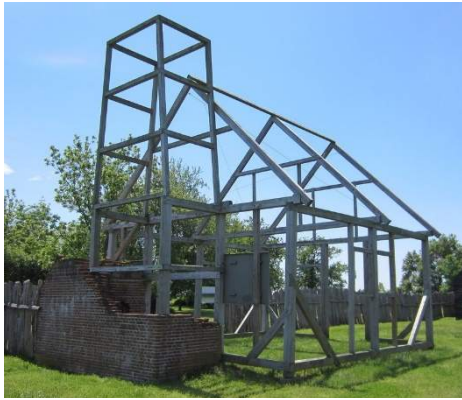
“Ghost frame” structures, created in other parts of the state and country, provide inspiration for how the Briggs House could be reflected in the new design.

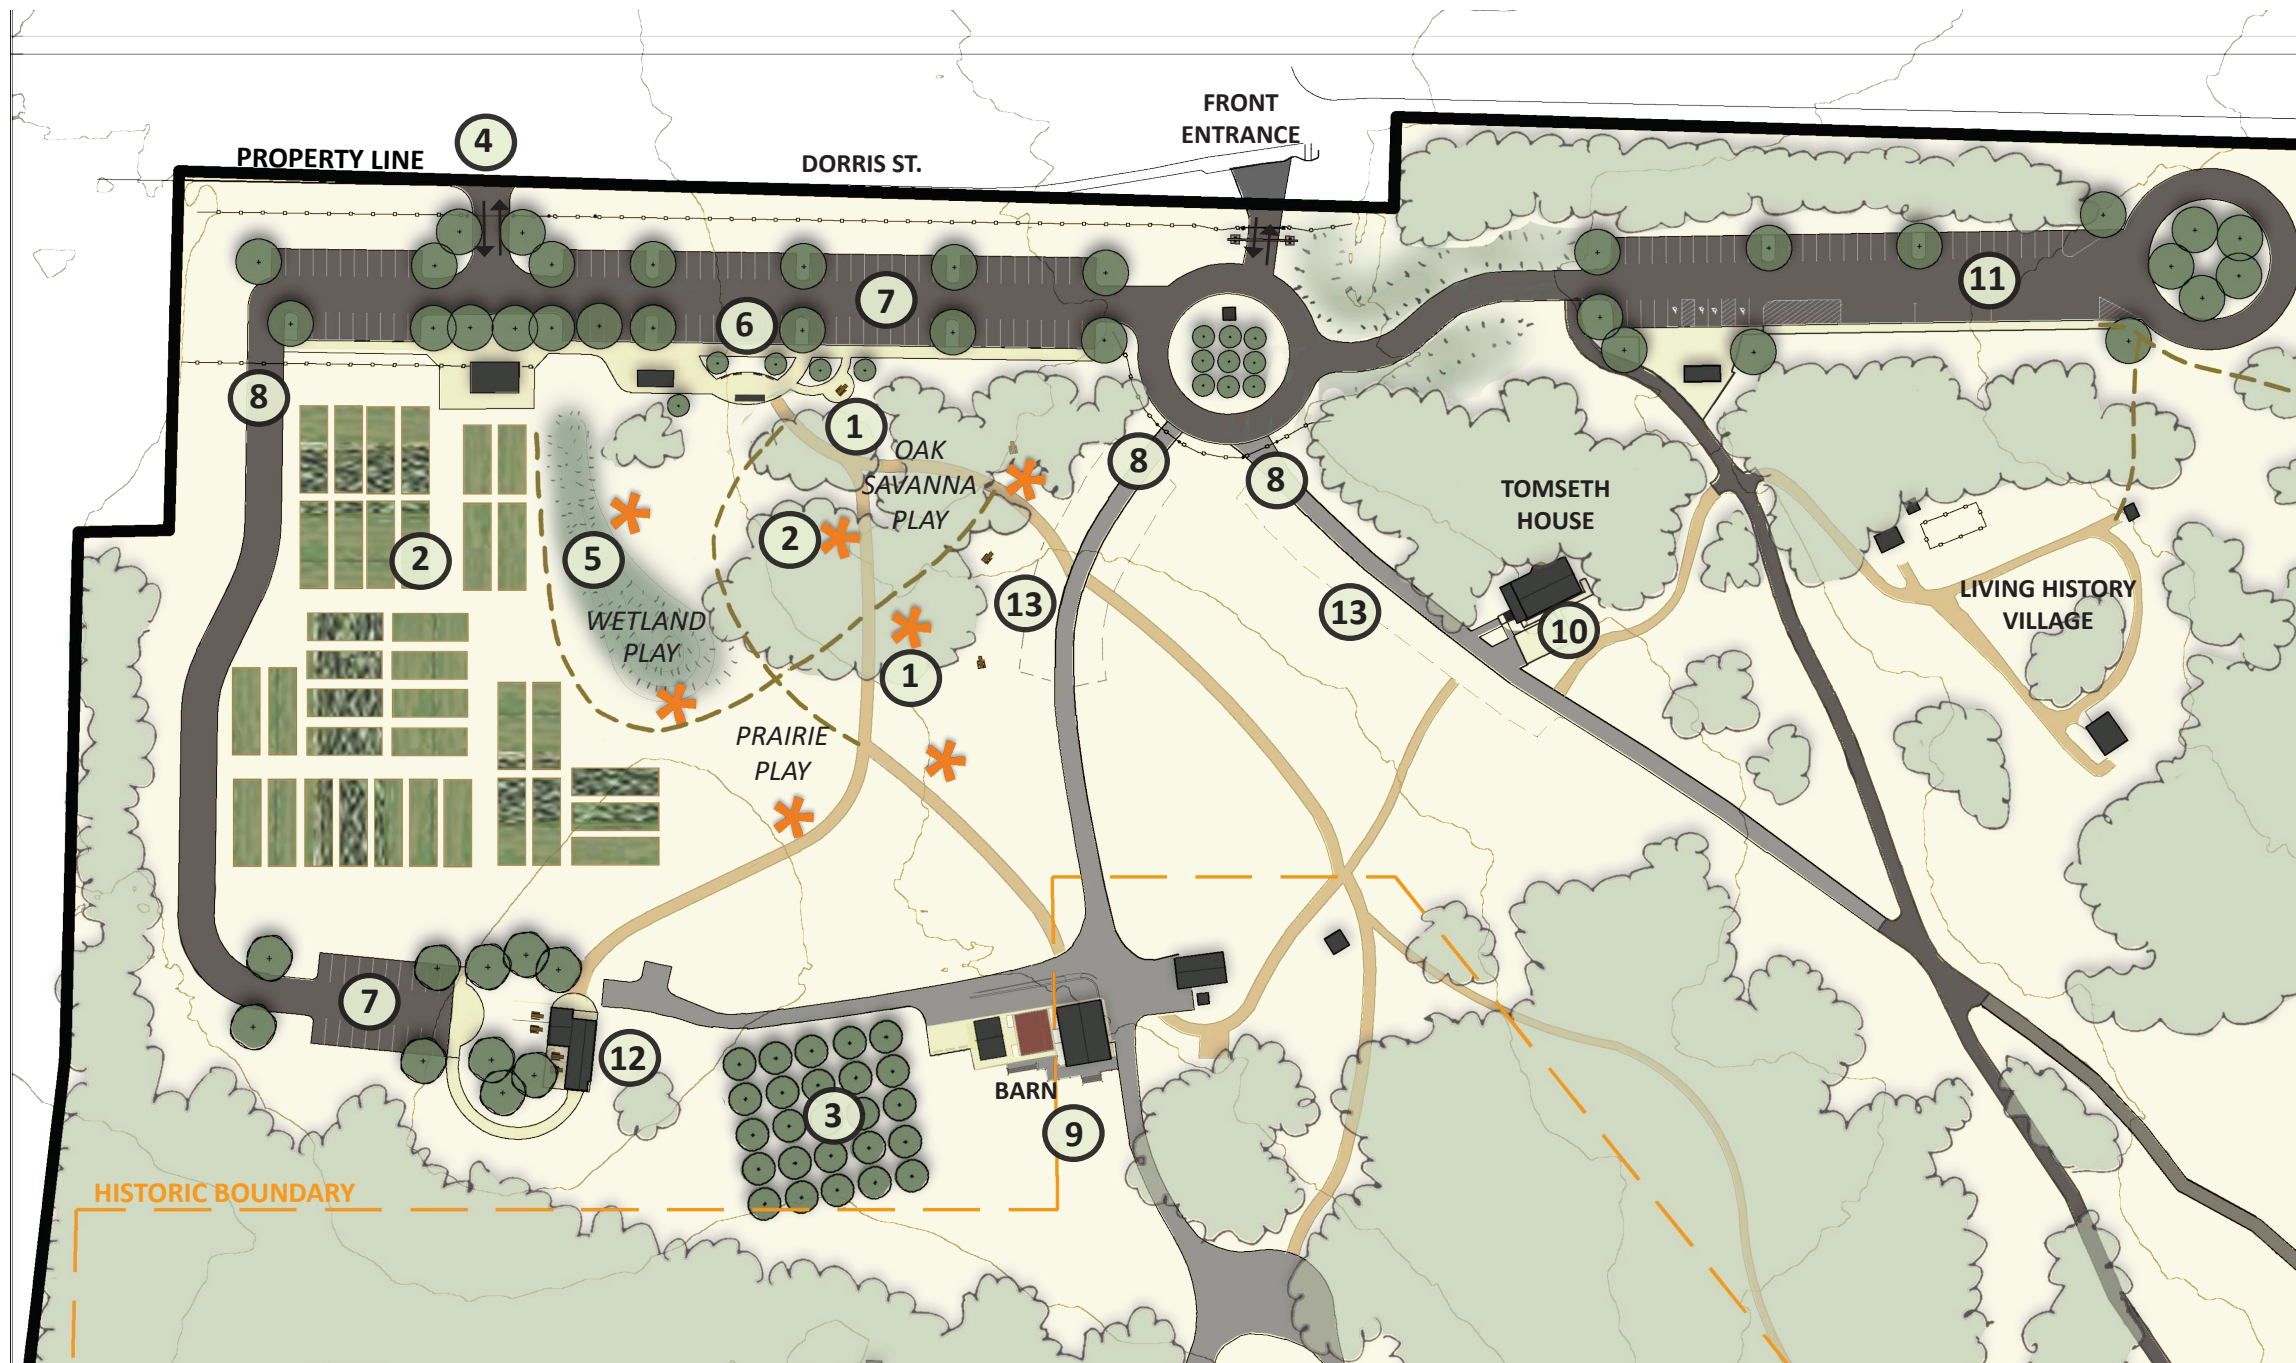
FRONT ENTRANCE, CONCEPT 2 (Demolish Briggs House)

- 1 - **PICNIC & NATURE PLAY AREA** *
Formal picnic area includes paths, concrete pads, and tables dispersed throughout preserved oak savanna. Nature play elements are scattered throughout the wetland, prairie, and oak habitats.

- 2 - **COMMUNITY AGRICULTURE**
Includes tool shed, fencing, and irrigation.
- 3 - **DEMONSTRATION CROPS**
Existing filberts are replaced with fruit trees or other crops planted historically at Dorris Ranch.

This concept proposes what would happen at the location of the Briggs House if the house were demolished. Given the significance of the Briggs House as the original farm house for the property, this concept proposes the building be replaced with a community gathering space that includes design elements that reflect the original structure. Portions of this concept that differ from Concept 1, as a result of demolition of the Briggs House, are described below.

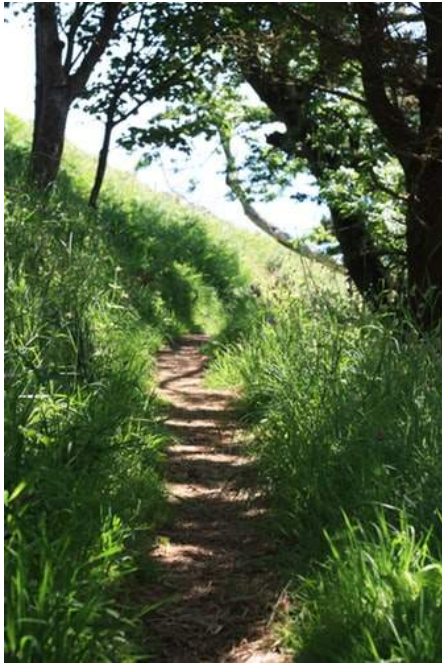
In addition to further definition of trails in the park, this plan proposes a hierarchy within the trail system. This hierarchy includes:

1. Multi-use Path (paved, 10-12 ft wide)
2. Pedestrian Paths (natural surface, 10-12 ft. wide)
3. Pedestrian Trails (natural surface, 2-4 ft. wide)

The 2008 Master Plan did not include a thorough analysis of existing trails, or create a separate plan for future trail planning. Figure 8 shows the proposed Gary Walker Trail and Wayfinding Plan for the property as part of this revision. Instead of including all potential trails on the property, this plan shows those that Willamalane is proposing to maintain and manage for recreational use into the future. Roads used for orchard maintenance and some user created trails are not included on these plans, though some may continue to serve as routes for regular users.

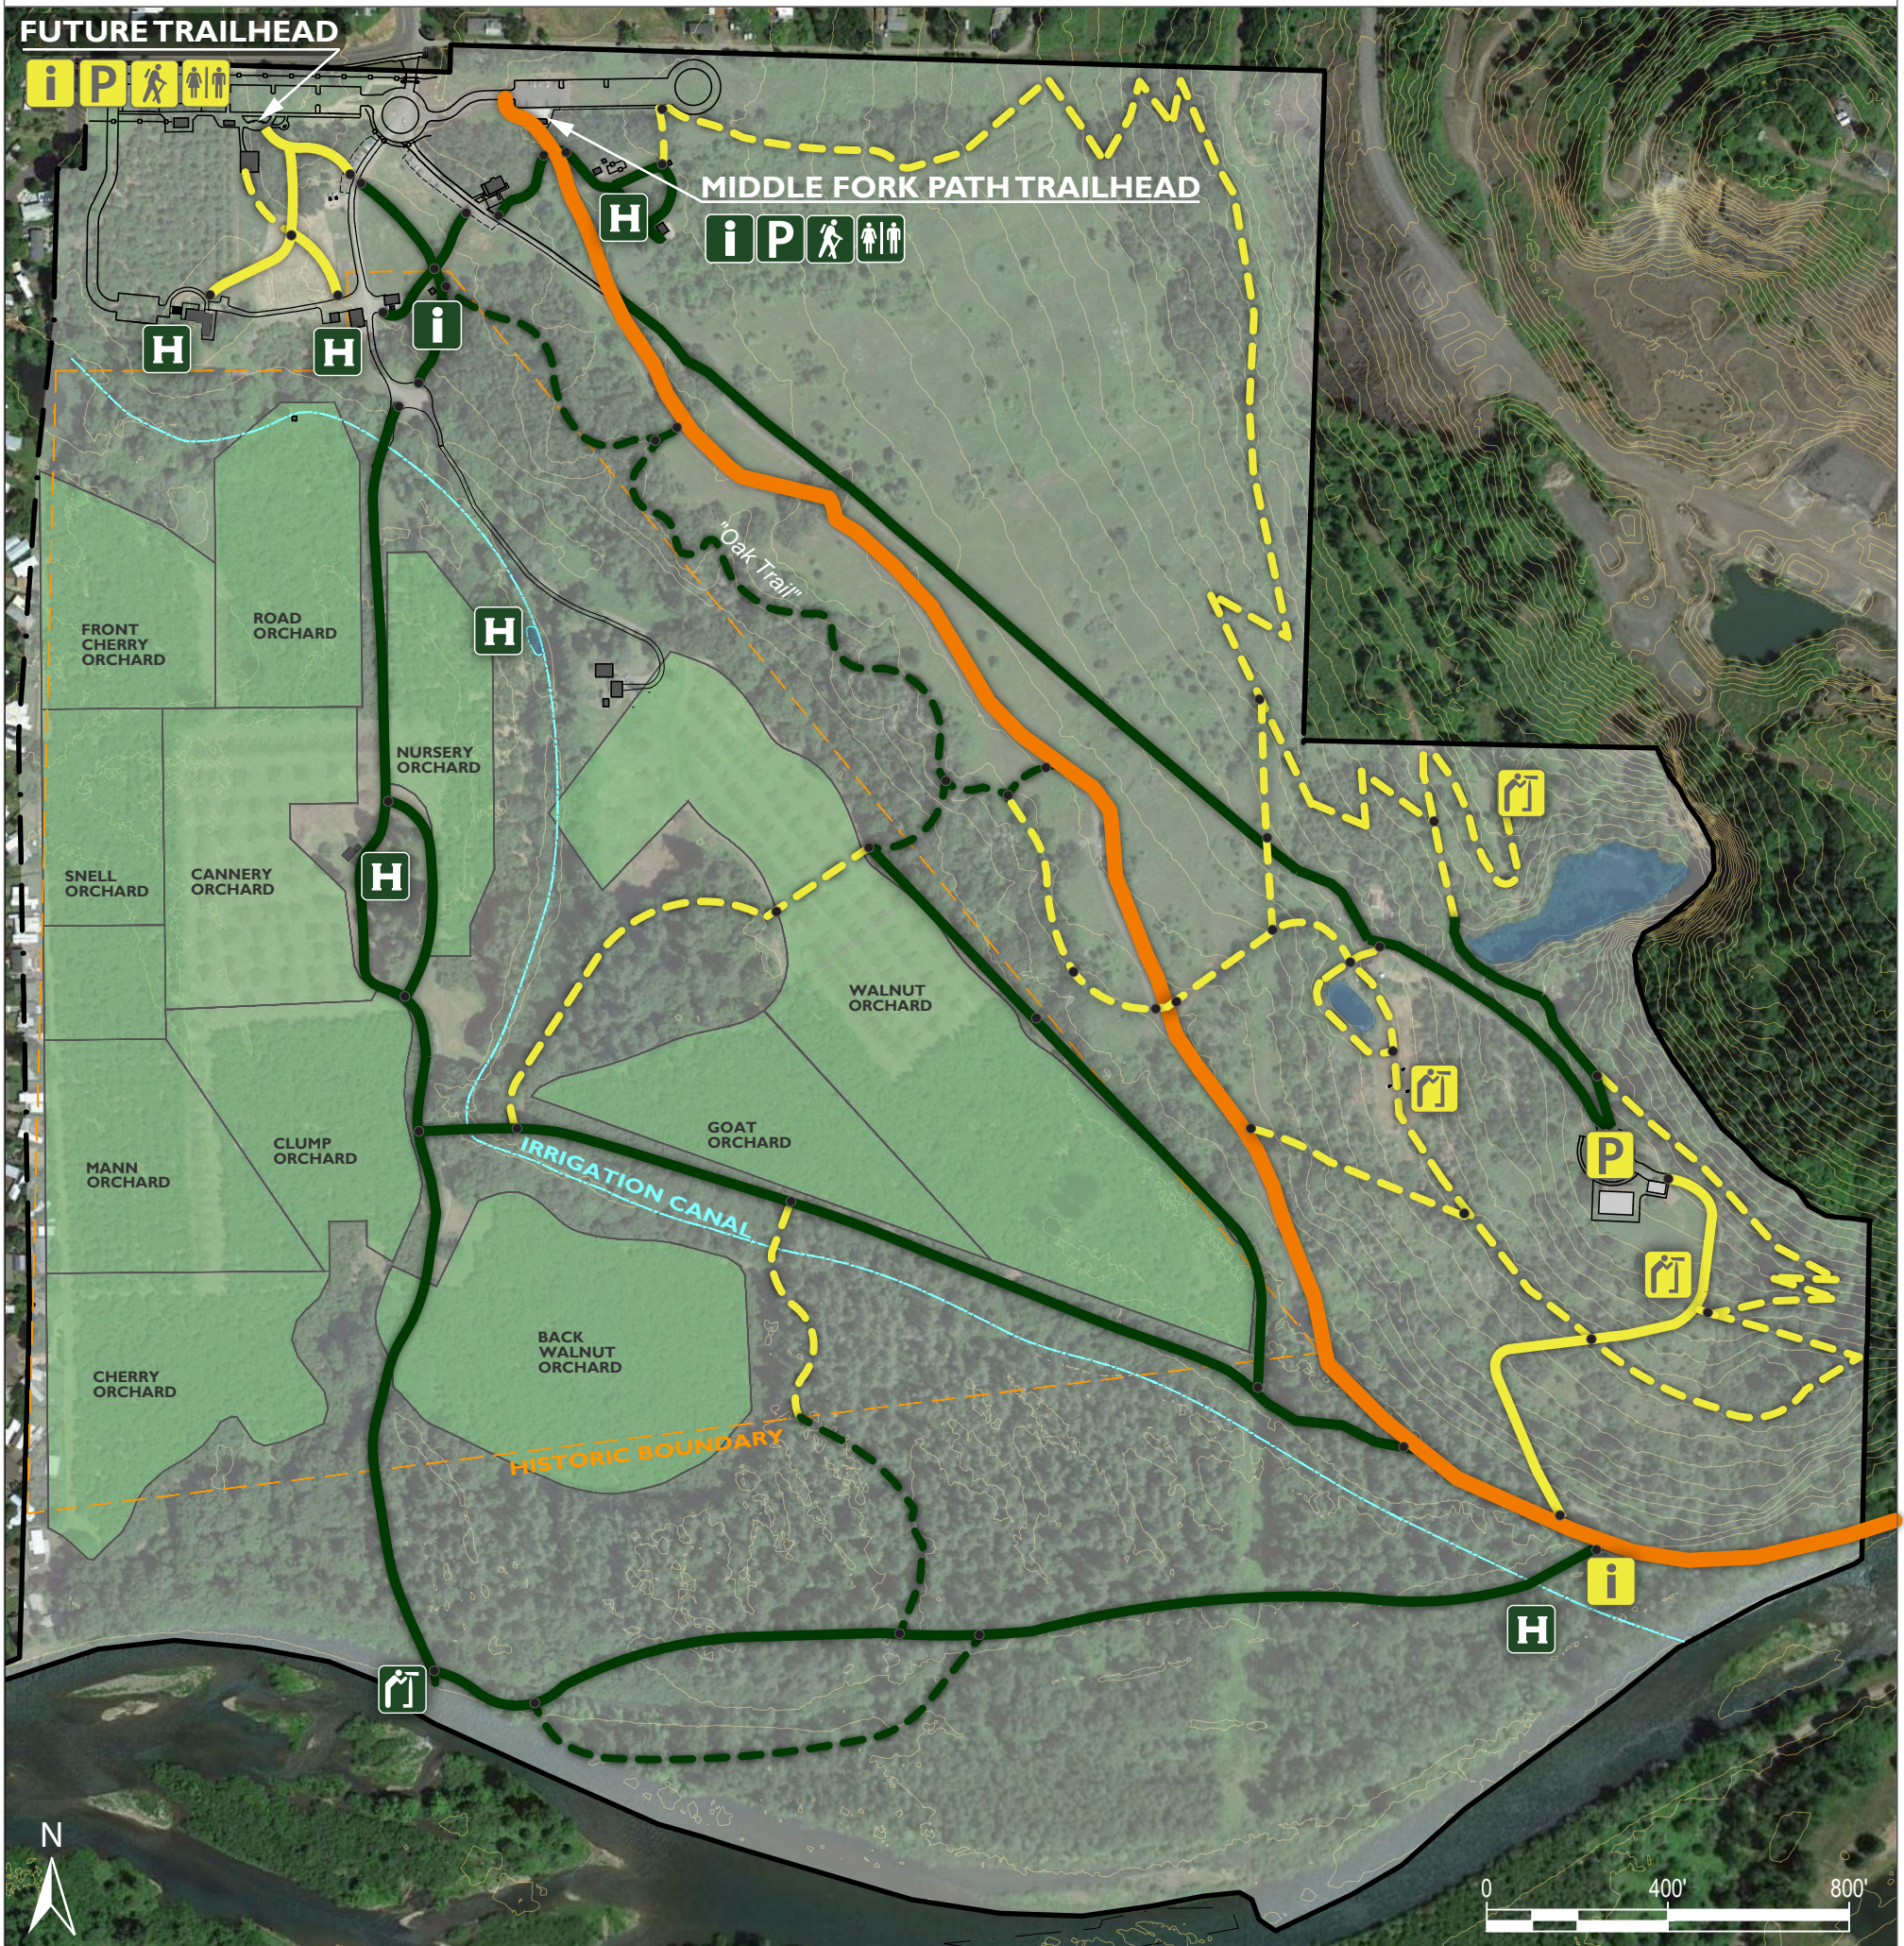
EXSITING/PROPOSED PATHS & TRAILS	EXSITING/PROPOSED AMENITIES	MAP NOTES
EXISTING MULTI-USE PATH	RESTROOMS	<ol style="list-style-type: none"> MULTI-USE PATHS are 10-12' wide and have paved surfaces. PATHS are 10-12' wide and have natural surfaces. TRAILS are 2-4' wide and have natural surfaces. Proposed trail alignments are conceptual. Actual alignments may be adjusted during design development and trail construction. Routes shown are all designed to be constructed to meet Architectural Barriers Act Accessibility Standards for Outdoor Developed Areas. Occasional landings may be required at areas showing switchbacks. Wayfinding signs to include mileage, directional arrows, trail names, and be uniform in color and materials.
EXISTING PATH	INFORMATION KIOSK	
FUTURE PATH	PARKING	
EXISTING TRAIL	TRAILHEAD	
FUTURE TRAIL	VIEWPOINT	
10 ft. CONTOUR	HISTORICAL FEATURE	
	WAYFINDING SIGN

For an assessment of current trails, in addition to proposed future trails, see the Gary Walker Trail and Wayfinding Plan (Figure 8), which is discussed further in the Recommendations section of this document.

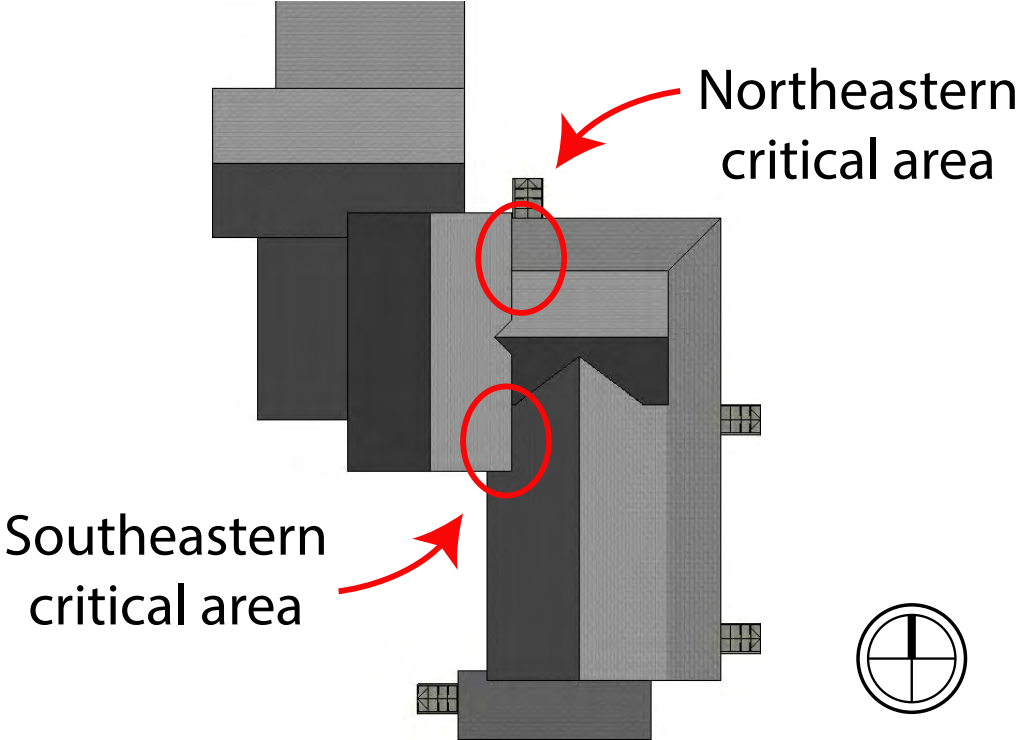
Figure 1: This diagram displays the northeastern and southeastern critical areas of the roof that exhibit a high level of water infiltration in the two-story volume.

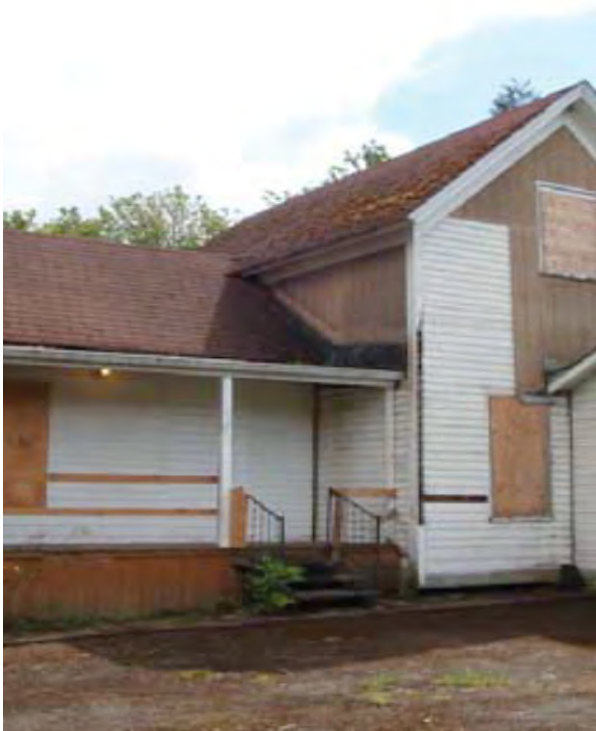
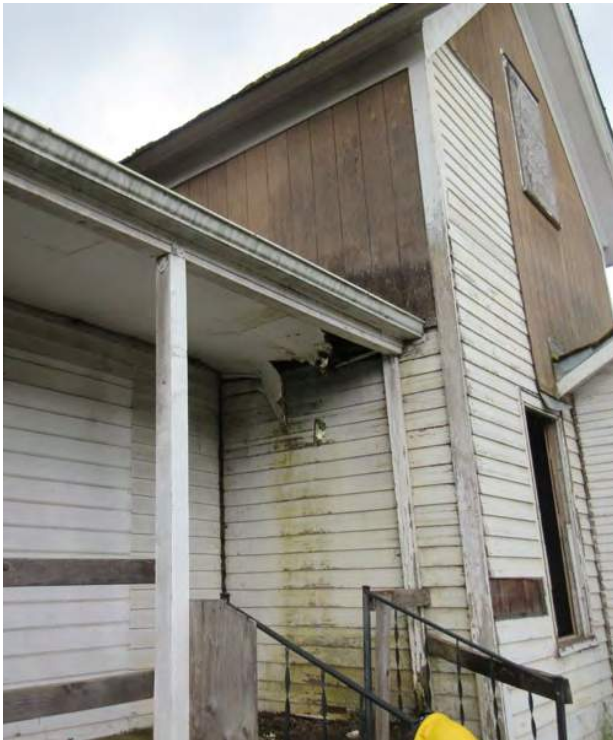
Figure 2: The image on the left (taken from the 2010 UO assessment) displays the roof above the porch in this northeastern critical area still intact, and the image on the right displays its current collapsed state. A piece of the cornerboard on the southeastern corner of the two-story structure (photo on the right) is missing on the northern face of the building.

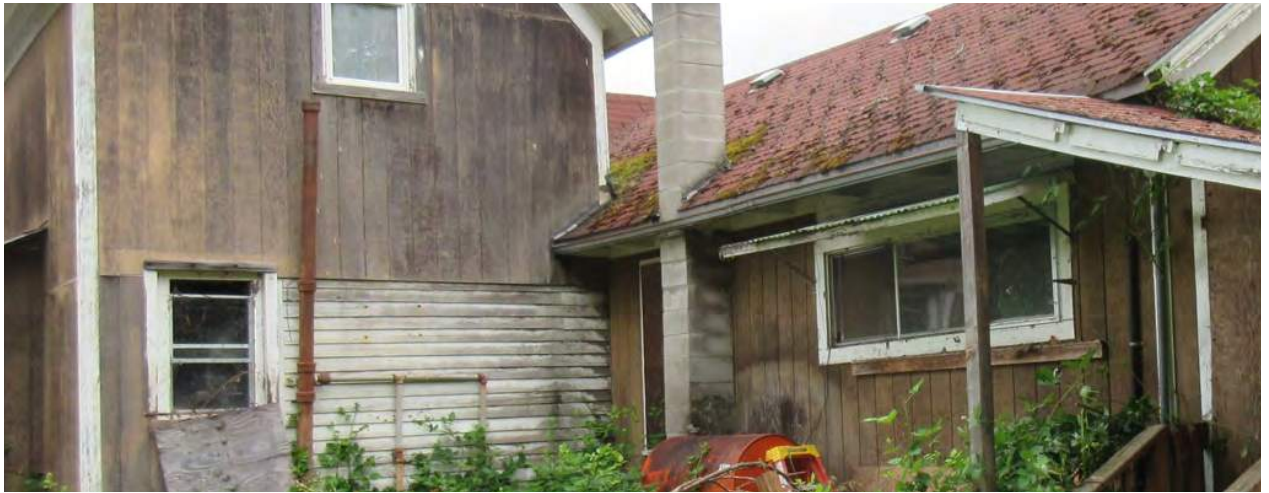
Figure 3: The image above depicts the current condition of the southeastern critical area as a result of continuous water infiltration. The increased growth of moss, warped shiplap siding, and joint where a cornerboard used to be are shown.

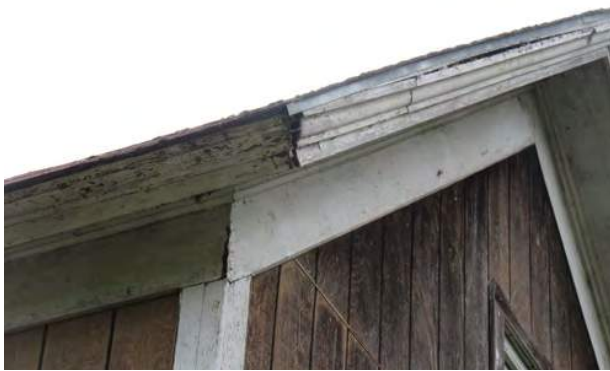
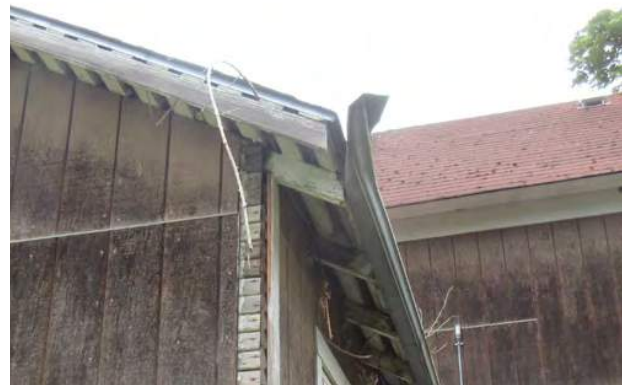
Figure 4 (left): The image above displays the tip of the cornice that is missing on the southern side of the two-story volume as well as the separation between the cornice and flashing on this edge. Figure 5 (right): This image depicts the loosely attached flashing on the southern roofline of the garage.

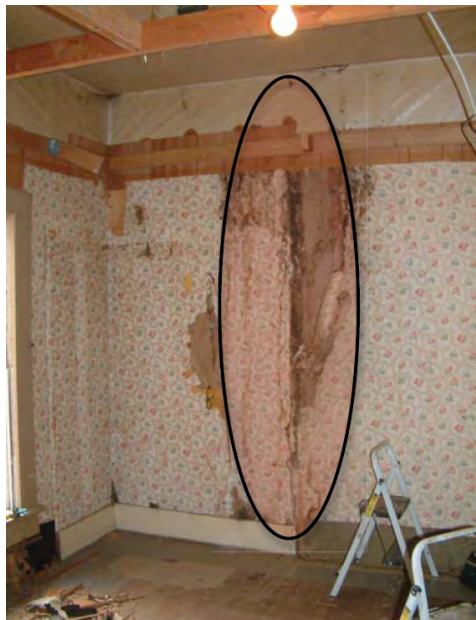
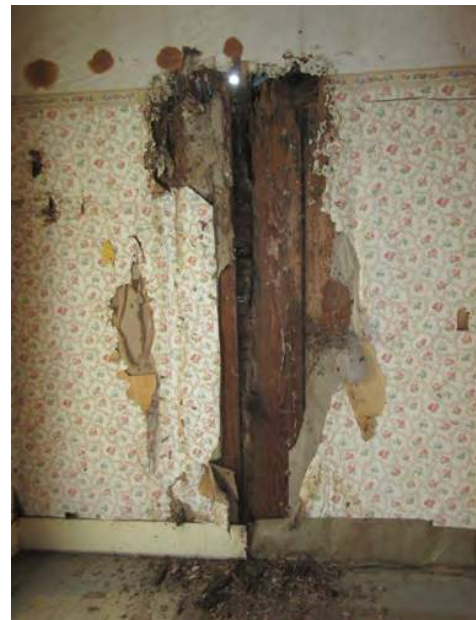
Figure 6: The image on the left is taken from the UO assessment and depicts the interior damage associated with the exterior northeastern critical area in 2010. The image on the right depicts how this damage has progressed over the past 7 years.

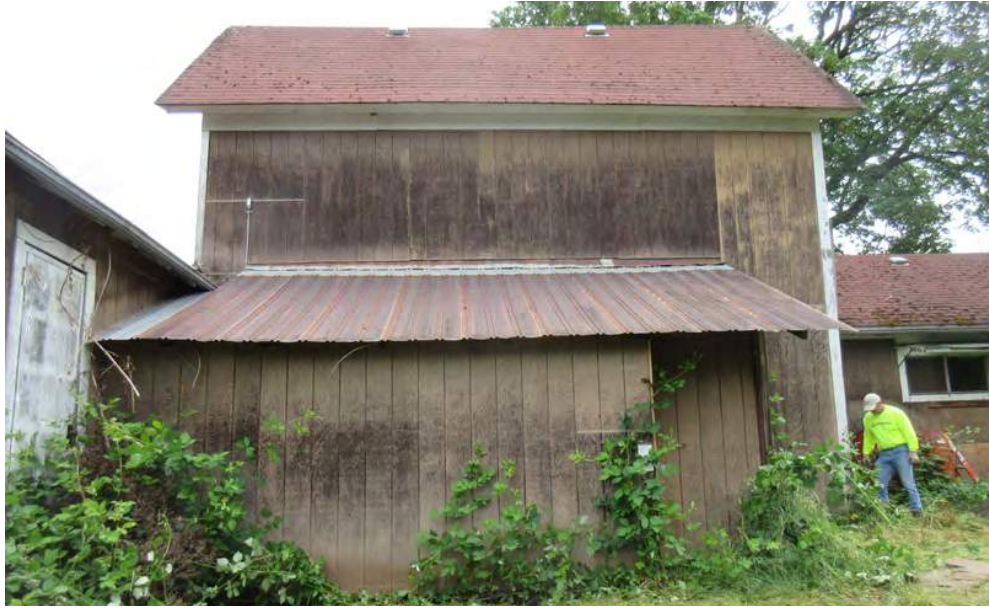
Figure 7: The image above exhibits a good example of the T-111 siding on the western façade of the main two-story volume and its attached shed that has accumulated water residue and lost a significant amount of color.

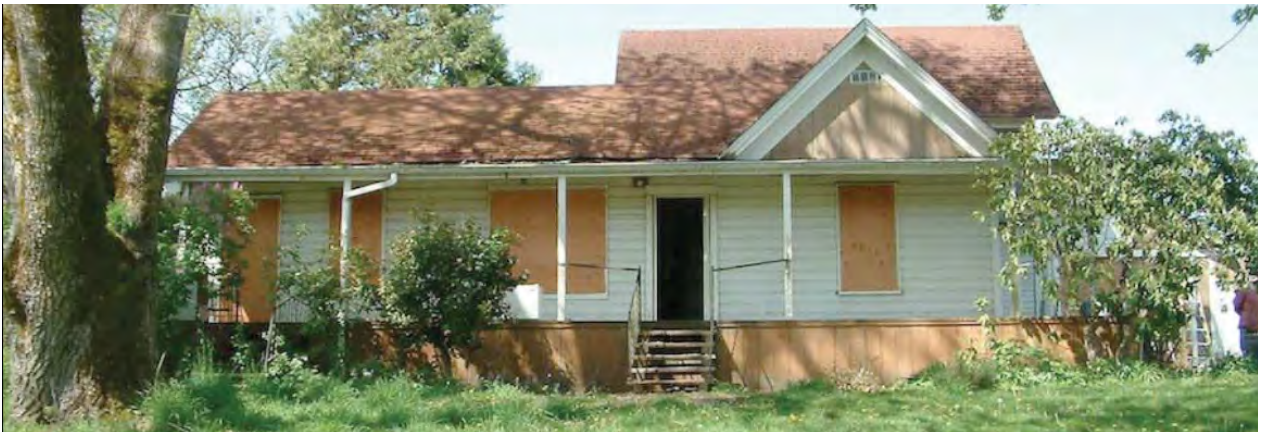
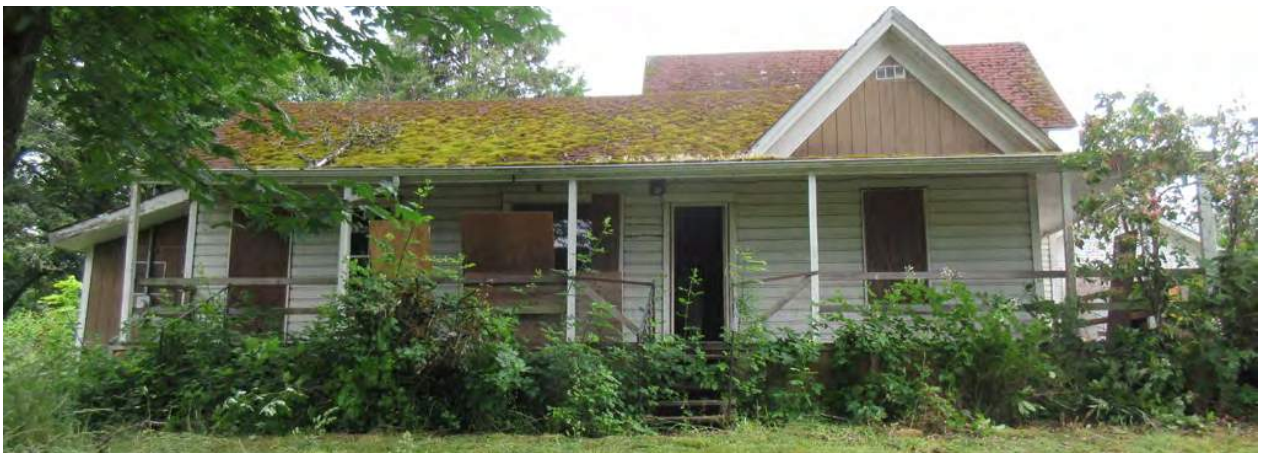
Figure 8 (before; after): The first image of the Briggs House above (top) exhibits the eastern façade in 2010 at the time of the UO assessment report, and the few handrails that were attached. The second image (bottom) exhibits the same façade in a poorer state seven years later. This image also displays the great amount of moss that has accumulated on top of the roof on this façade since 2010, as well as the placement of more temporary handrails.

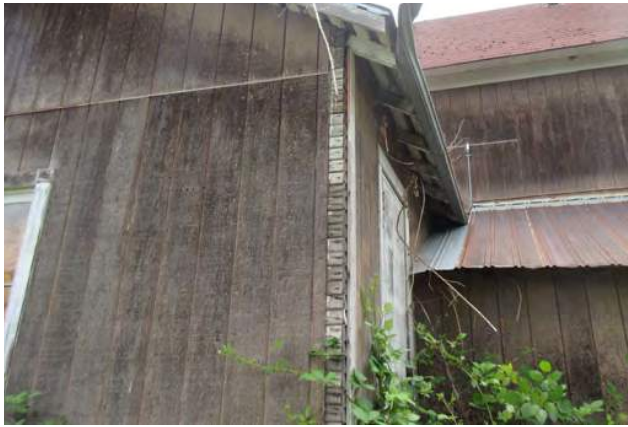
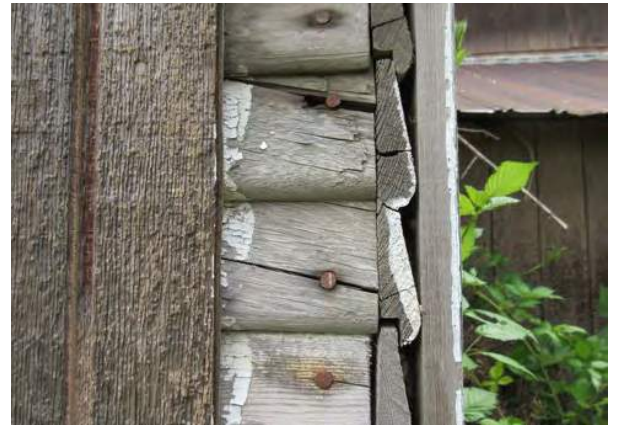
Figure 9: The image on the left displays the cornerboard that has been removed from the southeastern corner of the garage, and the image on the right displays the shiplap siding on this corner that shows paint erosion due to continuous water exposure over the past seven years.

Weathering to the shiplap on the eastern façade under the porch roof has increased. Although there are more visible signs of brittleness and cracking than were present in the UO assessment, the façade remains in good condition overall (Figure 8). A cornerboard has been removed or is missing from the western side of the southwestern corner of the garage, revealing historic shiplap siding. The white paint has worn off of only this exposed section of the underlying wall (Figure 9). Exposed weatherboards on the northern façade of the two-story structure exhibit some paint erosion at the mid-section near the level of the first-story roof and boards are missing east of the window frame on this façade.

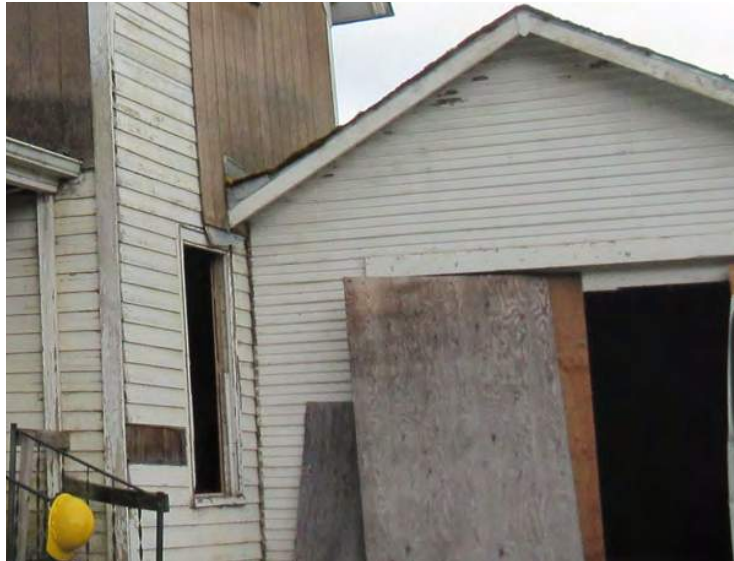
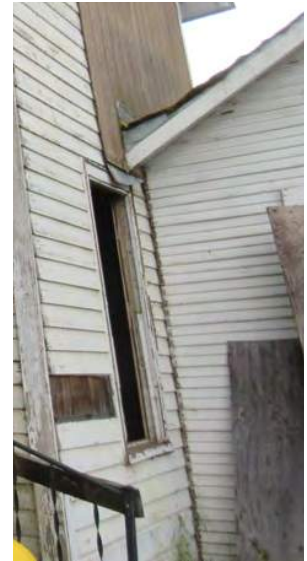
Figure 10: The first image above (left) exhibits the location where the cornerboard is missing at the juncture where the eastern façade of the garage meets the northern façade of the two-story structure. It also displays the paint chipping below the eave on the garage's eastern façade. The second image (right) depicts a close-up view of the vertical unpainted strip at the juncture along this eastern façade that suggests that a cornerboard had once existed there.

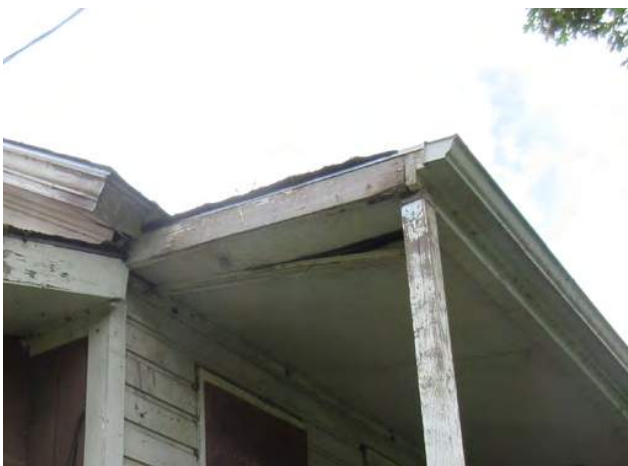
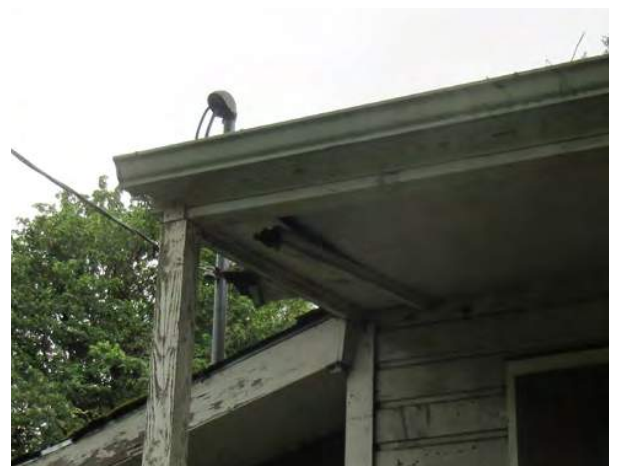
Figure 11: Both images above depict the southeastern corner of the current porch. The image on the left shows the paint erosion on the upper end of the post at this location, and the image on the right depicts the portion of the corner beam beneath this section of the roof that is missing.

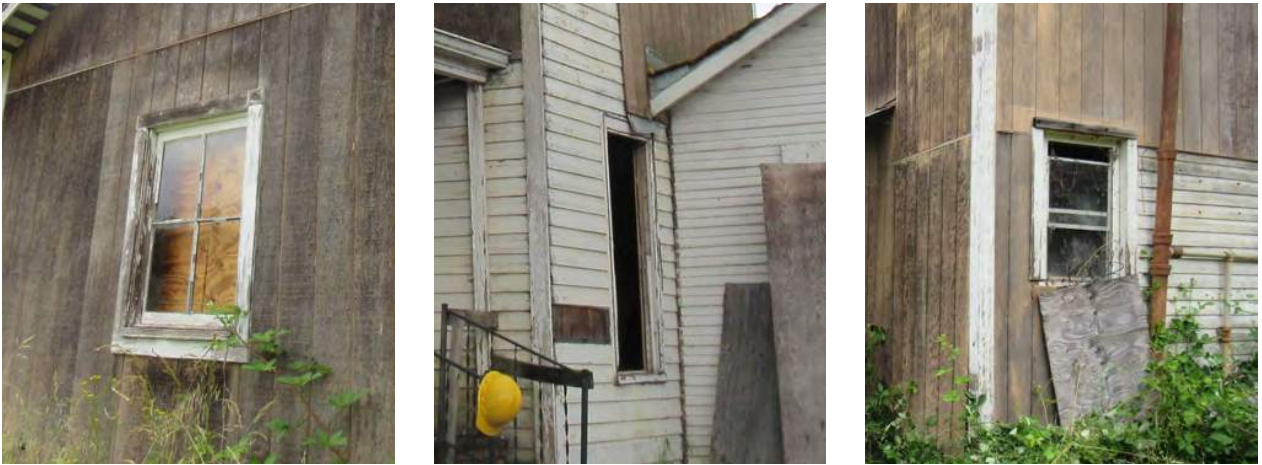
Figure 12: The three images above depict the splitting of the frames, muntins, and sills of the windows on the western façade of the garage and the northern and southern sides of the two-story upright structure, respectively.
