DORRIS RANCH LIVING HISTORY FARM

MASTER PLAN REVISION

December 2019

WILLAMALANE PARK AND RECREATION DISTRICT
REYNOLD & EVA BRIGGS HOUSE REPORT

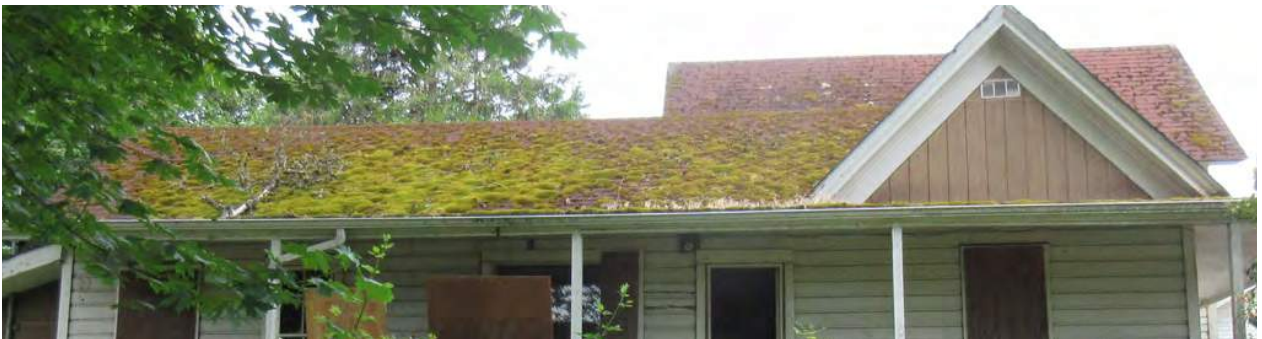
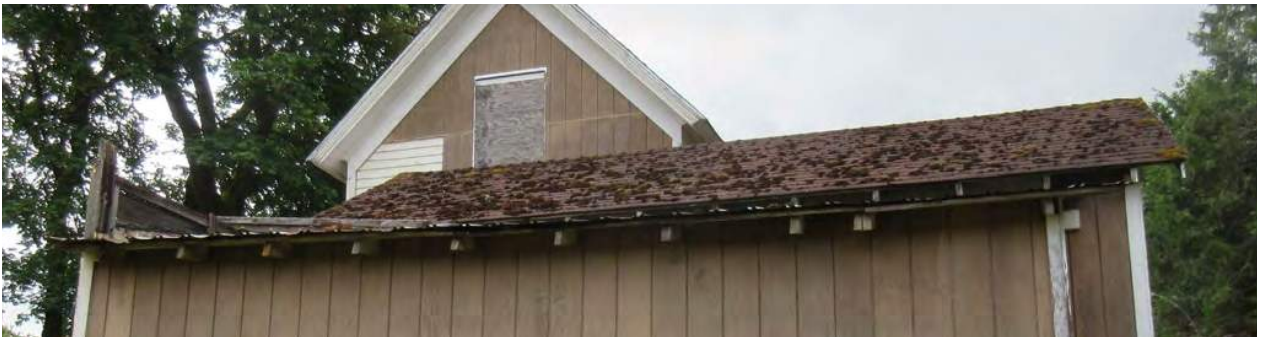
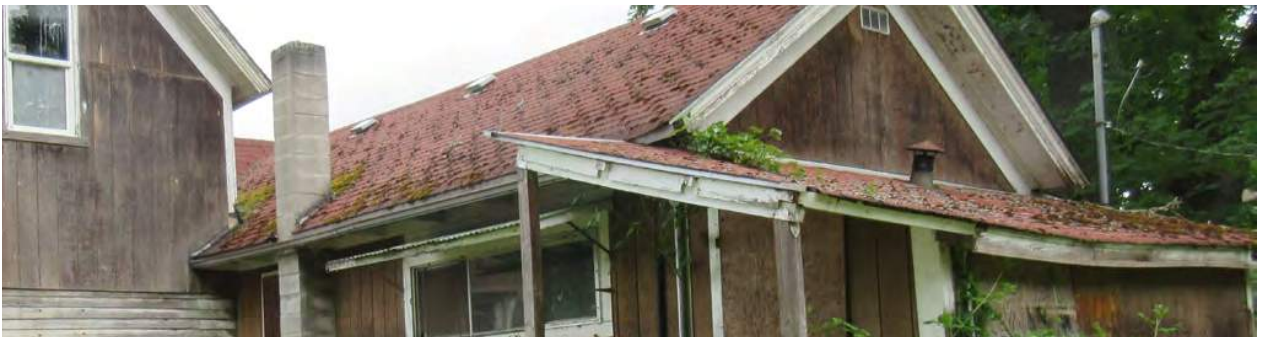
Figure 13: The three images above depict the amount of moss that has grown on the roof of the eastern façade of the 1890's kitchen addition (top), the northern façade of the garage and garage shed addition (middle), and the southeastern critical roof area as well as the roof of the 1890's kitchen shed addition (bottom).

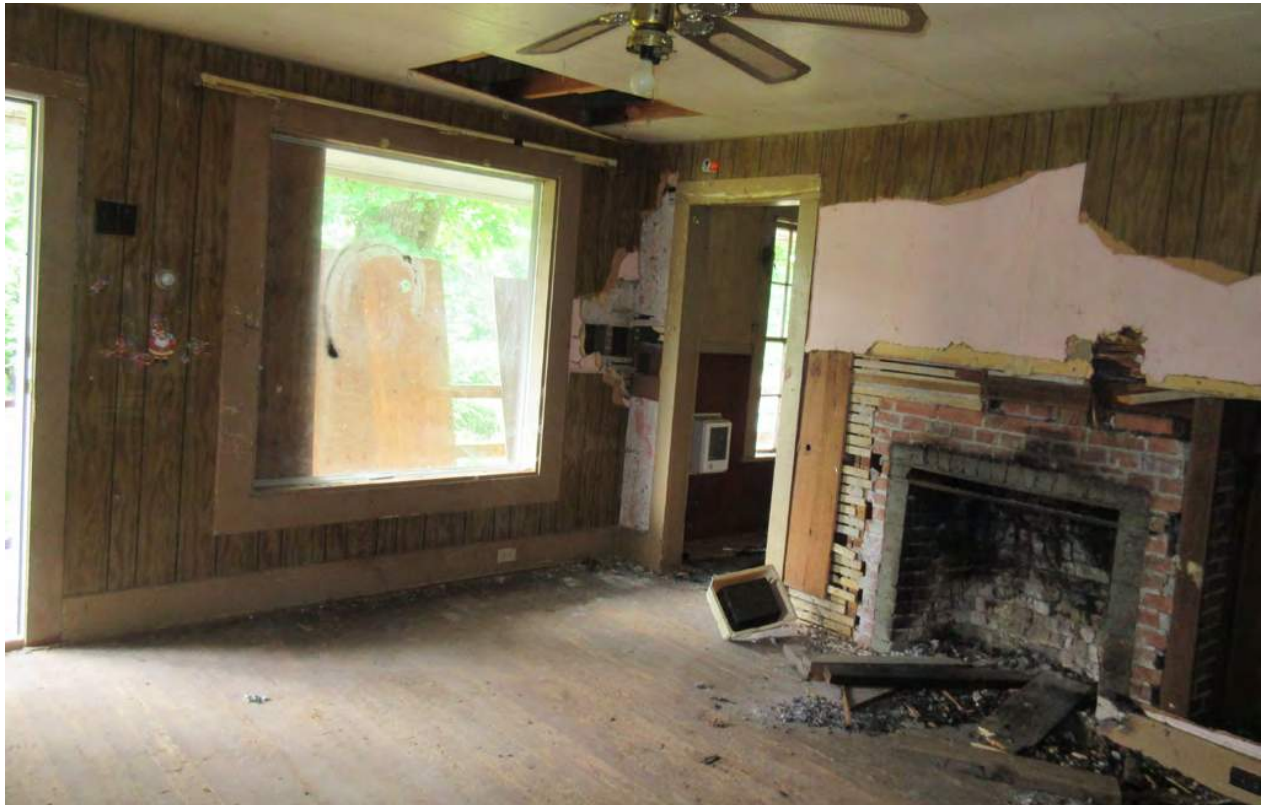
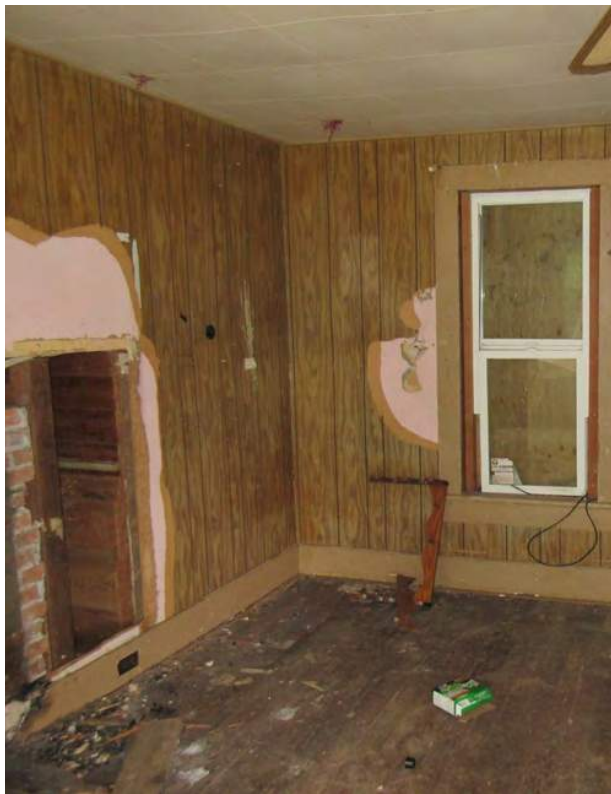
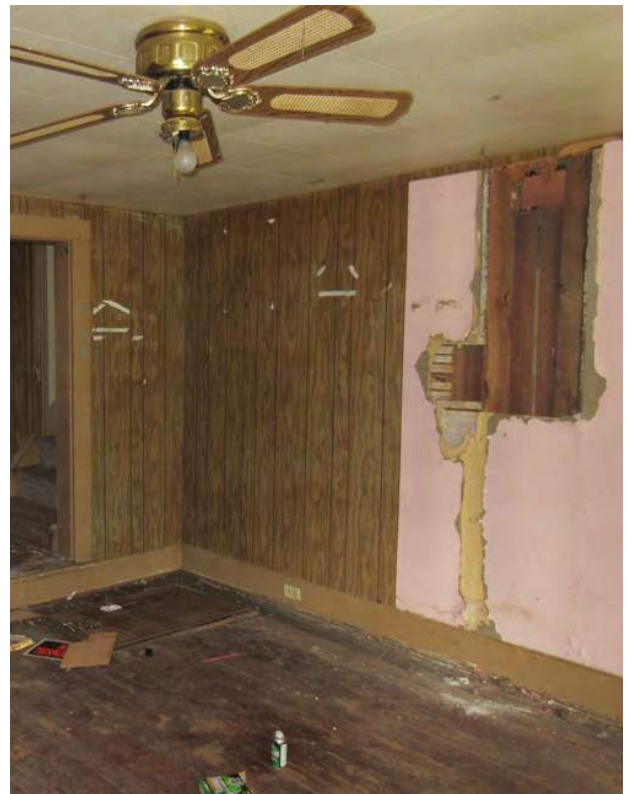
Figure 14: These images depict the living room in its current condition. Most pink wallpaper has been removed to reveal the underlying finishes, most notably around the fireplace. The final image depicts the damaged portion of the northern wall through which the dining room is visible on the other side.

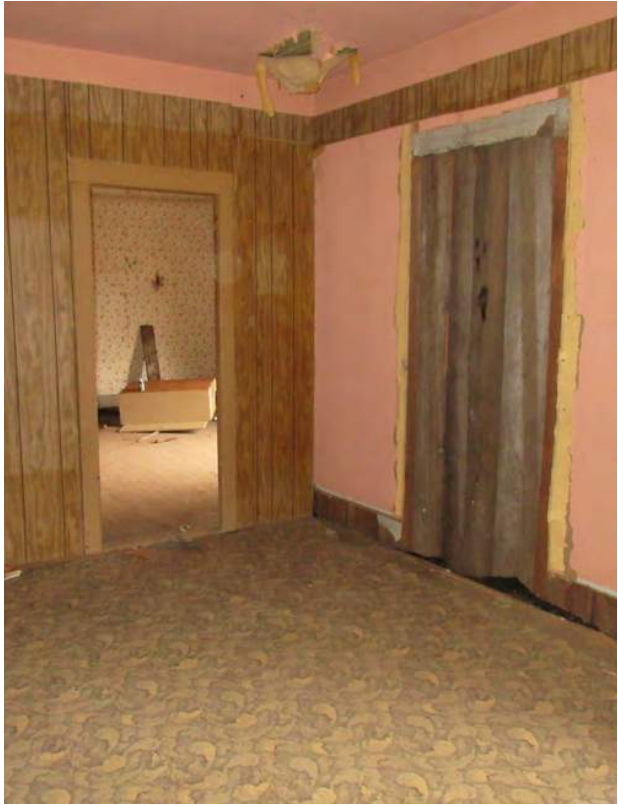
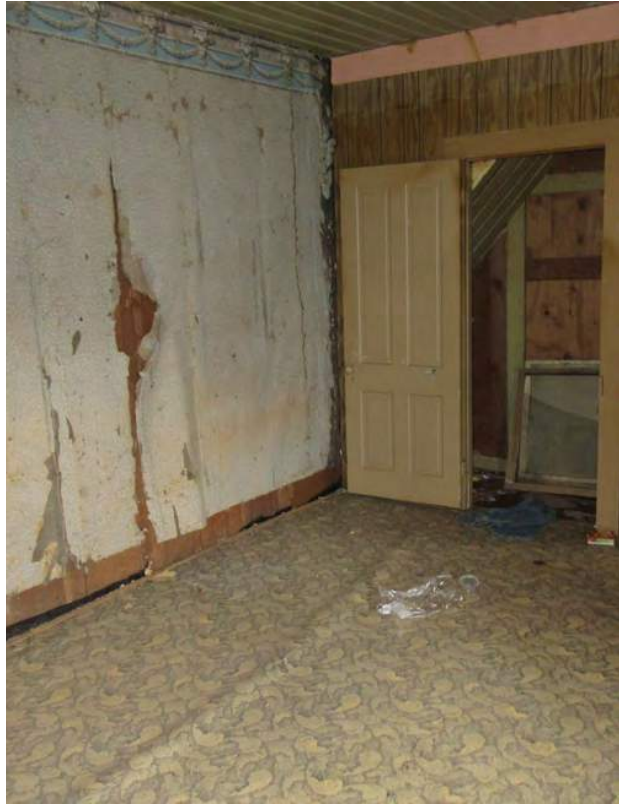
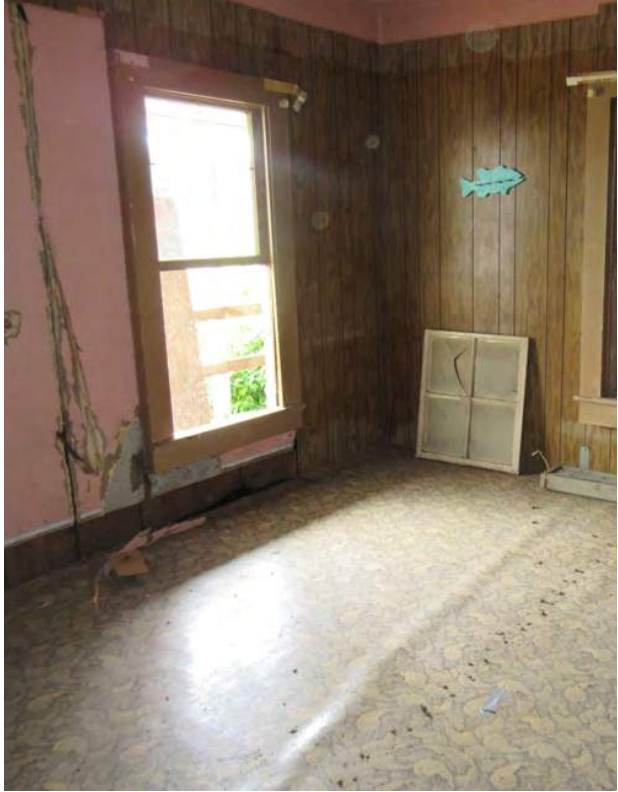
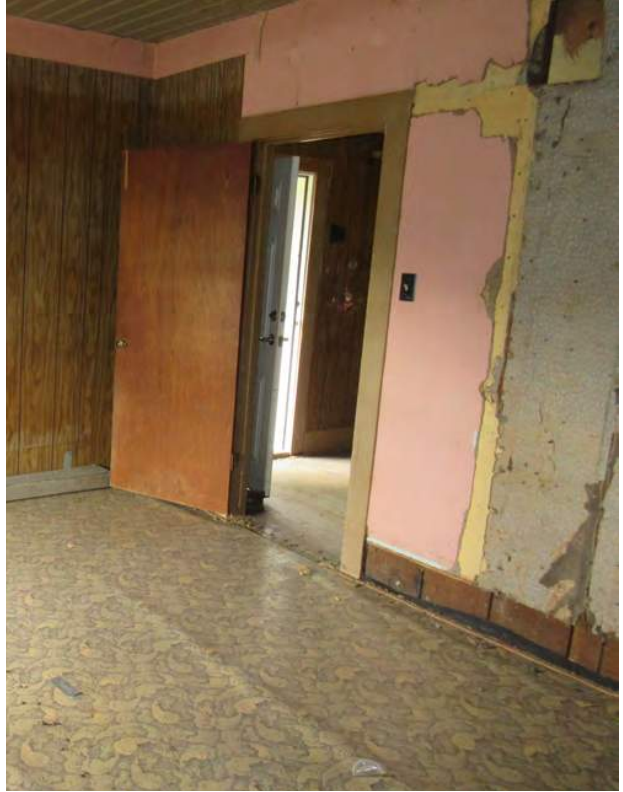
Figure 15: These images depict the current state of the dining room in the Briggs House. Most pink wallpaper from the walls and ceiling is missing, exposing the finishes beneath.

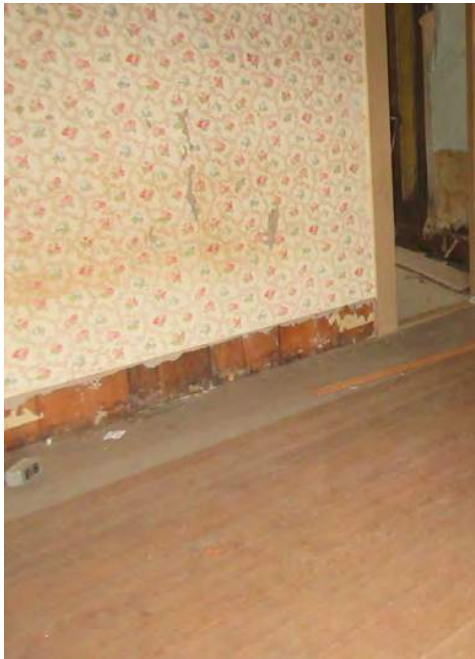
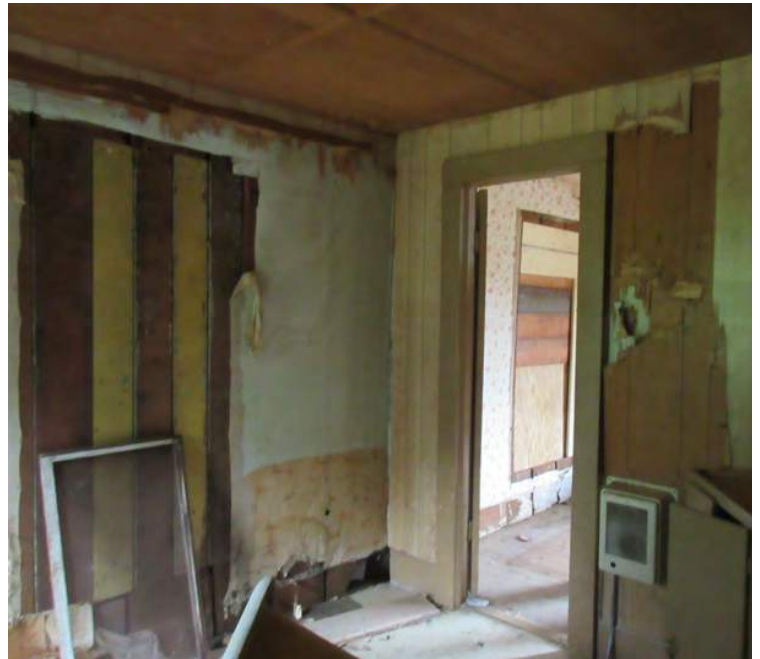
Figure 16: The image on the left depicts the southwestern corner of the original 1870's parlor. The wallpaper in this room is still intact apart from a strip (shown in this figure) that has been removed along the base of the walls in this room and the water damage that has occurred on the eastern wall (Figure 6). The image on the right depicts the removal of wallpaper in the original 1870's kitchen that displays the largest variety of underlying finishes out of all of the rooms in the house.

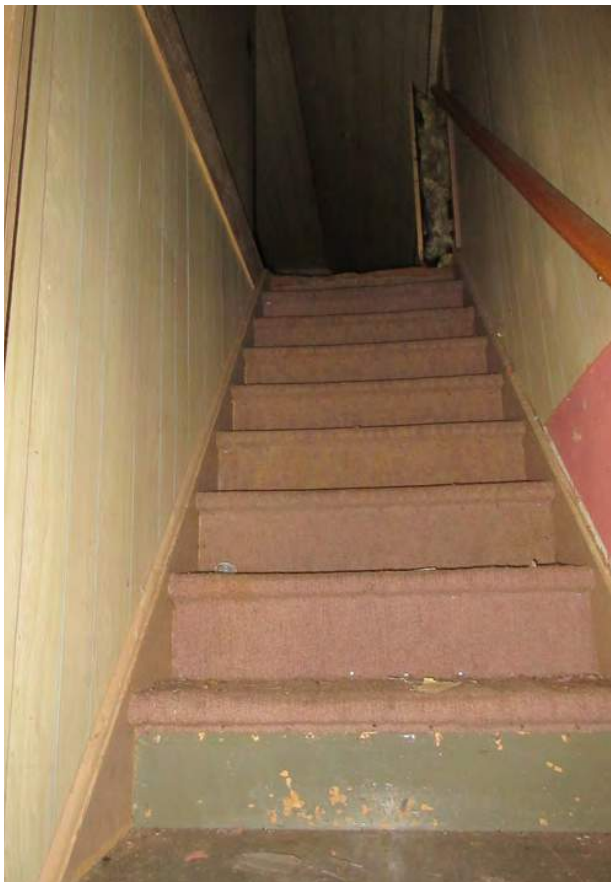
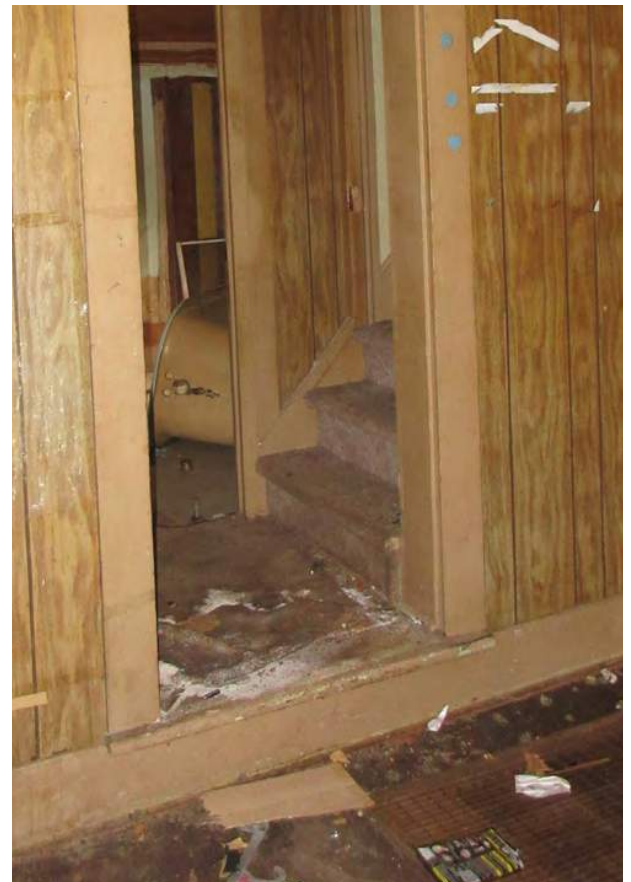
Figure 17: The image on the left depicts the carpet that is missing from the lower-middle steps in the stair case. The image on the right displays the white residue that has developed and a portion of the carpet that is missing at the base of the staircase.

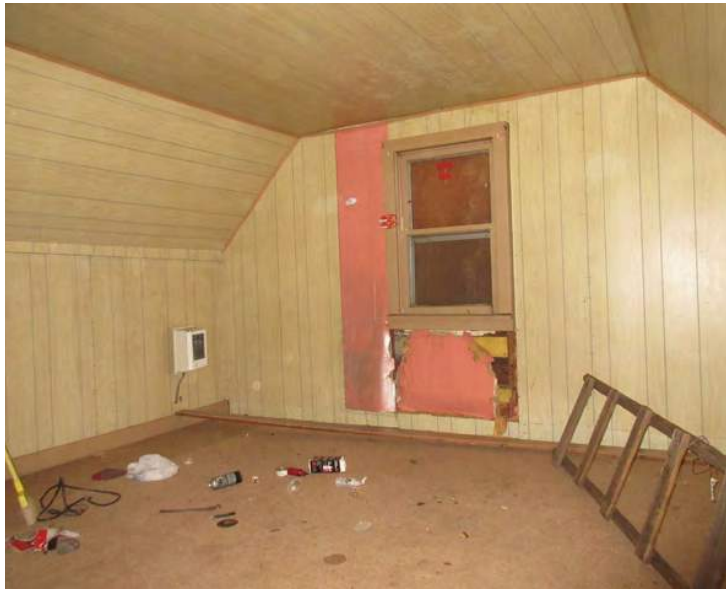
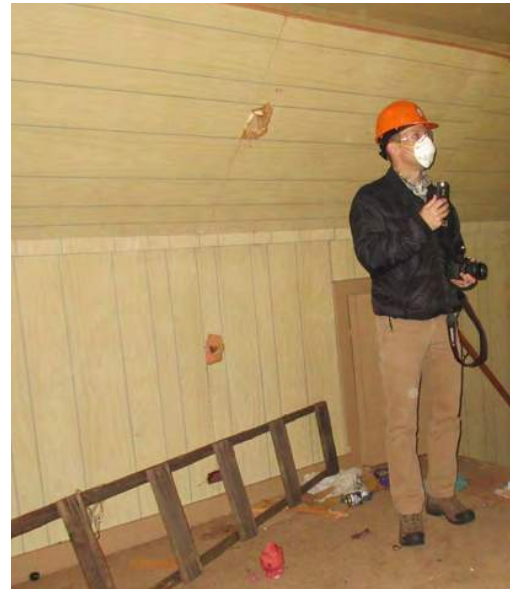
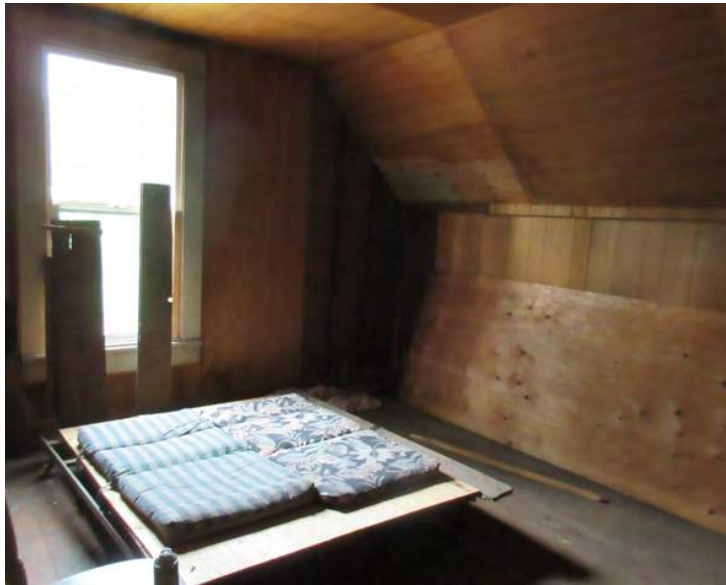
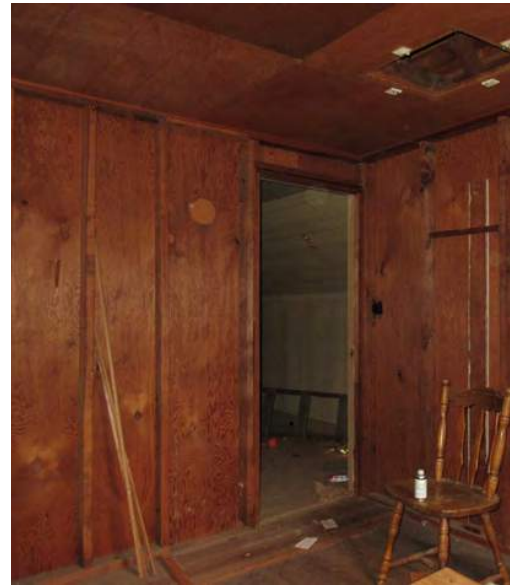
Figure 18: The top two images depict the first upper room on the second level of the Briggs House. The first of these two images shows the two portions of the wood laminate next to and below the window that have been removed. The second image depicts the eastern wall in good condition apart from two small patches that are torn. The bottom two images depict the second of the upper rooms in good condition.

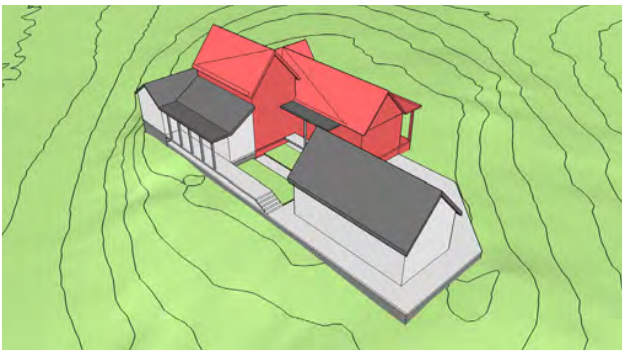
Southwest

Option 1B is designed to provide more space to accommodate larger rental parties and classes than Option 1A would, and exhibits the largest alteration to the building's historic footprint out of all of the options in order to do so. It expands the 1920's garage addition to avoid excavation below the building and includes a new structure southwest of the existing building that would mimic the stylistic appearance of the original house. A lack of excavation in Option 1B allows for optimal daylighting in all rooms. Also, the expansion of the Briggs House in this design does not alter the main (eastern) elevation of the building that is visible from the point of entry to the park near the Tomseth House.

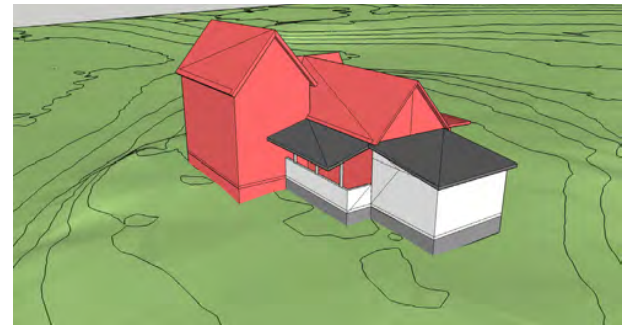
Southwest

A very strong method for preserving the integrity of the Briggs House would be to utilize the building in the way that was originally intended. Option 3 provides a rehabilitation plan that retains the property's original residential function and exhibits the least amount of alteration to the building's historic footprint in comparison with all other options. Part of the design intent for this option would be to preserve the Briggs House as much as possible in order to maintain its historic integrity. Due to its level of preservation, the Option 3 rehabilitation plan for the Briggs House would contribute well to the "living history" of Dorris Ranch.
