**Accessibility Review**

# Community Center
## City of Shakopee

Survey By JQP, MQP
Survey Date 07/14/2025

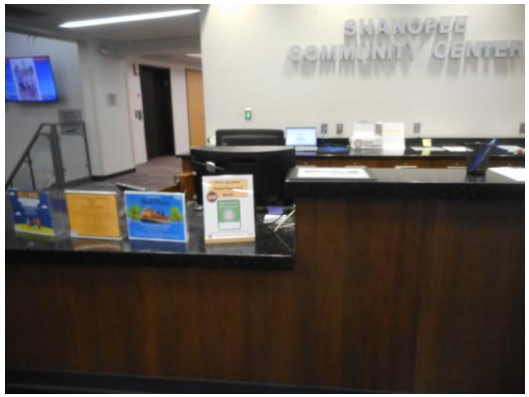
**Photo 1:** The main service desk includes an accessible section. *This is a good example of accessibility.*

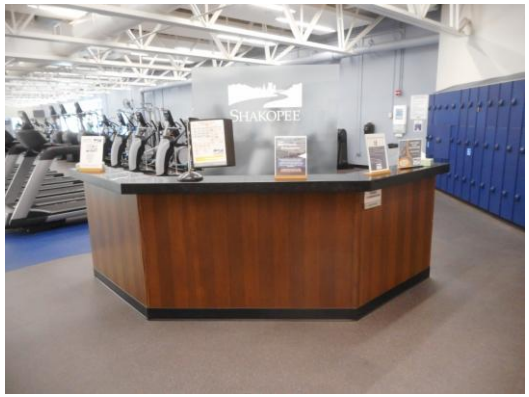
**Photo 3:** The service for the fitness coordinator is currently at 42" (vs. 36" maximum); there is not an accessible section of desk available.

**Photo 4:** The corridor leading to the fitness studios on the upper level currently protrude into the circulation route.

| Location / JQP # / Item # | | Solution / Comments | Qty | Unit Cost | Total Cost | Priority | Estimated Compl. Date | Person Responsible | Actual Compl. Date | Actual Cost |
|---|---|---|---|---|---|---|---|---|---|---|
| **21A** | *28573* | Lower a minimum 36" wide section of counter to a maximum height of 36" above the floor.<br>ICC ANSI 904.3<br>*Currently at 42". Photo 3.* | 1 | $1,000 | $1,000 | 3 | | | | |

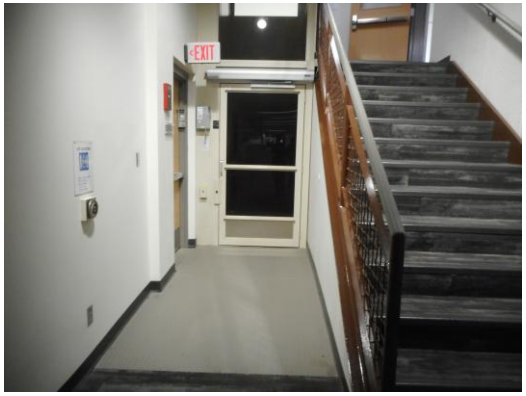
**Photo 5:** A platform lift has been added to create an accessible route to the raised walking track above the gym. *This is a good example of accessibility.*

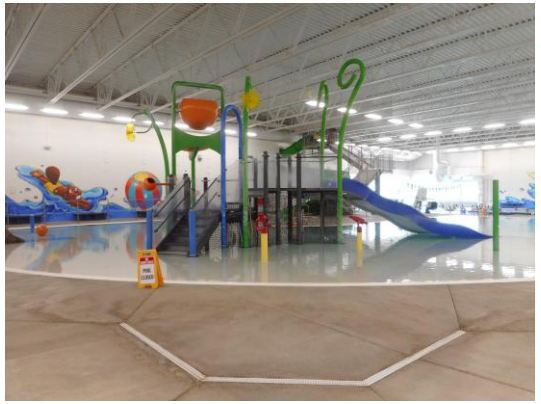
**Photo 6:** View of aquatic center play area. A sloped entry to the wading pool is provided.

**Photo 7:** A lift is provided in order to provide access in to the water of the swimming pool. *This is a good example of accessibility.*

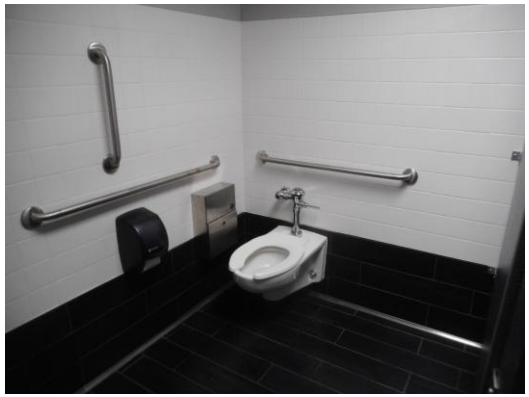
**Photo 19:** The women's toilet room in the entry vestibule currently provides a compliant wheelchair accessible toilet compartment. *This is a good example of accessibility.*

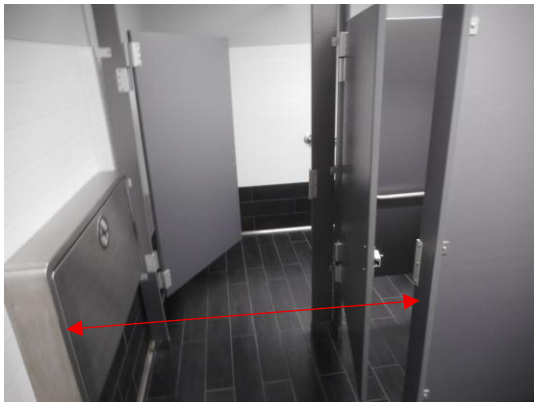
| Location / JQP # / Item # | Solution / Comments | Qty | Unit Cost | Total Cost | Priority | Estimated Compl. Date | Person Responsible | Actual Compl. Date | Actual Cost |
|---|---|---|---|---|---|---|---|---|---|
| *28613* | *The depth on the pull side of the ambulatory accessible toilet compartment is reduced to 40" (vs. 42" minimum) due to the baby changing table. Consider removal of the baby changing table. ANSI 604.10.3 Photo 20.* | 1 | $50 | $50 | 4 | | | | |

**Photo 20:** The women's toilet room in the entry vestibule currently provides an ambulatory accessible toilet compartment. *This is a good example of accessibility.* The baby changing table currently obstructs the maneuvering clearance on the pull side of the ambulatory door.

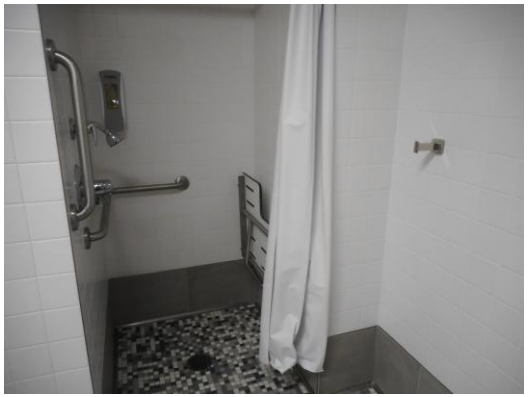
**Photo 21:** The locker rooms currently provide an accessible transfer shower. *This is a good example of accessibility.* The shower does not currently provide a hand-held spray wand.

**Photo 22:** In the family locker room, the bench is currently located within the maneuvering clearance on the pull side of the door to the corridor.

**Photo 23:** Room #7 within the family locker room currently provides features of accessibility, including an accessible transfer shower. *This is a good example of accessibility.*
Note: this is the only shower room in the family locker room that includes a toilet.

**Photo 24:** Room #7 within the family locker room currently provides features of accessibility. *This is a good example of accessibility.* The paper towel dispenser is currently located within the toilet clearance.

| Location / JQP # / Item # | | Solution / Comments | Qty | Unit Cost | Total Cost | Priority | Estimated Compl. Date | Person Responsible | Actual Compl. Date | Actual Cost |
|---|---|---|---|---|---|---|---|---|---|---|
| **24E** | *28694* | Provide a compliant hand-held shower wand.<br>ICC / ANSI 608.5, 608.6 | 1 | $500 | $500 | 3 | | | | |
| | | *Photo 21.* | | | | | | | | |
