All Seasons Arena Facility Assessment

Mankato, MN

The City of Mankato (the City) retained ISG to perform this facility assessment in connection with assessing existing conditions of All Seasons Arena, located at 1251 Monks Avenue, Mankato, Minnesota. It is ISG's understanding that the primary interest of the City is to locate and evaluate materials and building system deficiencies that might significantly impact the Arena's useful lifespan and continued operations. The conclusions and recommendations presented in this report are based on the review of the plans and records made available to Kevin Hildebrandt, CPE, CPS, and observations made during the walk-through site visit conducted on June 13, 2022, and ISG's experience with similar facilities.

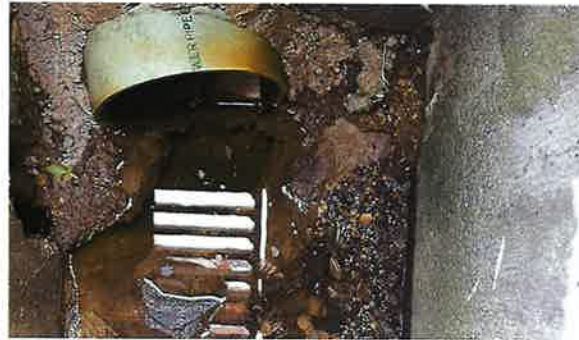
Southeast Catch Basin - West Parking Lot

Sub Category	Element/Location	Condition	Priority	Details	Recommendations	Estimated Cost
Drainage	North Catch Basin/ East Parking Lot	Good	2	There is sediment buildup in the bottom of the catch basin.	Remove sediment.	\$670
Drainage	South Catch Basin/ East Parking Lot	Poor	1	There is sediment buildup in the bottom of the catch basin. Concrete has broken off the catch basin and is visible in the bottom of the basin.	Remove and replace catch basin.	\$6,700
Drainage	Southeast Catch Basin/ West Parking Lot	Good	2	There is sediment buildup in the bottom of the catch basin.	Remove sediment.	\$670
Grounds Turf	Turf Area/South	Fair	2	The ground adjacent to the foundation is sloped. Gutter drainage flows back towards the building and does not meet building code drainage requirements.	Regrade turf areas to provide drainage away from the building.	\$6,000
Vehicle Routes	Entrance Apron	Poor	1	Entrance apron has a steep grade that exceeds 14.5%, and shows signs of vehicles bottoming out.	Remove apron and regrade parking lot.	\$11,200

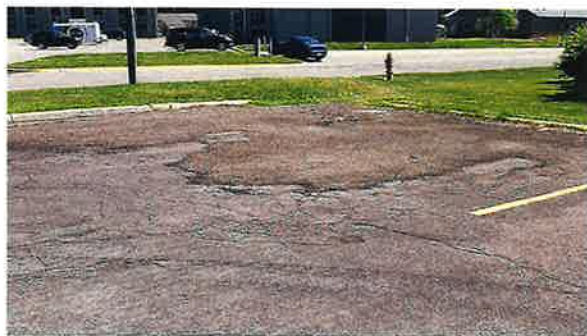
Vehicle Routes	Vehicle Ramp/ East Parking Lot	Poor	1	The concrete is extensive cracked, and there is no exterior drain to collect stormwater.	Remove and replace concrete pavement. Install trench drain and connect to existing storm sewer.	\$13,300
Vehicle Routes	ADA Accessible Stalls/ East Parking Lot	Poor	1	The accessible parking stall slopes are too steep and do not meet ADA Standards.	Regrade parking stalls to meet ADA standards.	\$2,700
Vehicle Routes	East Parking Lot	Poor	1	Northeast corner of parking lot drainage has no outlet so it ponds and overland flows to apartment complex drive or catch basin to the west. The parking lot has extensive cracking and pot holes.	Perform a full depth parking lot reconstruction.	\$357,000

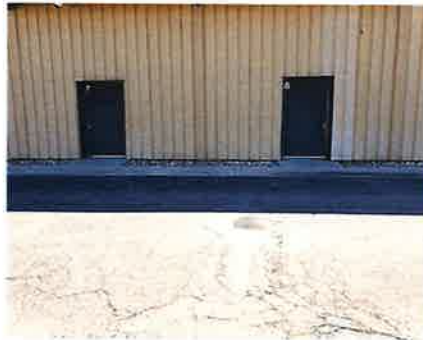
Door 6 and 7

Sub Category	Element/Location	Condition	Priority	Details	Recommendations	Estimated Cost
Vehicle Routes	Curb/East Parking Lot	Poor	1	The curb is extensively cracked.	Remove and replace curb.	\$26,000
Vehicle Routes	Curb/West Parking Lot	Good	2	Curb and gutter have minor chips and cracking from routine snow removal.	Perform regular maintenance.	\$0
Vehicle Routes	West Parking Lot	Poor	1	The parking lot is extensively cracked with multiple pot holes.	Perform a full depth parking lot reconstruction.	\$121,000
Vehicle Routes	ADA Accessible Stalls/ West Parking Lot	Poor	1	Accessible parking signs are not aligned with stalls and there are no accessible aisle signs as required per ADA Standards.	Relocate accessible signs and install accessible access aisle signs.	\$1,400
Pedestrian Routes	ADA Door 6 + 7	Poor	2	There is a curb step from the street level to the stoop. This does not meet ADA standards due to lack of a pedestrian ramp.	Construct pedestrian ramp between doors.	\$2,000

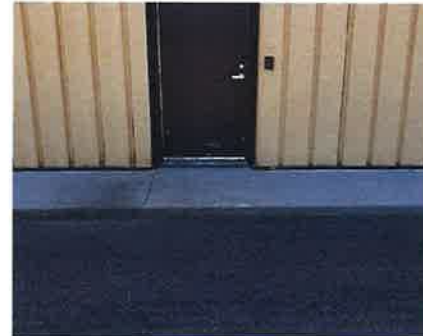
Pedestrian Routes	ADA Door 8	Poor	2	There is a curb step from the street level to the stoop. This does not meet ADA standards due to lack of a pedestrian ramp.	Regrade parking lot to remove step.	\$4,800
Pedestrian Routes	ADA Walk/North Side of Building	Poor	3	The pedestrian route between parking lots is not accessible.	Remove and replace walk to meet ADA standards.	\$20,000
Pedestrian Routes	ADA Door 2	Poor	3	The landing slope is too steep and does not meet ADA Standards.	Remove landing and regrade to meet ADA standards.	\$1,400
Pedestrian Routes	ADA Door 1	Poor	1	The landing slope is too steep and does not meet ADA Standards.	Remove concrete and regrade to meet ADA standards.	\$12,000

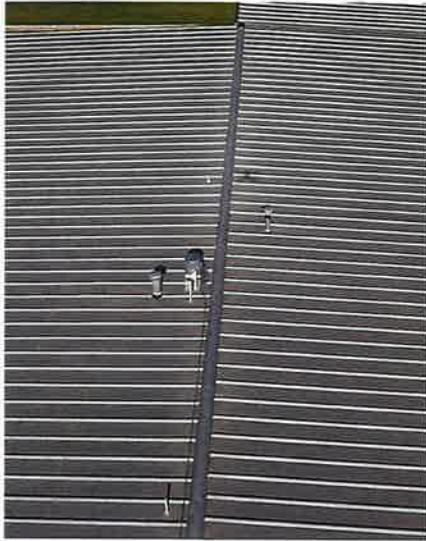
Sub Category	Element/Location	Condition	Priority	Details	Recommendations	Estimated Cost
Exterior Roof	Roof	Good	3	The roof is a pitched standing seam metal roof with exterior gutters on the north and south sides and was installed in 1998. The average useful life of this type of roof is 50 years.	Perform regular maintenance.	\$0
Exterior Walls	Wall Panels	Fair	2	The exterior walls are a metal panel system with damage throughout. Several locations are patched incorrectly.	Repair damaged panels. Prepare and paint building exterior.	\$120,000
Exterior Doors	Throughout	Fair	3	The exterior doors have normal wear and are fully functional.	Perform regular maintenance.	\$0
Exterior Doors	Overhead Doors	Poor	2	The north and south overhead doors have damaged panels.	Replace damaged panels.	\$1,200
Exterior Other	LIFE SAFETY Main Gas Piping	Poor	1	There are two unprotected natural gas meters serving the building. Safety bollards are needed to protect the gas meters.	Install safety bollards to protect gas meters.	\$1,400

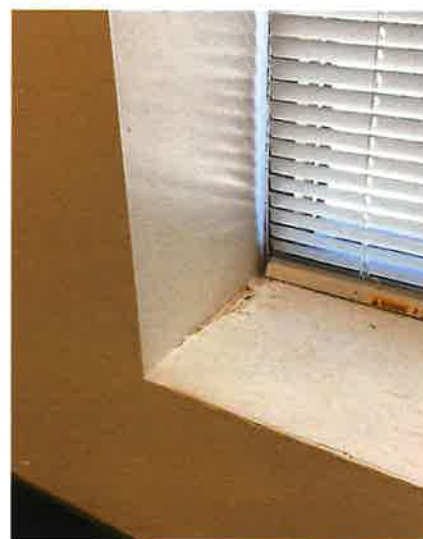
Interior Wall

Exterior Other	Concrete Buttresses	Poor	1	The tops of the concrete buttresses on the south exterior wall of the original building is deteriorated. Nearly every buttress will require patching in the near future (a few locations have already been patched).	Patch the deteriorated concrete buttresses with a new repair mortar.	\$20,000
Interior Walls	Existing Interior Walls	Fair	2	Walls are worn and damaged in spots.	Repair/repaint existing interior walls.	\$25,000

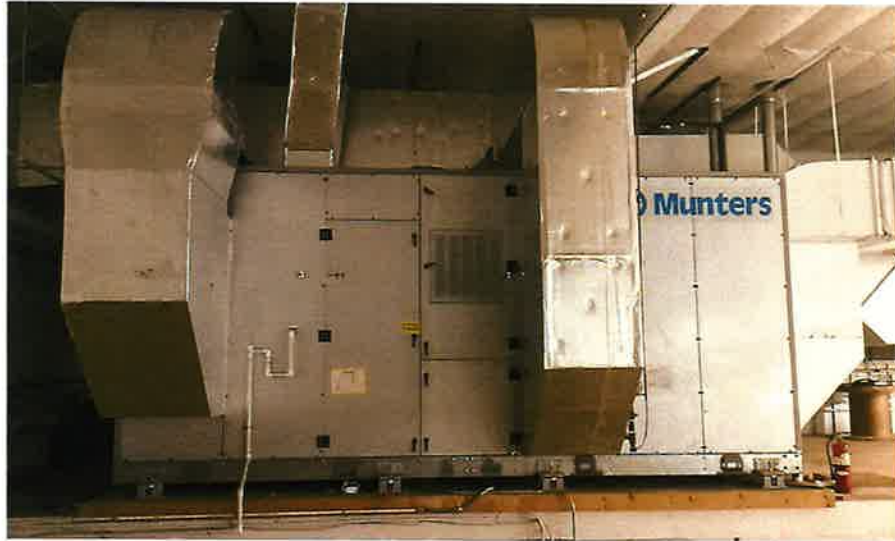
Rink Dehumidification Unit

Sub Category	Element/Location	Condition	Priority	Details	Recommendations	Estimated Cost
Heating Cooling	Dehumidification Unit/ Addition Rink Mezzanine	Good	2	The Munters brand unit provides heating and dehumidification to the two ice rinks. It was installed in 2005. The average useful life of this unit is 20-25 years.	Replace the dehumidification unit.	\$220,000
Heating Cooling	Addition/West Mechanical Room	Fair	1	The Trane brand air handling unit (AHU) has hot water heat and direct expansion (DX) cooling. The associated condensing unit sits on the ground to west of the building. It serves the west portion of the addition, including offices, locker rooms, and conference rooms. It was installed in 1999. The average useful life of an AHU is 25-30 years.	Replace the AHU and associated condensing unit.	\$120,000
Heating Cooling	Addition Rink Mezzanine	Good	3	There are two Payne brand furnaces and associated condensing units that serve the lower east portion of the addition. These units were installed in 2014. The average useful life of this equipment is 15 years.	Perform regular maintenance.	\$0

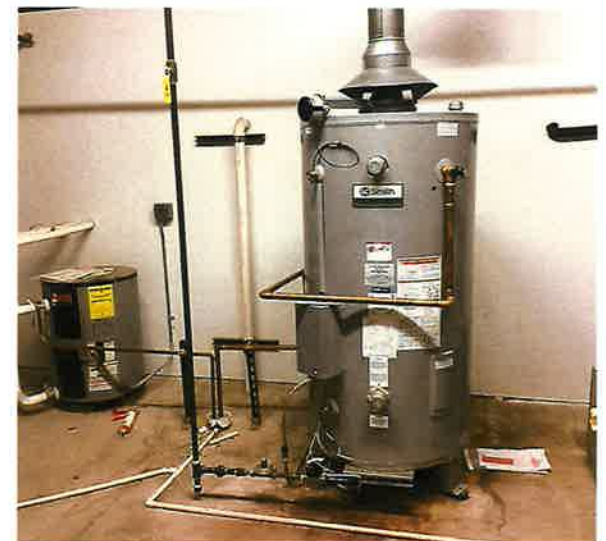
Water Heater

Sub Category	Element/Location	Condition	Priority	Details	Recommendations	Estimated Cost
Heating Cooling	Addition/West Mechanical Room	Poor	1	Two Weil-McLain brand hot water boilers were installed in 1998 and serve the Trane AHU and multiple reheat coils throughout the west end of the building. The maintenance staff report having issues with these boilers. The average useful life of these type of boilers is 15 years.	Replace boilers.	\$32,000
Heating Cooling	Addition/West Mechanical Room	Good	3	The Aerco brand boiler provides domestic hot water only and was installed in 2012. The average useful life of this type of boiler is 15 years.	Perform regular maintenance.	\$0
Plumbing Water	Addition Rink Mezzanine	Good	3	The AO Smith brand water heater serves the ice resurfacing machine. It was installed in 2019. The average useful life of a water heater is 15 years.	Perform regular maintenance.	\$0
Plumbing Water	Addition Rink Mezzanine	Good	3	The State Industries brand water heater serves the east portion of the addition. The install date is unknown. The average useful life of an electric water heater is 15 years.	Perform regular maintenance.	\$0

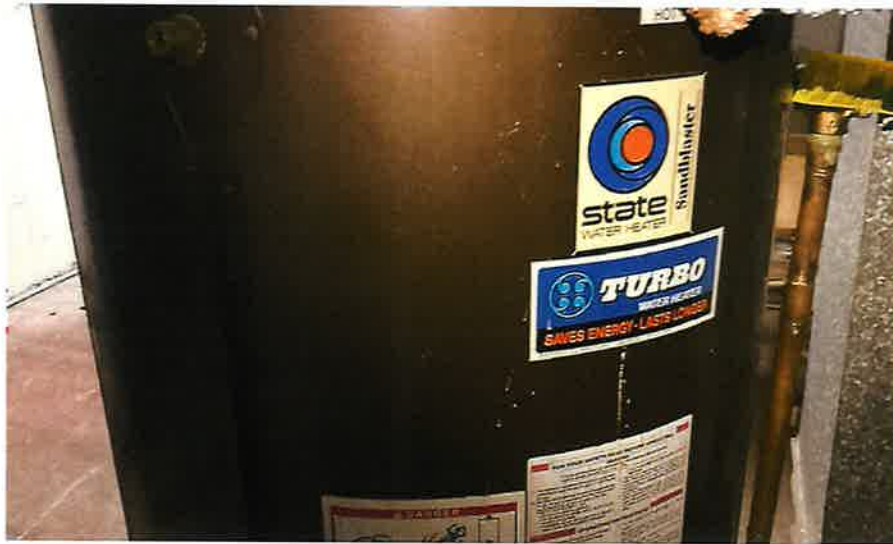
Water Heater

Sub Category	Element/Location	Condition	Priority	Details	Recommendations	Estimated Cost
Plumbing Water	Original Building- East Mezzanine	Poor	1	The State Industries brand water heater serving the east portion of the original building was installed in 1988. The average useful life of a gas water heater is 15 years.	Replace water heater.	\$3,500
Plumbing Water	Original Building/ East Locker Room	Fair	2	There are two AO Smith brand water heaters serving the locker rooms, installed in 2005. The average useful life of a water heater is 15 years.	Replace the water heaters.	\$7,200
Plumbing Water	Officials Rooms	Fair	1	A Rheem brand water heater serves the officials room and was installed in 1993. The average useful life of a water heater is 10 years.	Replace water heater.	\$3,500

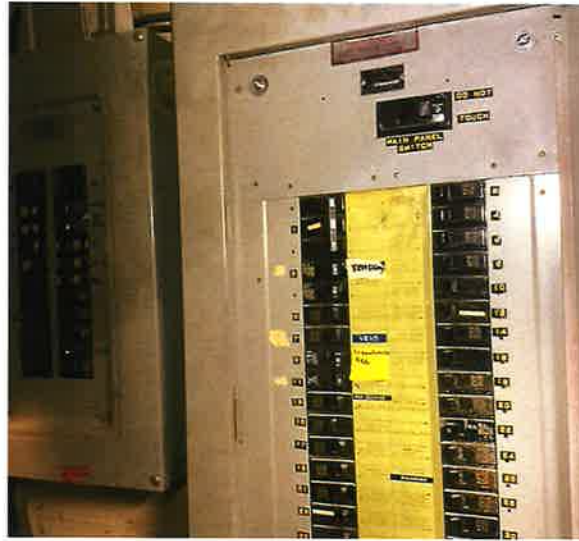
Original Branch Panels

Sub Category	Element/Location	Condition	Priority	Details	Recommendations	Estimated Cost
Power Supply	Main Distribution Panel	Good	3	The Square D brand, 2,000 amp panel, was installed in 1998 and serves the entire building. The average useful life of a main distribution panel is 40 years.	Perform regular maintenance.	\$0
Power Supply	Branch Panels	Good	3	Branch panels are located throughout the building's mechanical rooms. There is a combination of original and updated equipment. The average useful life of a branch panel is 30 years.	Replace original branch panels.	\$28,000
Power Supply	Motor Control Center (MCC)	Good	3	The GE brand MCC feeds the pumps for the two ice rinks and was installed in 2006. The average useful life of an MCC is 30 years.	Perform regular maintenance.	\$0
Exterior Lighting	Exterior Lighting	Fair	2	The exterior lighting of the building appears to be older wall packs that were retrofitted with LED bulbs.	Perform regular maintenance.	\$0

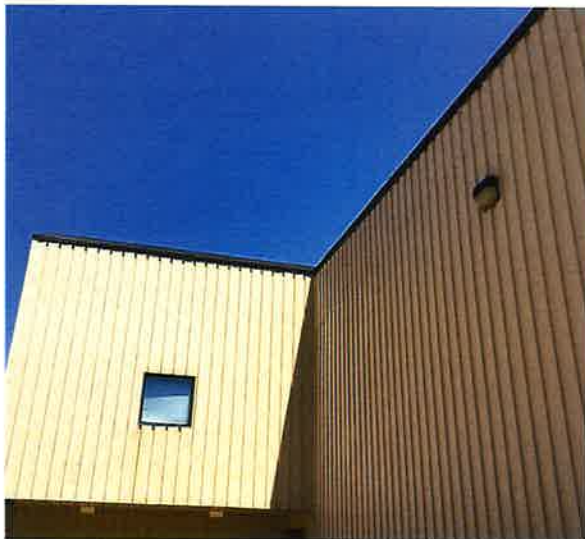
Exterior Lighting

Interior Lighting	Throughout	Fair	1	The lighting in the two rinks was converted to LED. The remaining fluorescent fixtures are original to construction.	Replace light fixtures with LED and install occupancy sensing controls.	\$326,000
Life Safety	LIFE SAFETY Fire Alarm	Fair	1	The fire alarm system is original to the addition construction, making it 24 years old. The average useful life of a fire alarm system is 15 years.	Replace fire alarm system and all associated devices.	\$63,900
