RAVINE MANAGEMENT

October 2020

Prepared by: The City of North Mankato

Date: September 23, 2020
To: John Harrenstein, City Administrator
From: Daniel R. Sarff, P.E., City Engineer
CC: Nate Host, Public Works Director
Subject: Lake Street Bluff Drainage and Erosion Issues
BMI Project No. OM1.122664

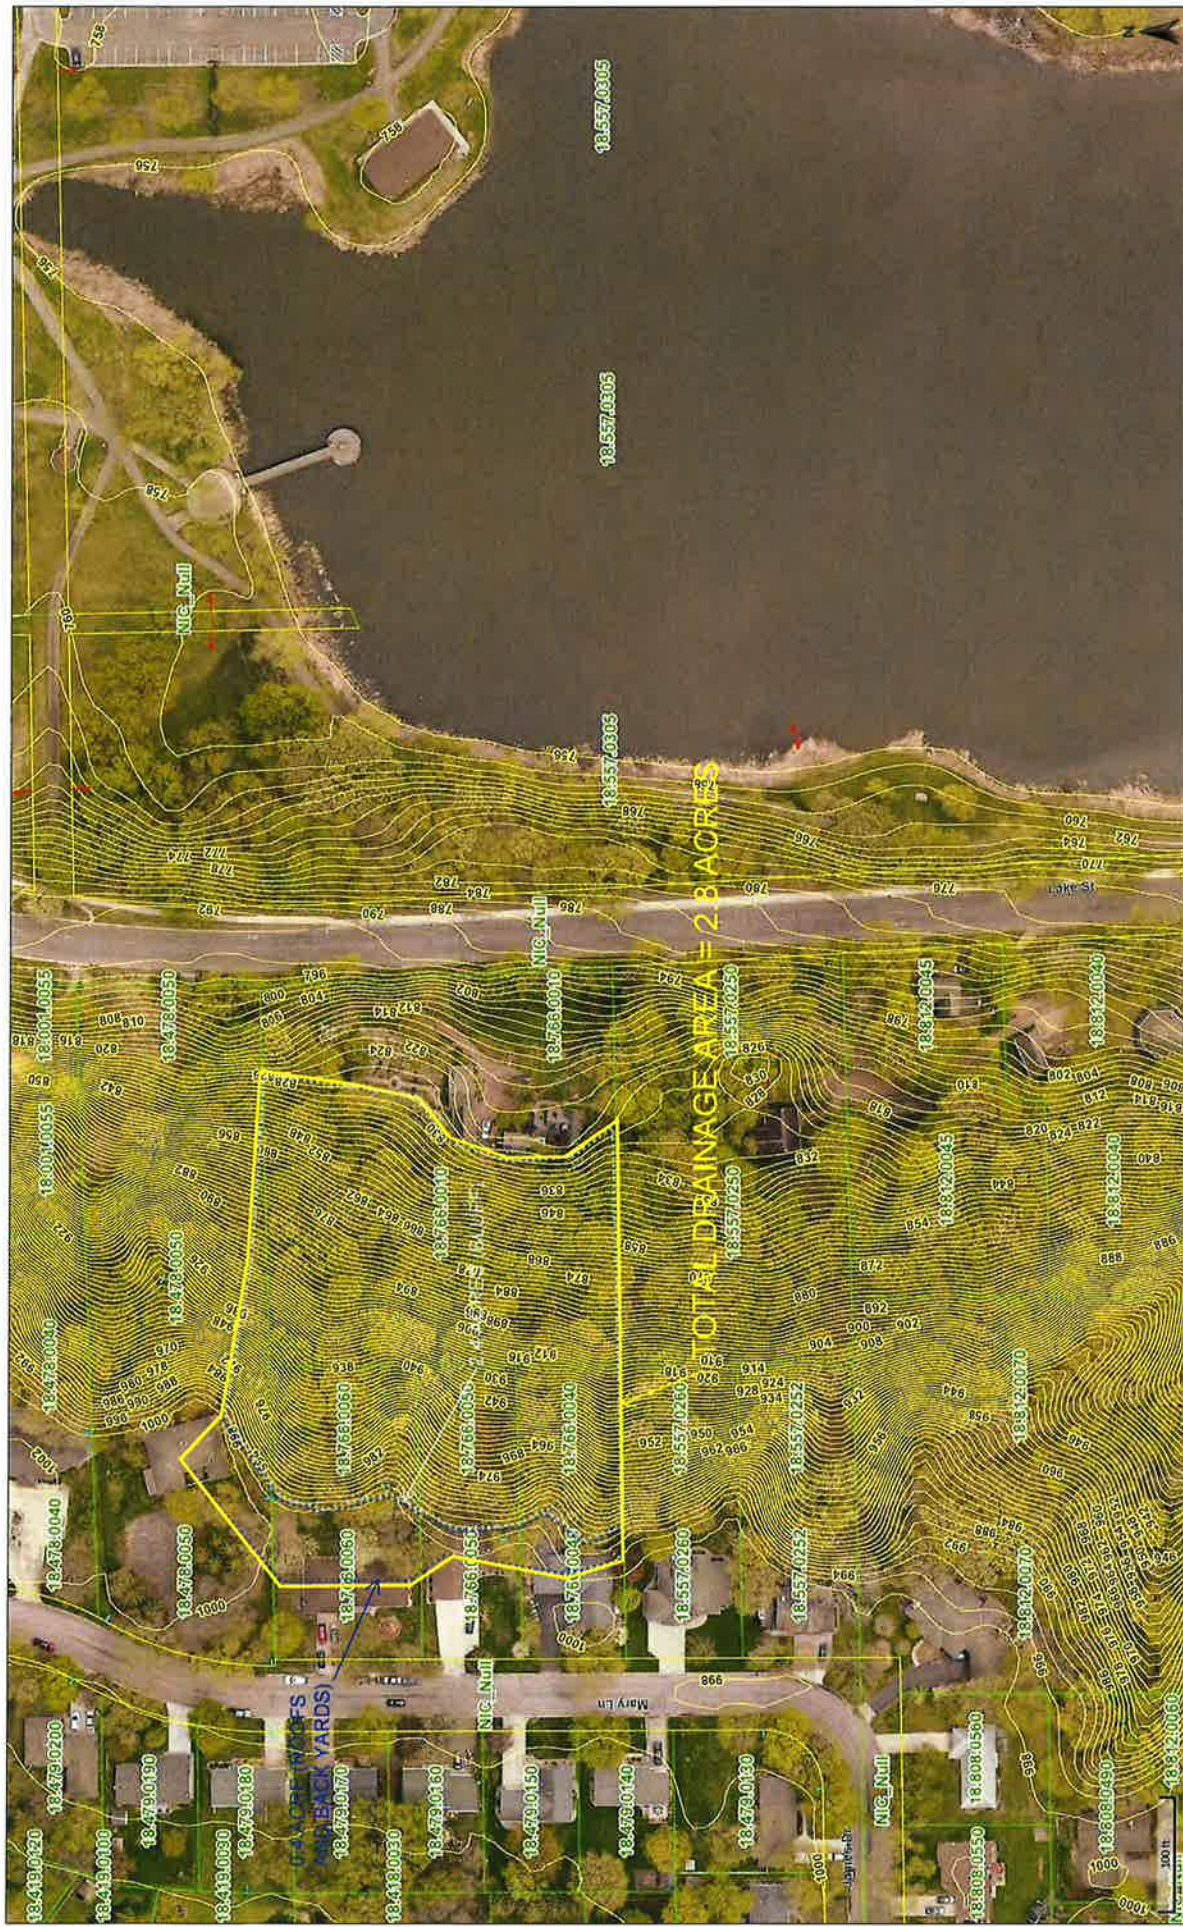
EXHIBIT 7 - 927 LAKE STREET DRAINAGE AREA

The storm water runoff coming from the bluff at this location appears to be more distributed and less concentrated in ravines than in the other locations discussed in this report. While this property experienced excess overland flows and some minor erosion and sedimentation during the 7.5" rainfall event in July of 2020, runoff rates and erosion were much less severe in other locations, and problems appear to be limited to extreme rainfall events. There is no storm sewer collection or piping system at this location, and no improvements are recommended at this time.
