# KING HARBOR

PUBLIC AMENITIES PLAN

## King Harbor Public Amenities Plan 100% Draft for City Council Approval

#### **SWA Group**

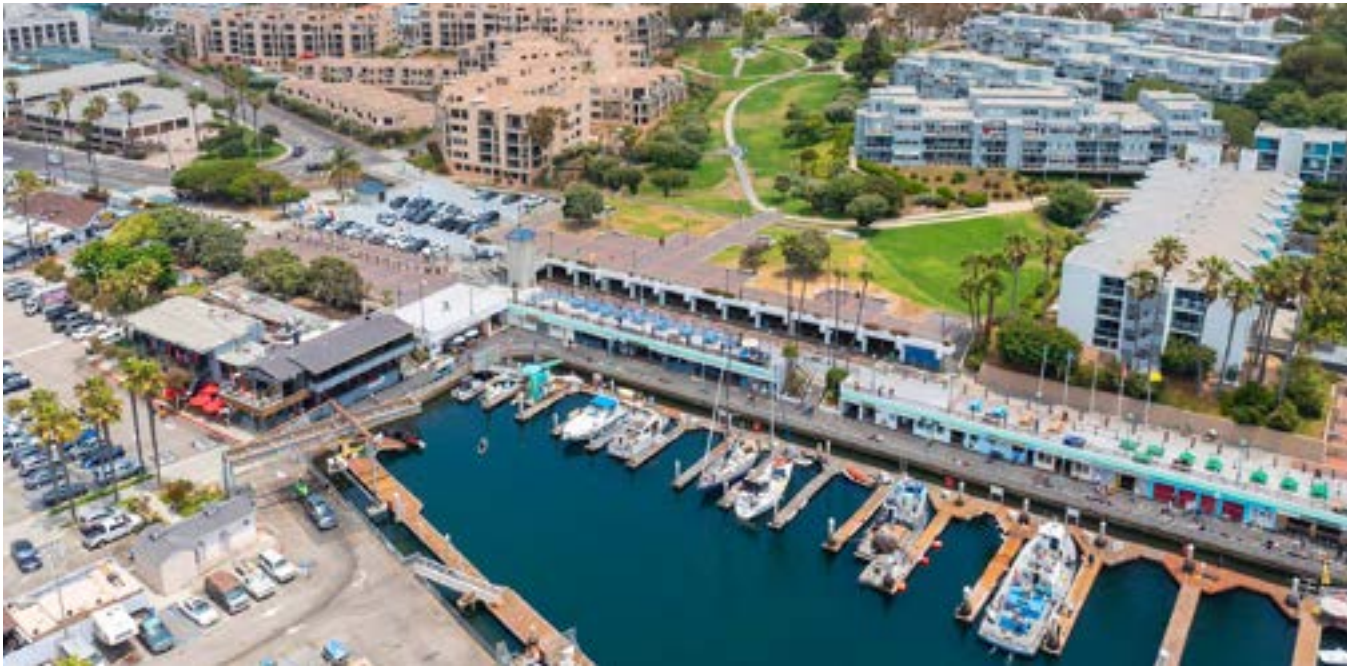
Aerial view of International Boardwalk

- The 1,545-foot-long Basin 3 bulkhead is a reinforced concrete L-shaped wall with a toe (cut-off) wall built in 1962. The top of wall and adjoining sidewalk are at a +7 feet mean lower low water (MLLW) elevation. These sit one to two feet below the parking lot level at Mole D, and several feet below the upper level of the Municipal Pier.

- As noted in a condition assessment performed in 2019 by the City's consultant, the bulkhead is in poor condition, with spalled concrete, exposed and corroding steel reinforcements, and vertical and horizontal cracks – conditions which have been confirmed as part of field walks for this study. The bulkhead has sustained damage over its lifetime. The floating dock mooring system caused damage to the cut-off wall, resulting in loss of material and destabilization of the footing portion of the L-shaped wall; a repair was performed in 1976. The repair involved pressure grouting behind the cut-off wall to seal the void created by the damage. Additional pressure grouting was performed above the L-shaped wall footing to densify the soil and improve soil conditions under the sidewalk. Lastly, rock was placed at the toe of the bulkhead to prevent undermining from erosion and overturning of the wall. The City's consultant

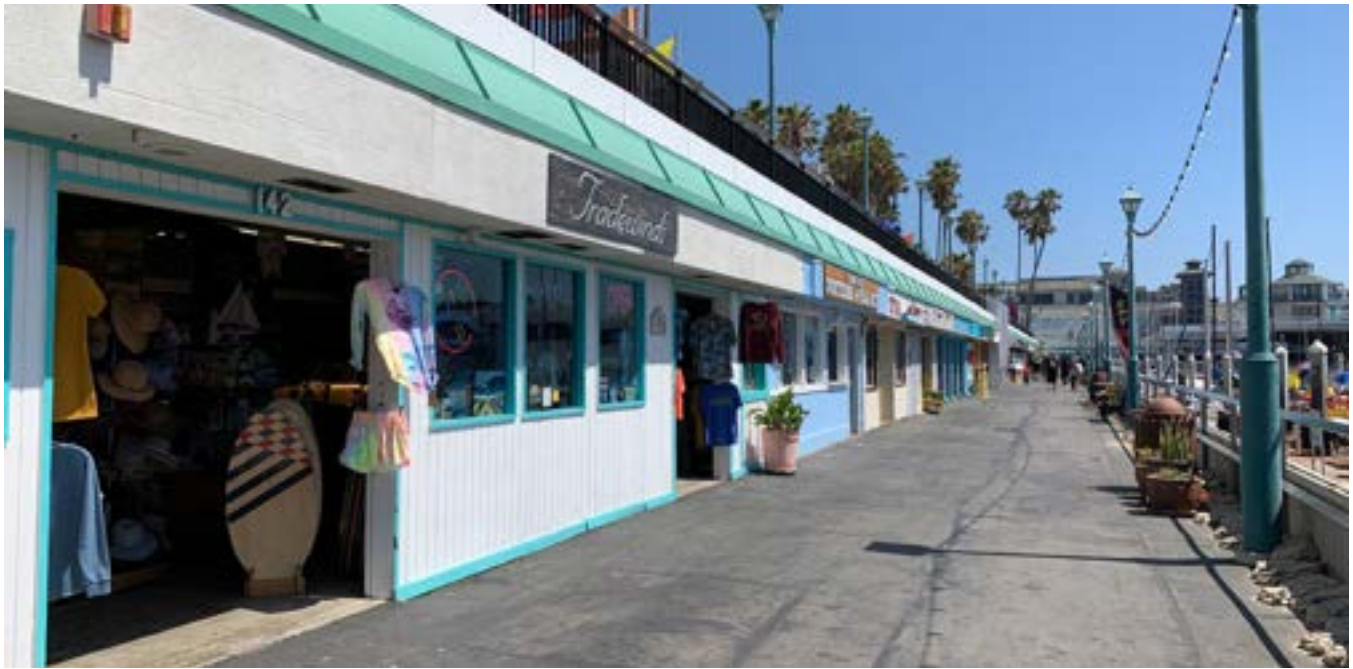
Ground level view of International Boardwalk

- An approximately two-foot-high timber wall was built atop the bulkhead, extending it to a +nine-foot MLLW elevation. There are openings at each gangway entrance, as well as degradation of the timber wall itself. The gap between the bottom of this timber extension and the bulkhead coping is sealed with sandbags. It appears that the intent of the timber wall extension is not to prevent flooding, but to limit splashing from swells and breaking waves in Basin 3.

- Given the condition of the bulkhead and gangway platforms, we agree with the previous assessment that the bulkhead is near the end of its useful life and only temporary repairs are recommended until the bulkhead is replaced as part of a larger marina redevelopment project. No new loads should be placed on the wall, so any work performed on the buildings along International Boardwalk should take this into consideration. Also, a more robust, albeit temporary solution to seasonal flooding is recommended to seal the gap between the top of the wall and its extension and close openings at the gangway access points during high tide events.

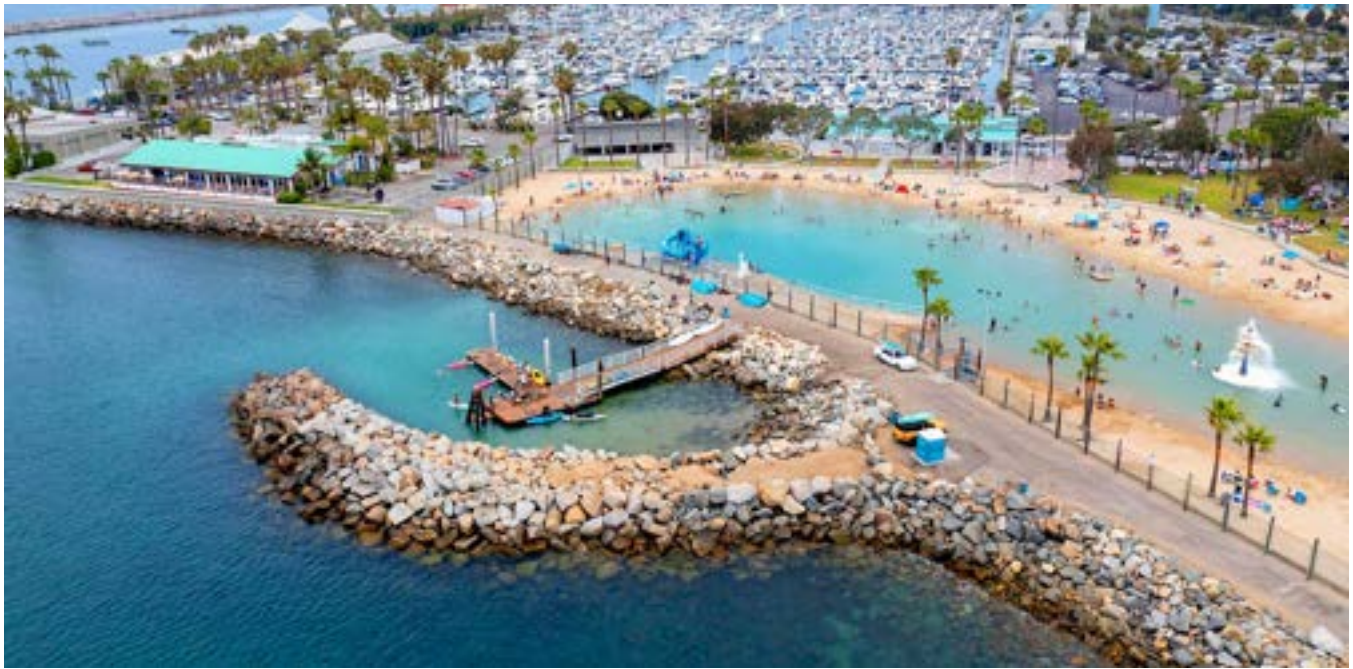
Aerial view of Seaside Lagoon

The Seaside Lagoon is a designated open space amenity located off of Portofino Way, and is owned and operated by the City of Redondo Beach. The key features of the Lagoon include a 1.4-million-gallon man-made saltwater lagoon, a sandy beach area, children's play area, snack bar facilities, and other recreational areas. The surface area of the water in the lagoon is approximately one acre, with a maximum depth of seven feet. The Lagoon was originally constructed in 1962, and is open to the public seasonally from Memorial Day to Labor Day.

Seaside Lagoon is fed both by discharged cooling water from the gas-fired power plant, when it is in operation, and by seawater pumped in through an intake pipe. The tide gate on the intake pipe is often left open, resulting in water partially filling the lagoon to equilibrium with the current tide level. The City has left the hatch to the tide gate open after it has repeatedly been swung ajar by rushing water in the pipe. To prevent falls, this area is enclosed in a locked fence. Water overflows from the access hatch during high tide events. The lagoon is separated from the harbor by a rock revetment with underlying sand.

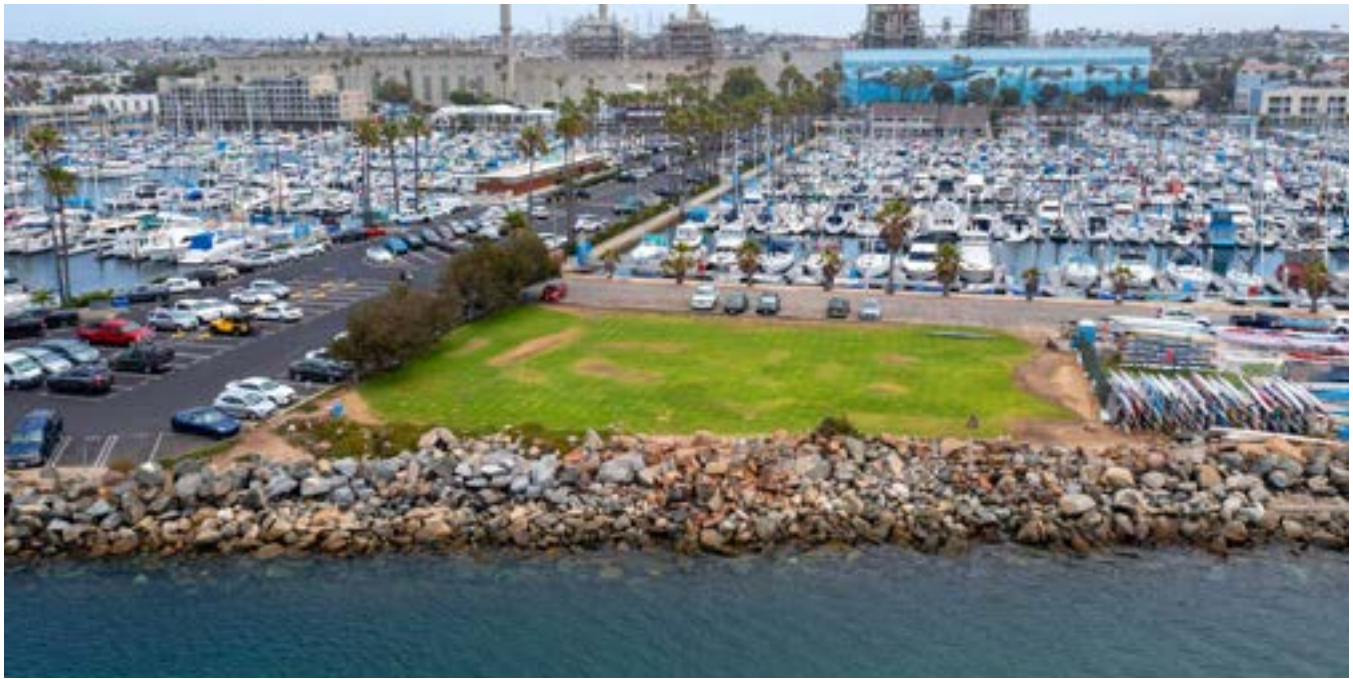
Aerial view of Moonstone Park/Mole B

Moonstone Park is a public park located at the end of Marina Way at Mole B. Named after the moonstone gemstones that would once wash ashore in Redondo Beach in the early 1900s, the park features an open lawn and waterfront views. It is also home to the Lanakila and Nahoa Outrigger Canoe Clubs. These outrigger clubs currently operate on 13,000 square feet of the park, leaving the park's remaining 20,000 square feet of the park as an open lawn area. At the southern end of the park, the Redondo Beach Fire Department operates Fire Station 3 Marine Rescue. There is currently no restroom facility located on-site other than a portable one. Free public parking is located on the edge of the park. The Marina Way entrance, which provides vehicular access to the park, does not have sufficient signage to inform people of the park's location at Mole B.

There are two key factors that will determine the design and planning of Moonstone Park. The first is that per the Coastal Commission, 33 percent of the open space must be maintained on the site. The second is that a 110-foot-diameter clear area is required for emergency helicopter landing (H).

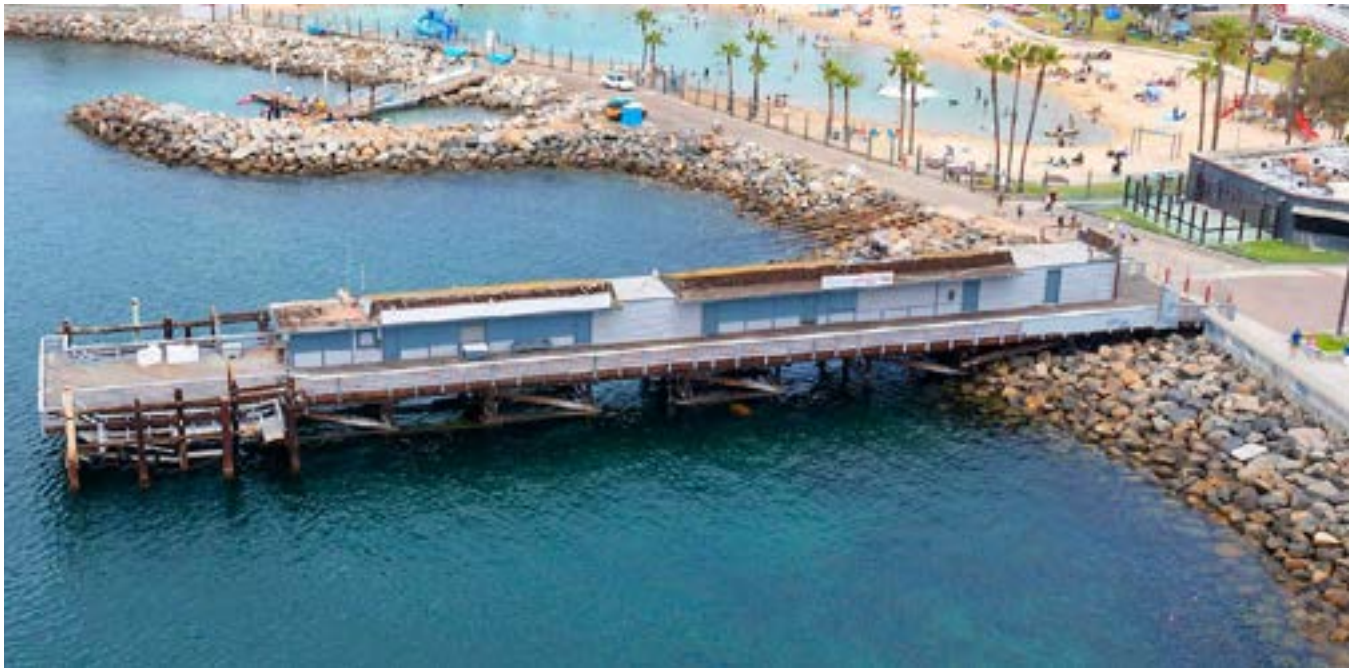
Aerial view of Sportfishing Pier

A structural inspection of the Sportfishing Pier was performed in 2017 and concluded that the structure was in serious condition and beyond feasible repair. It was subsequently closed to the public. Of primary concern were three timber piles needing immediate replacement due to complete section loss or displacement, which compromised the integrity of a portion of the structure. In addition to these, other timber piles exhibited damage from marine borer attack and dry rot, which have been worsened from the exposed location of the pier. The pier faces the opening in the breakwater, making it ideal for quick ocean access, but also exposes the pier to swell and wave impacts, resulting in damage.

The pier superstructure appeared to be in fair condition, but in need of solid piles on which to sit. The findings of the report noted that extensive repairs to the piles were required to bring the Sportfishing Pier back into serviceable condition. A portion of the pier was sagging from the previously noted pile failure. Portions of the pier, including timber bull rails and bracing, continue to fall off of their corroded steel bolts and connectors, a condition often worsened by wave action. The debris poses a navigational hazard, particularly at night when it is not readily identifiable.

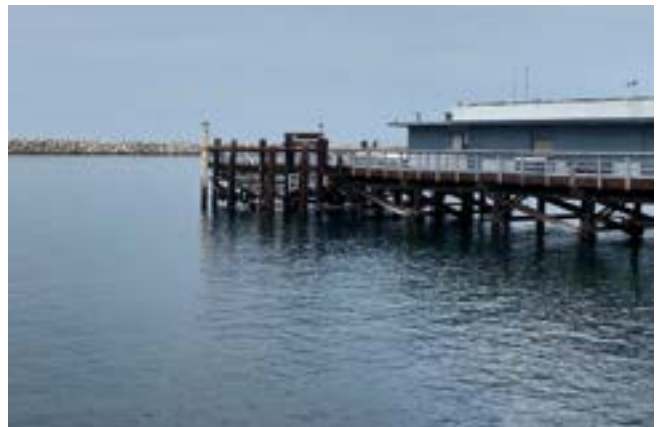
Existing infrastructure of Sportfishing Pier

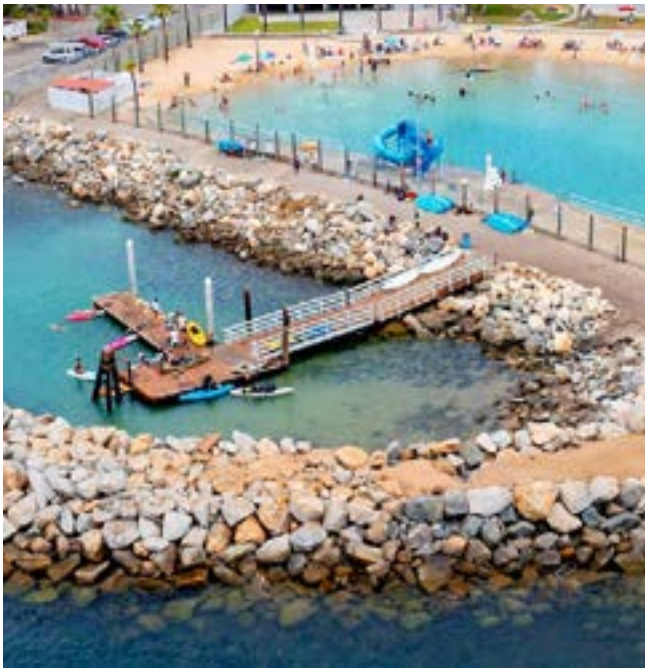
Existing Hand Launch

The existing hand-carried small Hand Launch is located west of the Sportfishing Pier and south of Seaside Lagoon near the interface between Moles C and D. It is made up of a 10-foot-wide timber-framed and decked sloped abutment founded on concrete footings, a 10-foot-wide timber gangway, and timber docks. The docks consist of a main float and a landing float roughly forming a “T” shape. The docks are supported by two 16-inch-diameter piles; one 16-inch-diameter, creosote-treated timber pile with HDPE wrap; one 12-inch-diameter creosote-treated timber pile that was rebuilt with a fiberglass-reinforced plastic jacket and structural grout; and one six-inch-diameter coated steel pipe pile connected to a three-pile timber dolphin.

City maintenance staff explained that the rebuilt timber pile was one of three that snapped near the mudline due to heavy wave action, which stressed the floating dock. The other two piles were replaced with the concrete piles. In addition, the dock that forms the leg of the “tee” was also replaced after being torn away from the main landing float and being displaced when the two timber piles securing it were broken. This information indicates that the non-motorized small boat launch is in a location that is susceptible to large wave forces based on swell and storm

The main float does not have sufficient buoyancy at the gangway landing. The weight of gangway causes the main float to slope towards the gangway. To limit a steep gangway down to the dock at low tides, the pile-supported gangway abutment is sloped towards the dock. This has the unintended effect of inundation of this abutment at high tide events, estimated to be at +6.5 feet MLLW or higher. The abutment can also be over-topped by waves at lower high tides. Waves of one foot in height were observed, clearly indicating that water elevation of +5.5 feet MLLW could result in overtopping.

Lastly, the dock has a standard freeboard of 16 inches, which is suitable for motorized boats. However, this freeboard makes it difficult to enter and exit a hand-carried boat such as a kayak or stand-up paddleboard. A lower freeboard of eight inches or less is preferred for hand-carried watercraft.

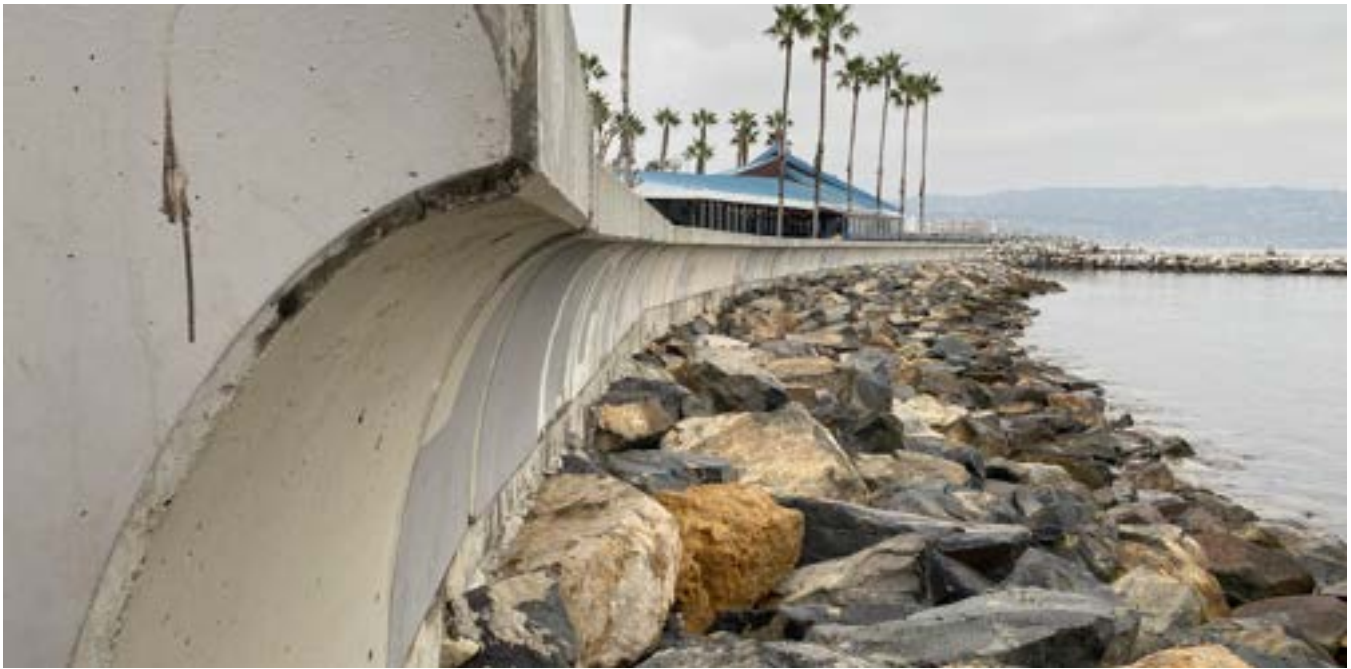
The splash wall that runs along the waterfront path through Mole D

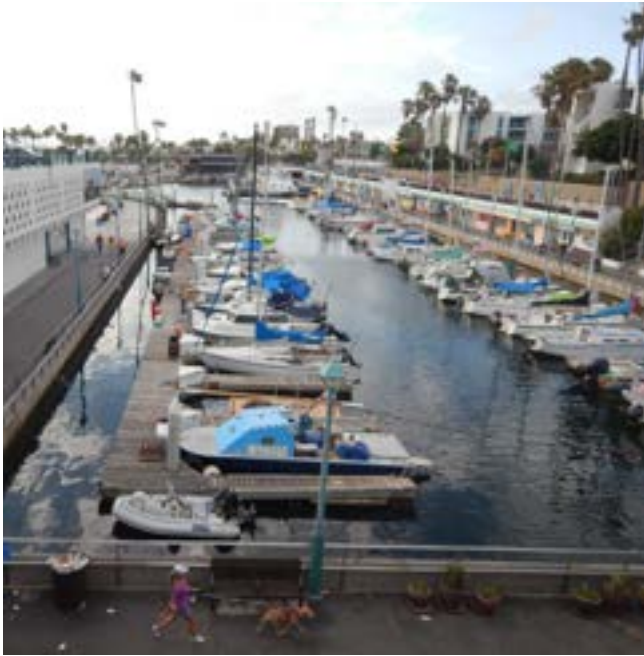
Basin 3 docks

Basin 3 contains the Redondo Beach Marina, which is owned by the City and operated by a concessionaire. The docks in Basin 3 are at the end of their useful life. The gangway platforms were noted in the condition assessment performed of Basin 3 by the City's consultant in 2019 as being in poor condition, with spalled concrete and exposed and corroding steel reinforcements. These assessments were confirmed in the field as part of this effort. Planning for replacement of the docks in Basin 3 is recommended.

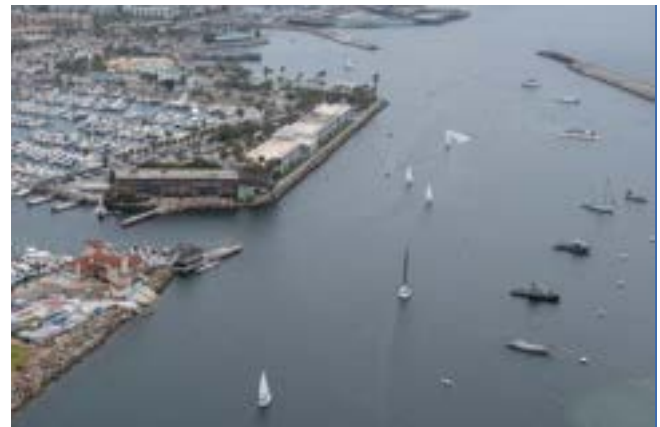
Mooring fields

There are a few moorings between the breakwater and main channel along Moles B and C. A few of the moorings were observed to be used. A review of historical aerials on Google Earth reveals that few moorings are in use at any given time. Their location, which is susceptible to wave overtopping and swell impacts, likely makes these moorings undesirable. Further study is warranted, with input from Harbor boaters,

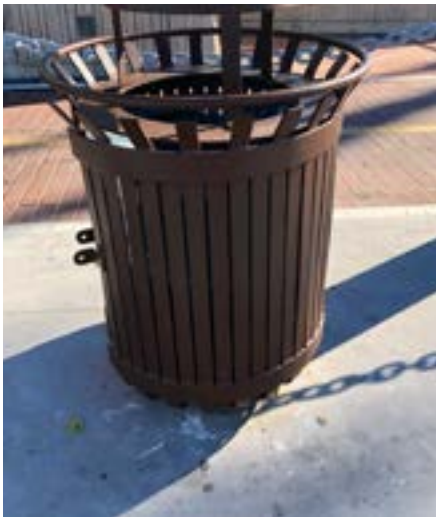
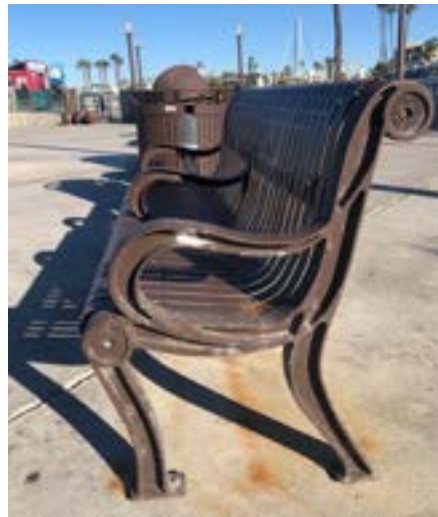
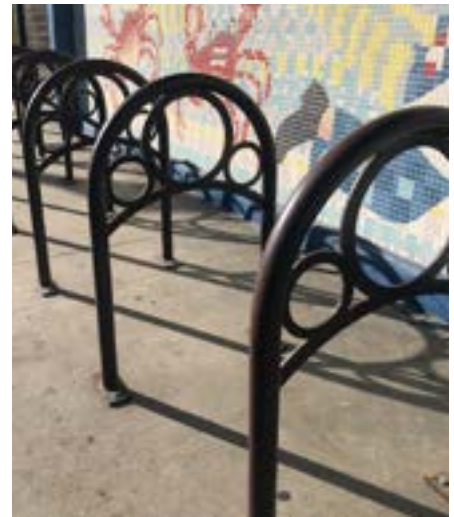
Primary furniture family

The primary furniture throughout the harbor is a dark brown metal family consisting of benches, trash receptacles, and bicycle racks. This family is layered throughout the site and is one unifying element. The condition of the furniture varies; some locations are in good shape while some show visual disrepair or graffiti. In the past year, benches within the harbor have been repainted a similar brown color.

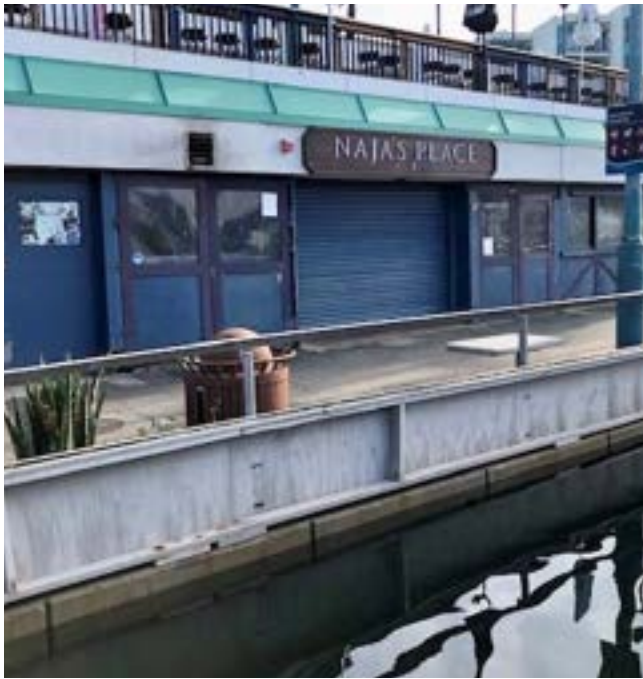
King Tides at International Boardwalk

The existing bulkhead within Basin 3 is estimated to have a top of wall elevation of +7 to +7.5 feet MLLW (the average height of the lowest tide recorded at a tide station each day during a 19-year recording period). These volumes are based on recent measurements, using tides and elevations noted in the Sea Level Rise Vulnerability Assessment for King Harbor (2019) and derived from Sea Level Rise Policy Guidance by the California Coastal Commission. The elevations are lower than originally designed due to subsidence in the area from oil extraction activities. The current top-of-wall elevation is too low to prevent overtopping from king tides as well as typical storm events.

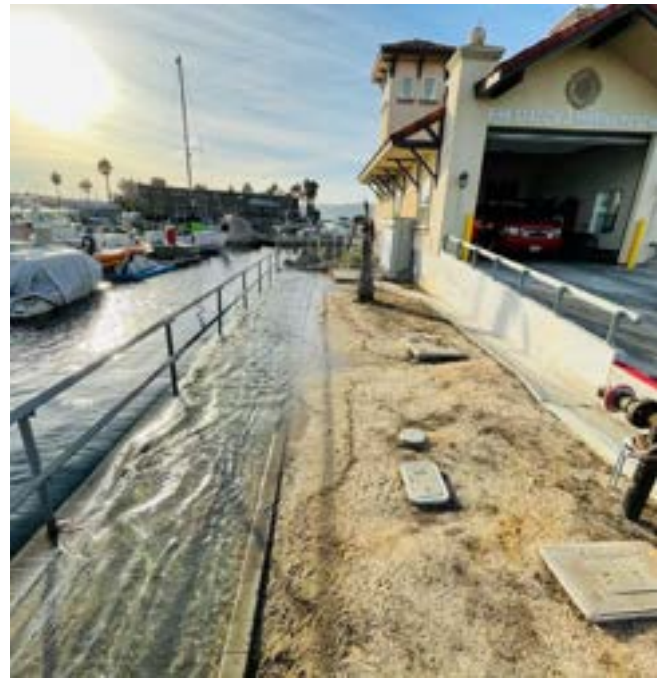
King Tides flooding at Mole B

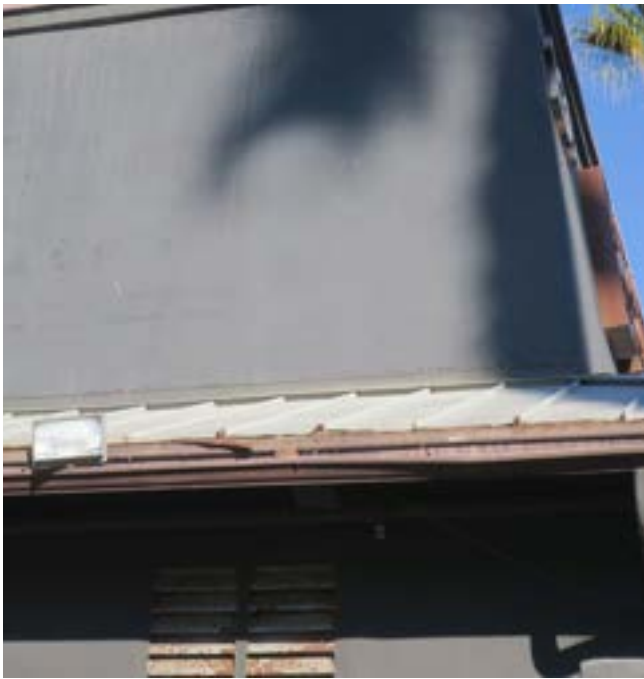
Localized corrosion (rust) at standing seam roofing

- Localized corrosion (rust) at standing seam roofing, typically near eaves
- Warped or bent corrugated roofing sheets at front entrance canopy
- Corroded and bent edge flashings
- Deteriorated sealants at wall and roof flashings; poor previous repairs
- Cluttered flat roofs, limits drainage
- Abandoned openings and equipment at roof
- Sections of cracking and spalling of stucco facades; paint loss
- Abandoned conduit/fixtures at stucco walls
- Soiling, guano, graffiti at building walls
- Checking, splitting and wood decay at entrance columns
- Wood decay at exposed rafter tails
- Wood decay and peeling paint at window sills/apron trim
- Wood decay and deteriorated flashing at base of doors

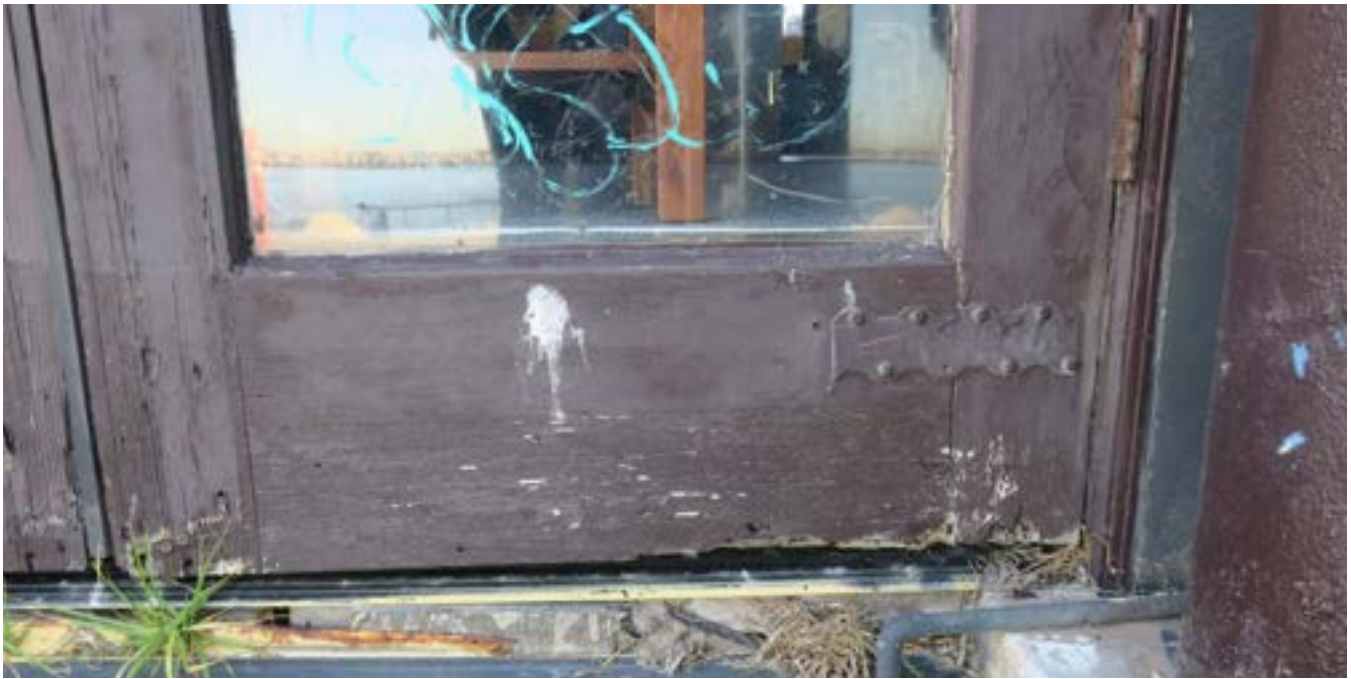
Wood decay and deteriorated flashing at base of doors

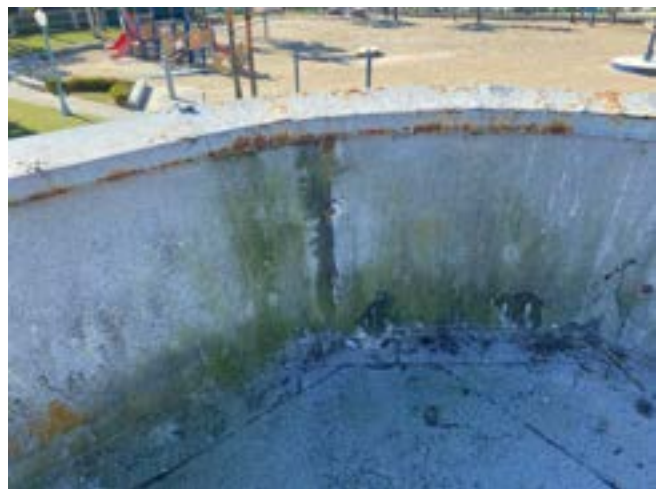
Bio growth at roof-side of parapet walls

- Some deteriorated membrane seams and flashings at membrane roof; poor previous repairs
- Large area of poor previous repair; appears low spot/poor drainage
- Corrosion and paint loss at sheet metal parapet wall copings
- Bio growth at roof-side of parapet walls
- Trash/debris blocking roof drains
- Remains of restaurant use in kitchen
- Stucco cracking and spalls at trash enclosure walls
- Stickers and graffiti at door glass

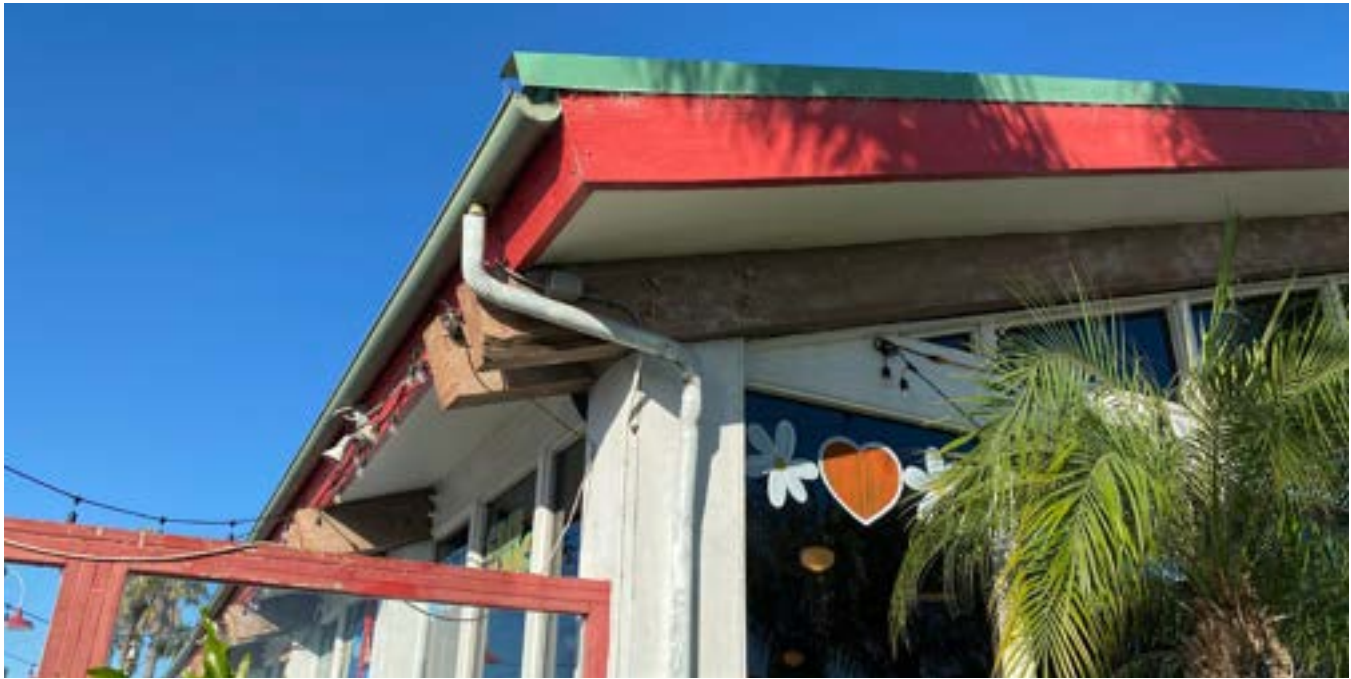
Downspout disconnected from gutter

- Roof debris/soiling at flat roofs
- Weathered wood siding and paint loss at patio enclosure walls
- Wood decay and paint loss at service area
- Deteriorated sealant, soiling/salts at window walls
- Stains and corrosion at service entrance/loading dock
- Downspout disconnected from gutter
- Minor ceiling damage at kitchen
- Minor floor damage at outdoor patio
- General wear and tear from use

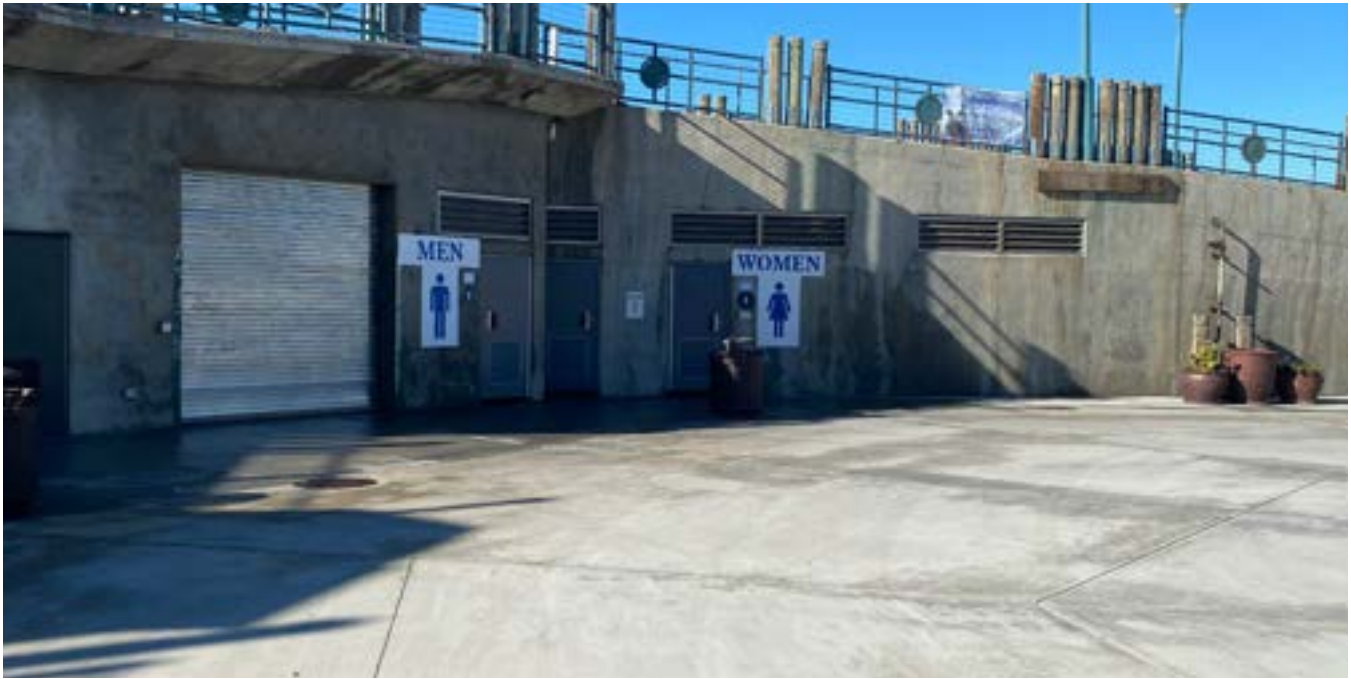
International Boardwalk Public Restrooms near courtyard

- o Mismatched wall panel in accessible restroom
- o Approximately 16-foot-long section of damaged wall with peeling paint
- o Missing portion of ceiling covered by vinyl sheet, secured with visible screws
- o Crack running through “toe” of coved base, throughout

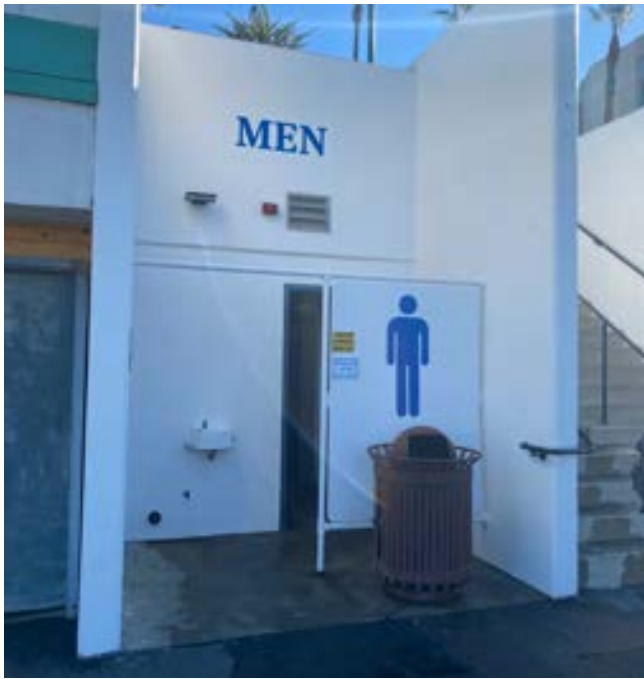
International Boardwalk Public Restrooms near stairs

- Accessible Features: The same compliance issues that were noted in the 2017 are still present, except for the following:
  - o Mirrors have been removed from above the sinks
  - o Toilet seats are missing in the accessible stall and one other stall
  - o Accessibility symbol has been removed from entrance door

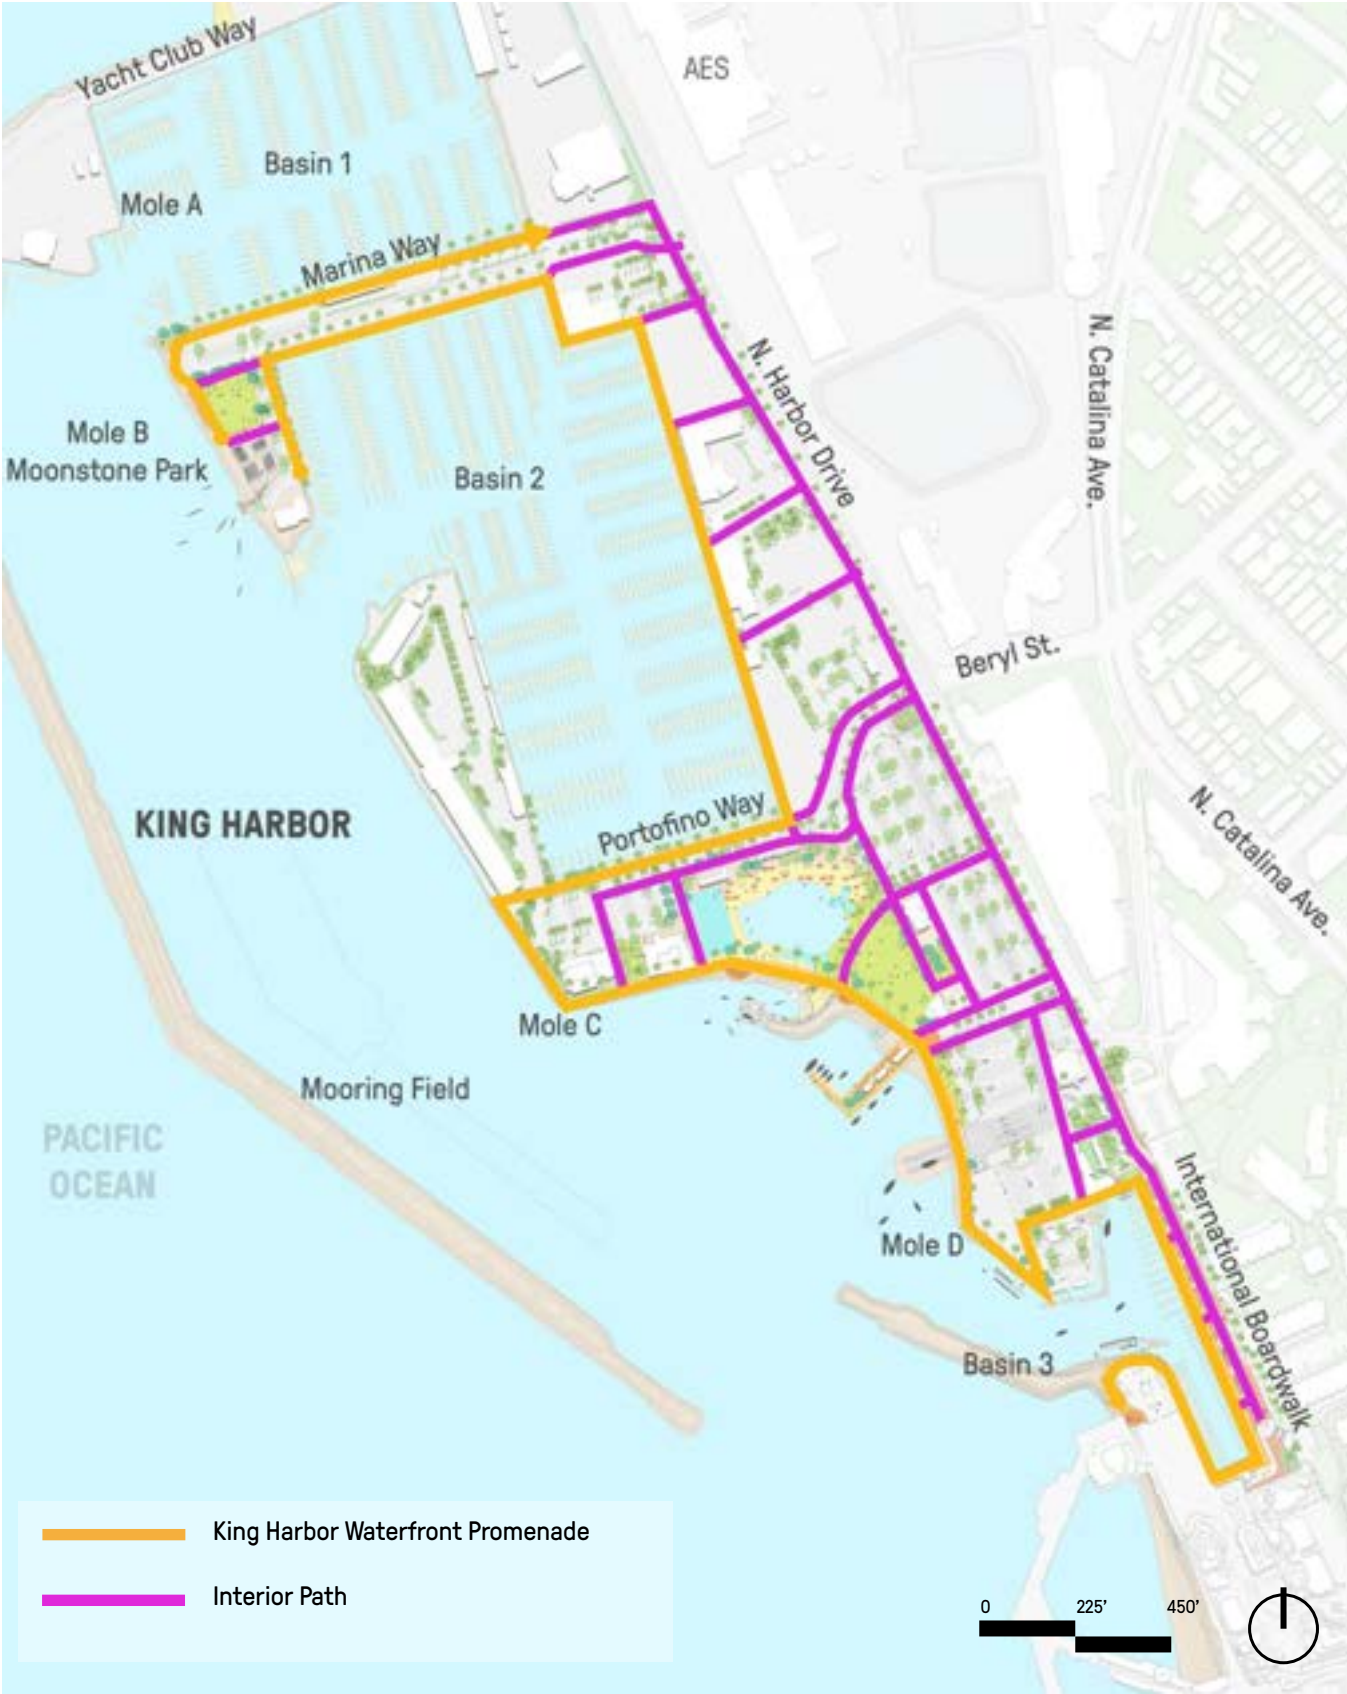
# PEDESTRIAN PATHS

## 5.4 Pedestrian Paths

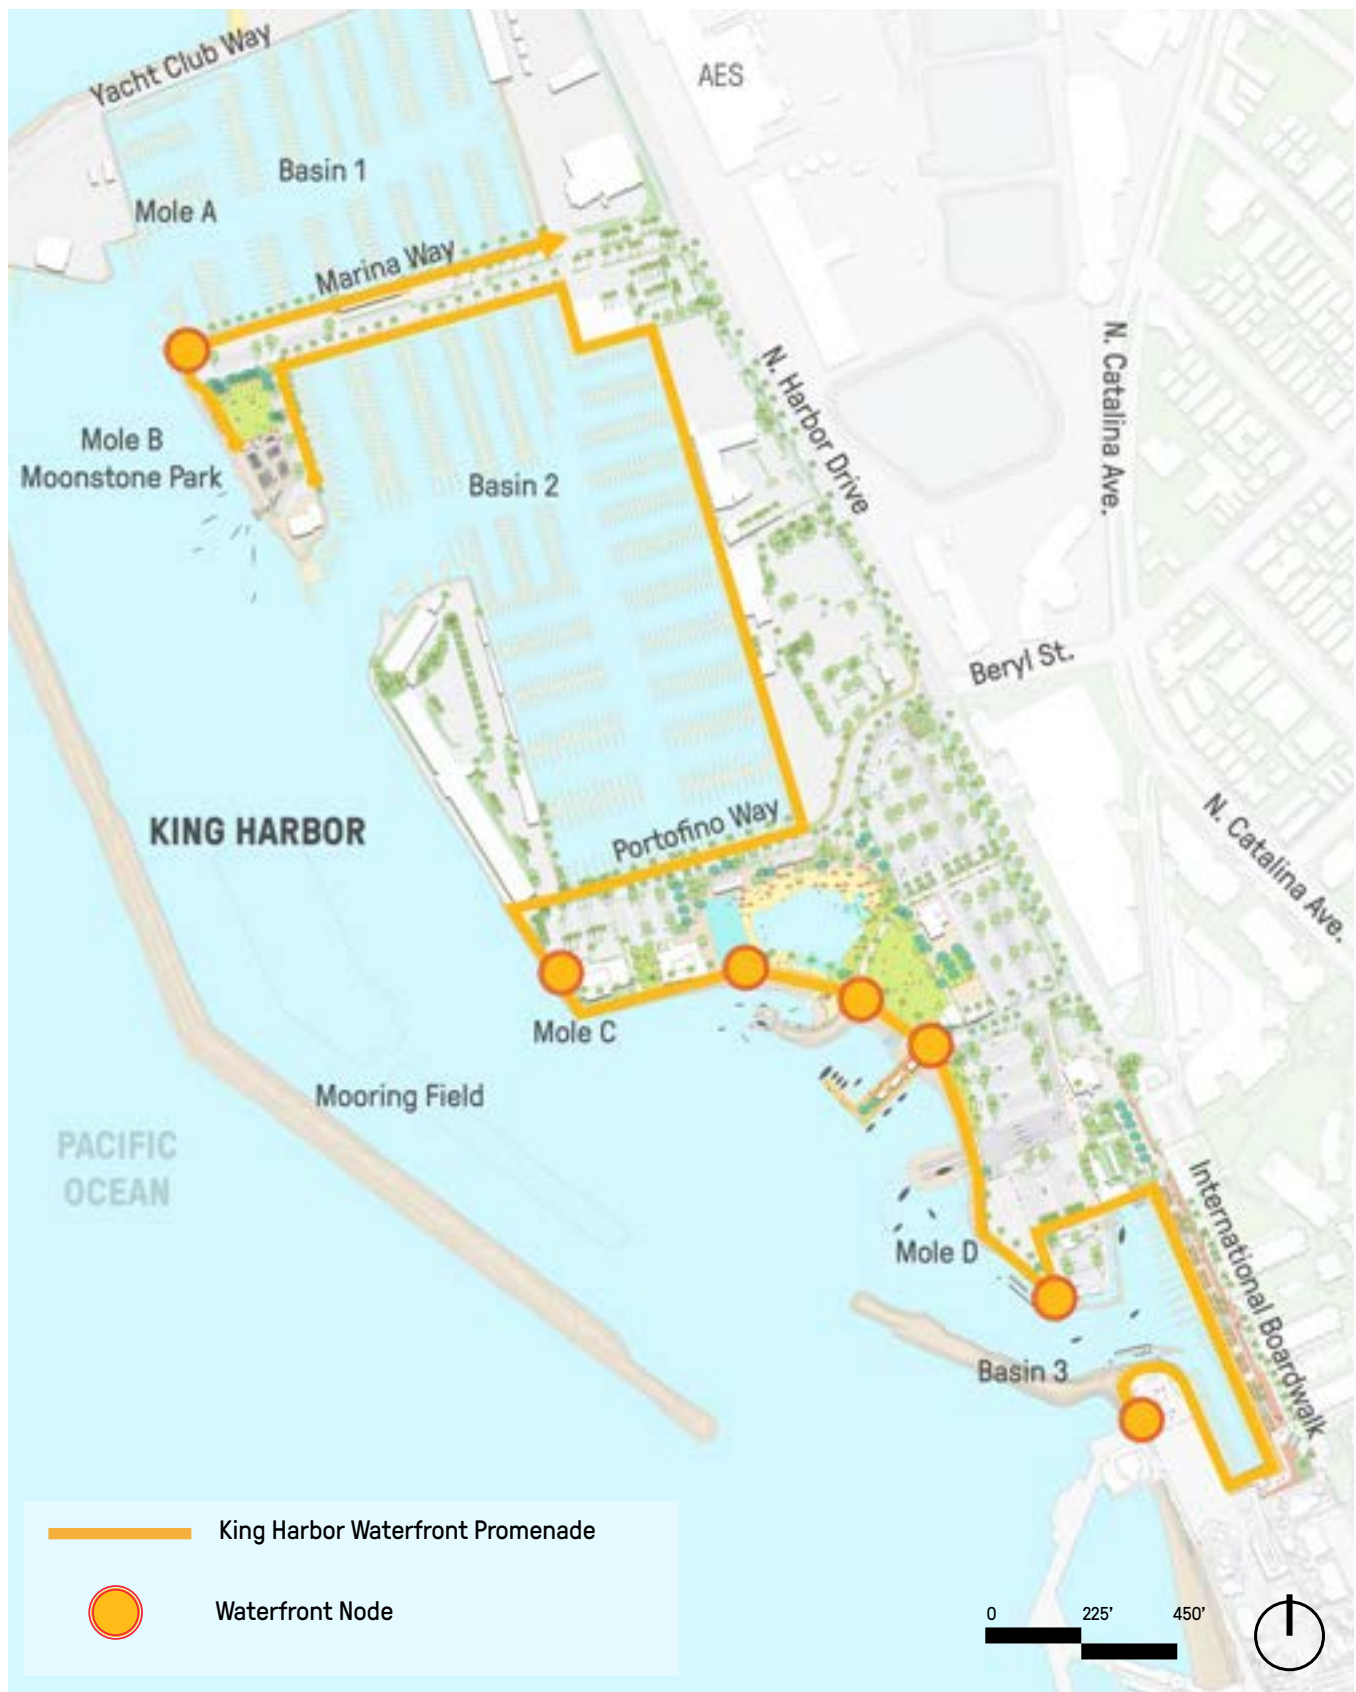
# WATERFRONT NODES

## 5.5 Waterfront Nodes

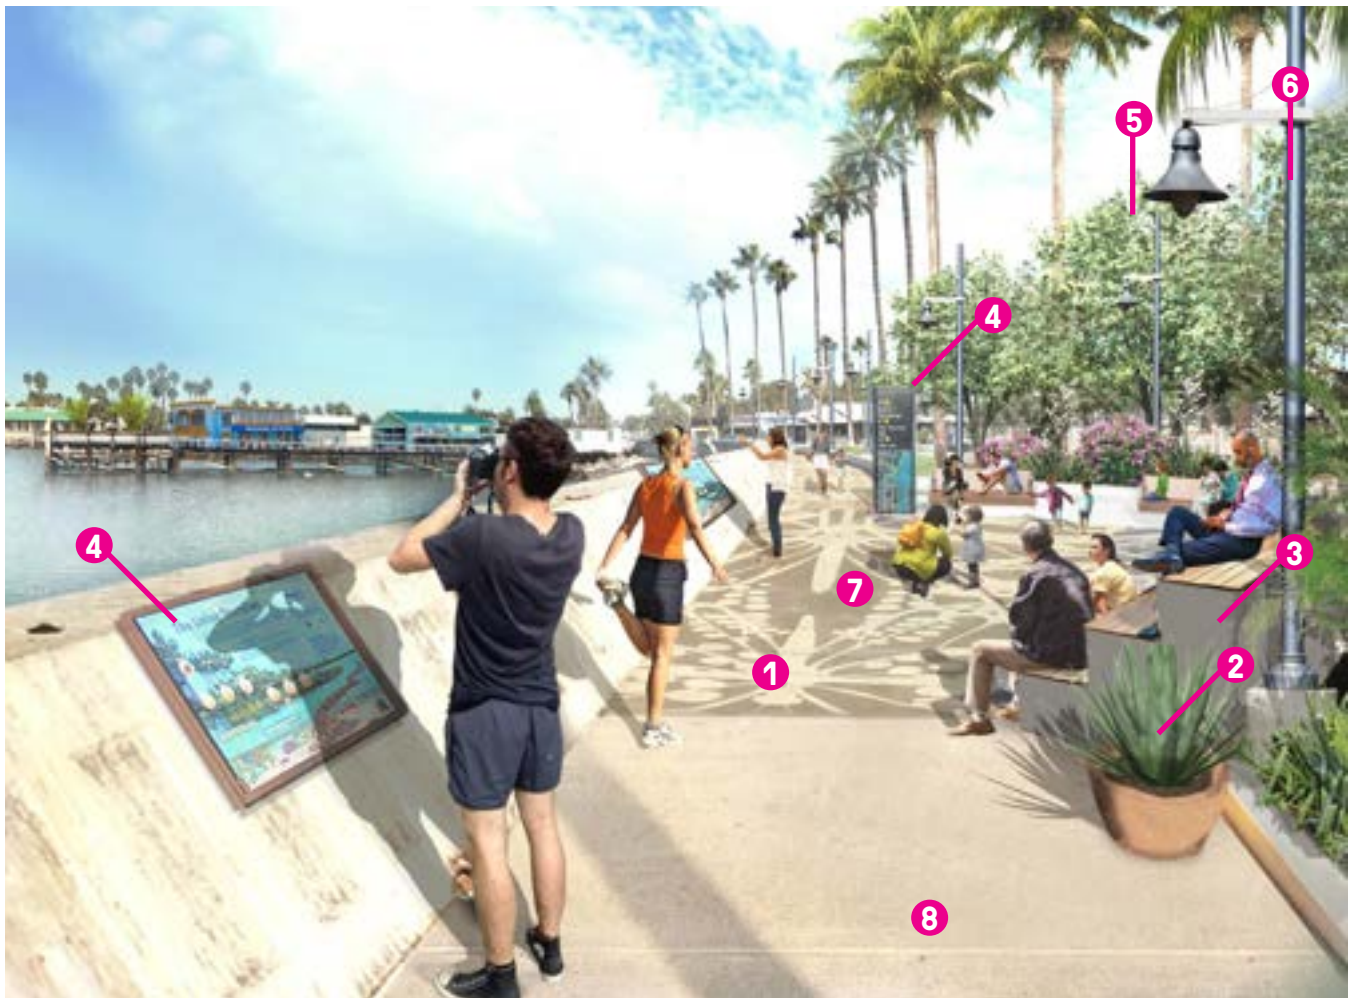
After: A new vision and experience at the waterfront nodes after design interventions

- ① Accent paving
- ② Planting
- ③ Benches and amphitheater seating
- ④ Informational kiosk and educational signage
- ⑤ Trees and shade
- ⑥ Pedestrian lighting
- ⑦ Open space
- ⑧ Connection to pathways

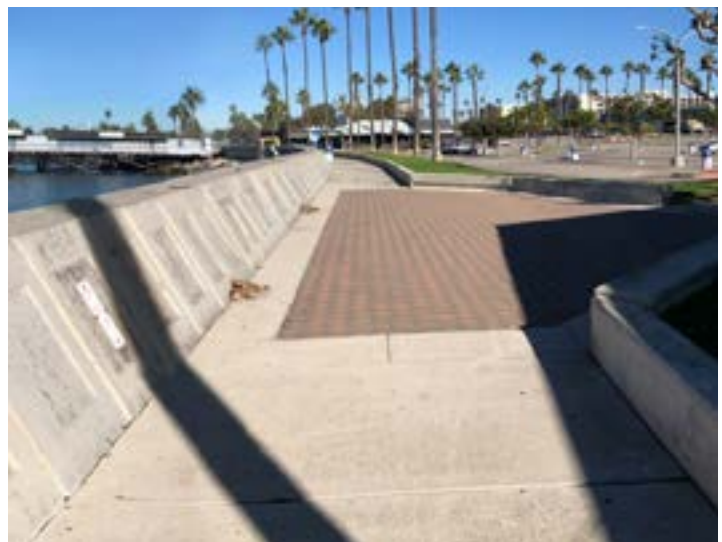
Before: Existing waterfront node before design interventions
