# KING HARBOR

PUBLIC AMENITIES PLAN

## King Harbor Public Amenities Plan 100% Draft for City Council Approval

#### **SWA Group**

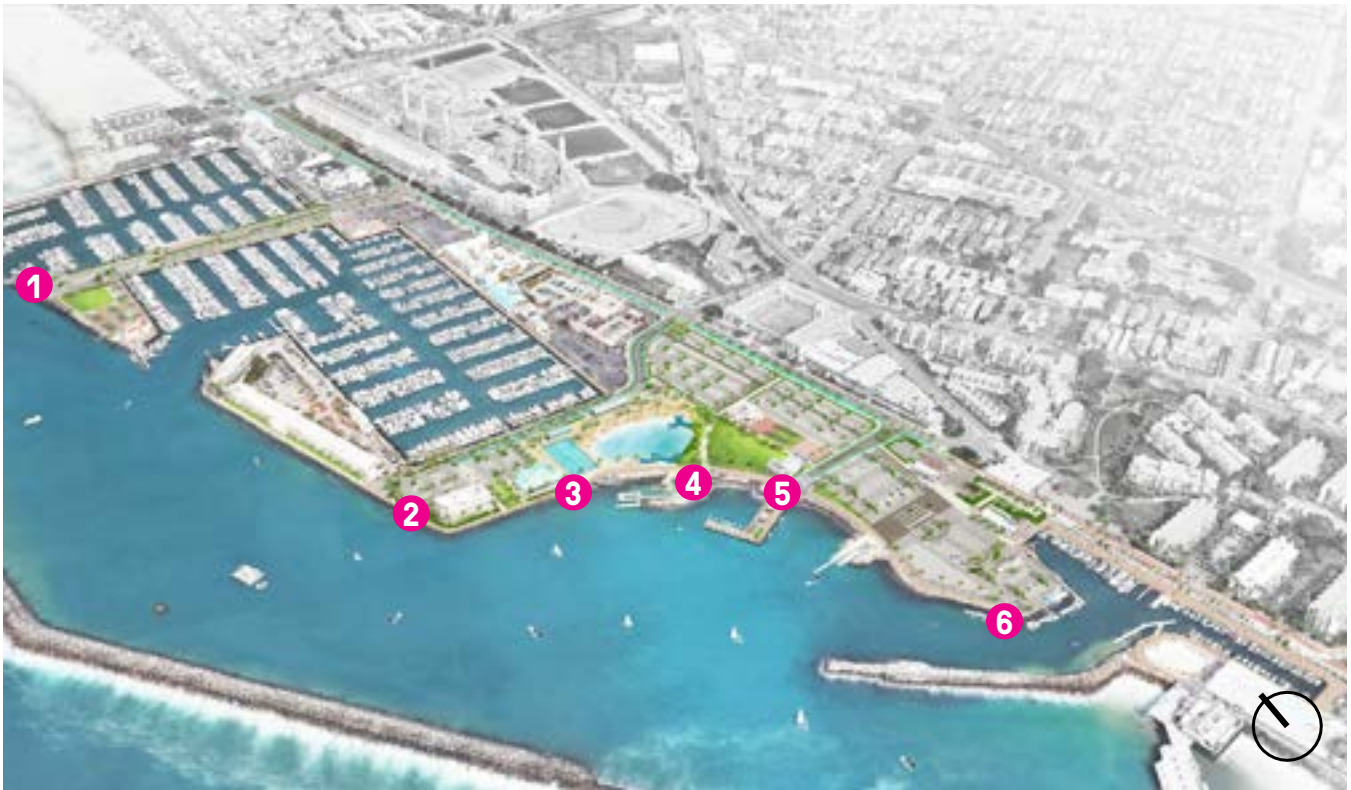
Waterfront node locations

Each node presents an opportunity for a unique name and identity for variation in amenities. Most nodes are existing, but need to be enhanced and recognized. The following locations and branding are recommended:

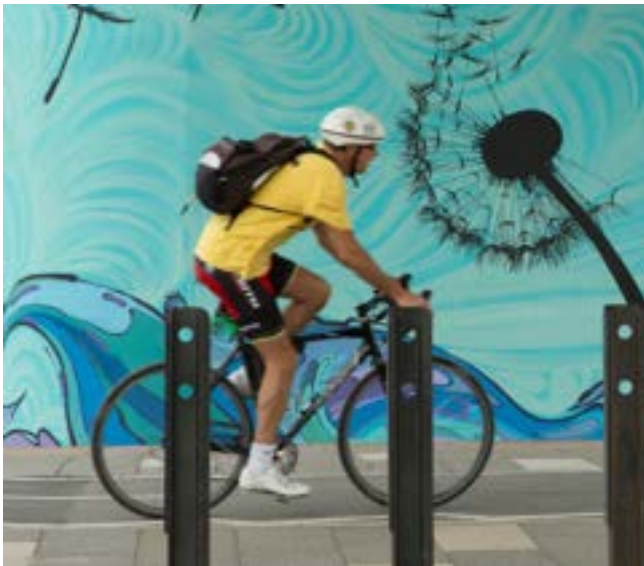
Separated bike lane

The Class II Bike Lane will include a dedicated bike lane for bicyclists. This plan proposes a new dedicated path at Portofino Way and Mole D Entry Drive. Bike lanes are one-way facilities, striped adjacent to motor traffic traveling in the same direction. The striping can be accompanied by colored concrete to increase awareness of the bike lane. Following the same color currently seen on Harbor Drive is recommended for consistency. Portofino Way may have enough width to create two lanes; Mole D Entry Drive would need to be slightly expanded in order to incorporate two lanes.

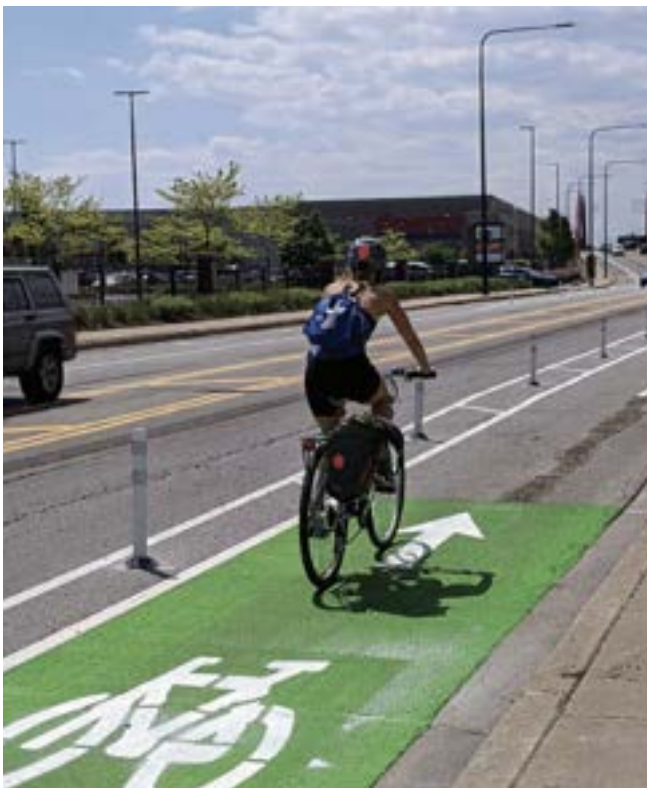
Class II lane example

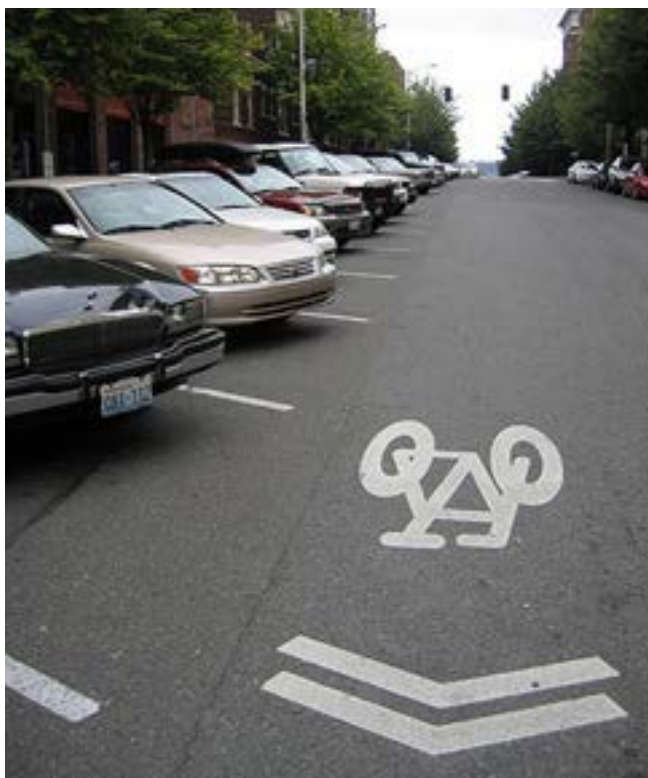
Sharrows example

This denotes areas where markings will be included to identify shared use by bicyclists and vehicles. This will occur on Marina Way and through the Seaside Lagoon parking lot. Class III bikeways designate the preferred route through the parking lot through sharrows markings without a designated bike lane striping. This is essentially a non-dedicated bike lane indicative of the best place to ride, which will also alert car drivers that bicycles may be riding through the area. Without the marking, motorists will have less indication of where to expect bicyclists.

5. For Marina Way and the bike connection at Seaside Lagoon, Class III sharrows should be utilized. Sharrows should be placed at least 11 feet from the curb. Sharrows should be placed immediately after an intersection.
6. For Bike lanes at Portofino Way and Mole D Entry Drive, Class II Bike lanes shall be included within the street.
7. The bike lane shall have a minimum of five feet and be located on the travel lane side.
8. Pavement surface for the bike lanes should be smooth and free of structures where possible. The lane shall be striped by a white line at minimum for use on existing streets. If possible, asphalt coloring should be incorporated to match the bike lanes along Harbor Drive.

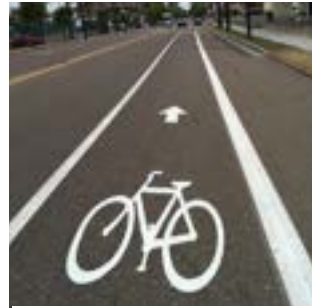
Bike lane

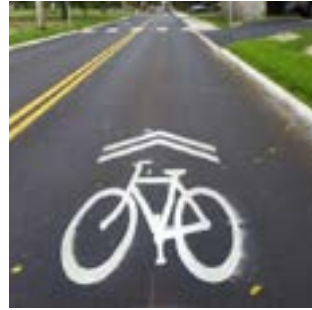
Bike sharrow

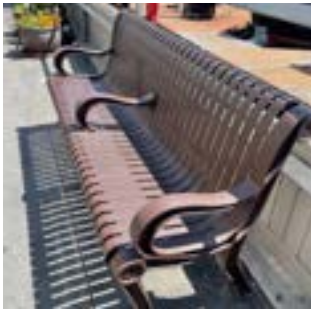
Repainting existing benches

- Existing benches should be evaluated for condition and replacement, and potentially phased out over time. Repainting the existing metal benches may be a short-term option.
- Provision of a variety of informal seating options near areas of heavy foot traffic throughout the harbor is recommended.
- Simple bench elements should be located throughout the waterfront path and interior of the harbor.
- Nodes along the waterfront path should integrate more sculptural amphitheater seats or spaces where possible.
- Benches must be made of durable material.
- Bench pads should accommodate ADA access.
- Seat walls can be considered in areas where retaining walls are required along the waterfront path.

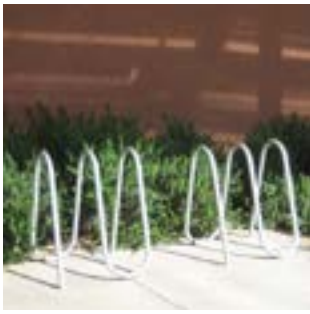
Connected bike rack

- Existing bicycle racks should be evaluated for condition and replacement, and potentially phased out over time.
- Adequate bicycle parking should be provided along bicycle nodes and throughout the harbor.
- Bicycle rack counts should reflect adjacent programs and potential future traffic studies.
- Hubs should be evaluated to incorporate micromobility parking such as e-bikes and scooters. Public safety must be considered along pedestrian and bicycle paths.

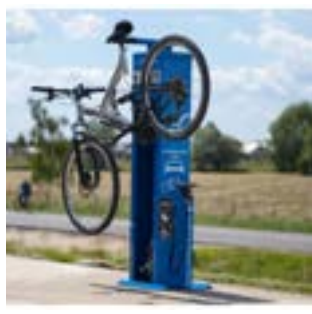
Bike repair station

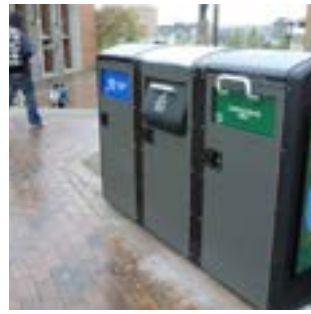
Trash, recycling, and compost

- Existing trash receptacles should be evaluated for condition and replacement, and potentially phased out over time.
- When integrating receptacles, location and quantity should be based upon the scale of open space or pedestrian paths.
- Receptacles should be proximate to seating areas and nodes where benches or tables are present.
- Recycling and compost receptacles should be considered if possible.

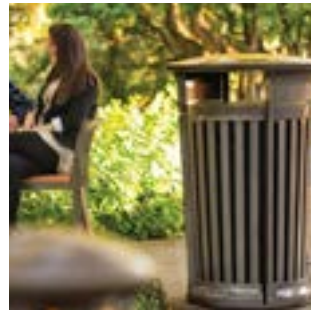
Covered garbage receptacles

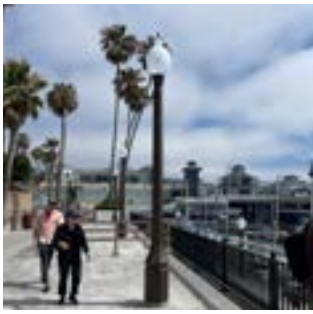
International Boardwalk fixtures

- Existing lighting fixtures should be evaluated for condition and replacement, and potentially phased out over time.
- The recent replacement fixtures at International Boardwalk should be embraced and referenced for future lighting options.

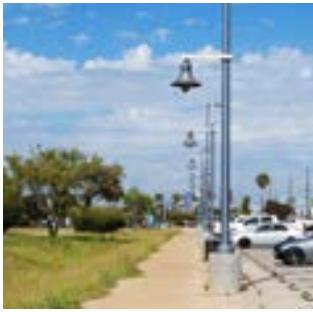
Capped lighting  
*Concept imagery for design intent only*

- Lighting should not interfere with boats navigating the harbor between sunset and sunrise.
- Utilize caps on top of lights to reduce light pollution.
- Lighting should be designed to shine downward to avoid glare along the waterfront promenade.

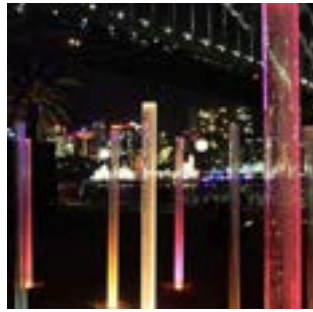
Lit directional markers

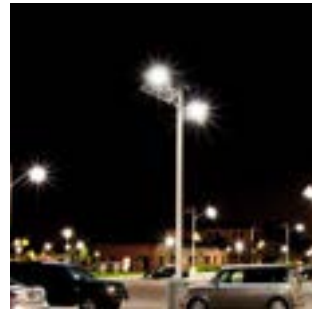
Parking lot lighting

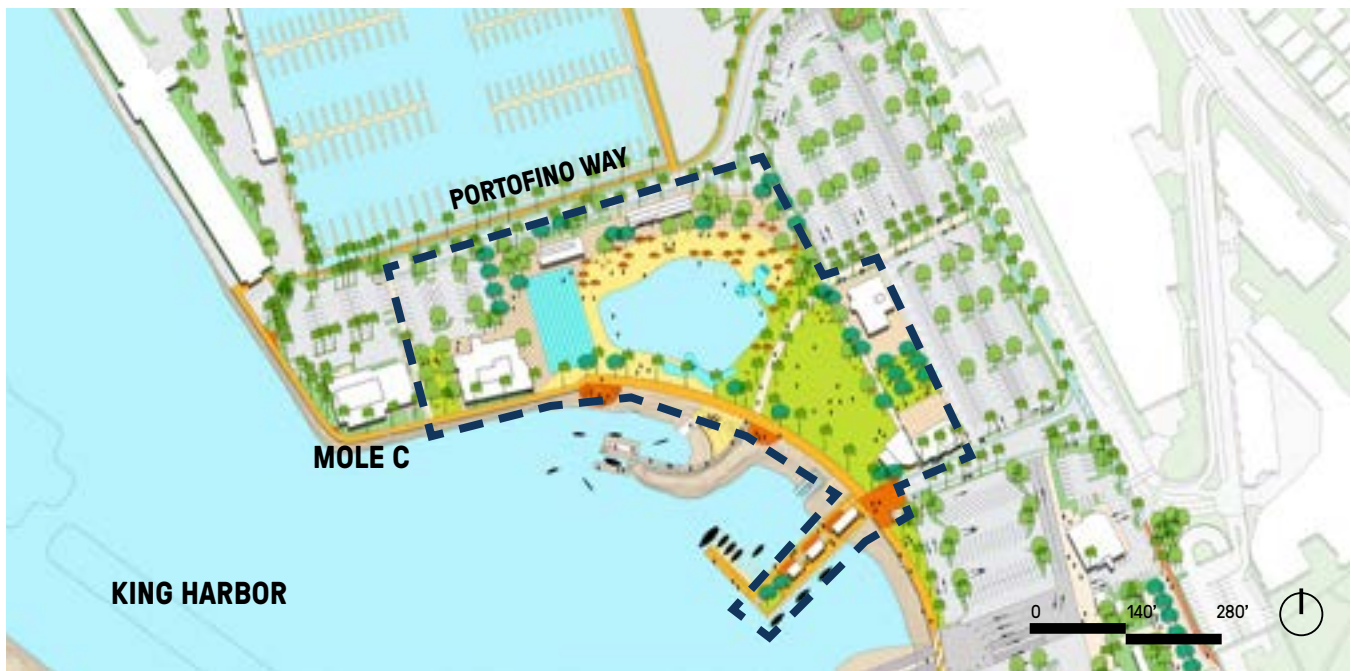
Harbor Hub and Educational character zone boundary

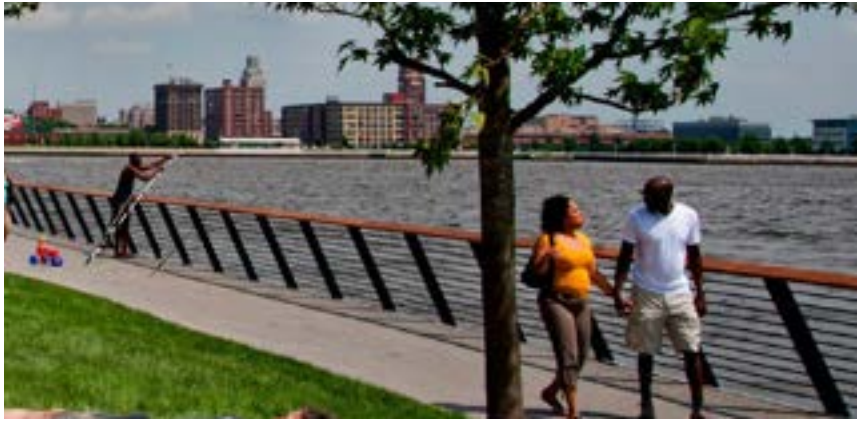
Modern railings

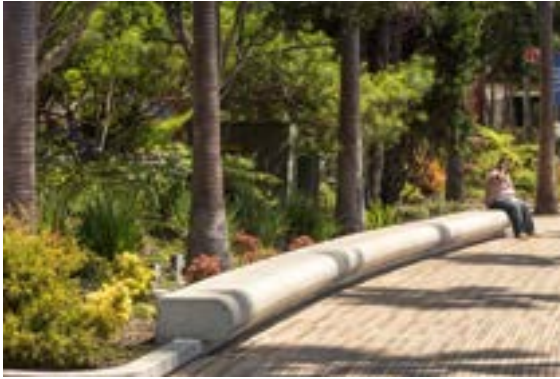
Seatwalls integrated at the waterfront promenade

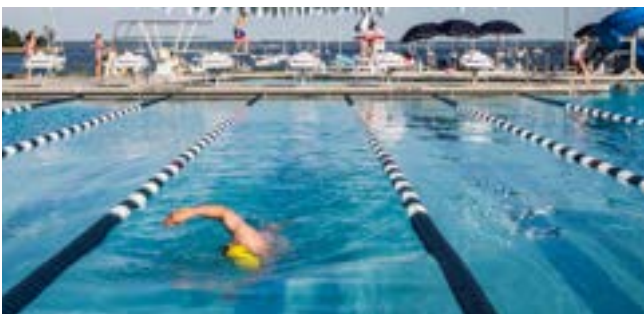
Olympic lap pool

Seaside Lagoon should consider introducing a new Olympic sized pool that is 50 meters long and 25 meters wide. This pool can be used in various ways: by adult swimmers and high school/extracurricular teams as well as for community swimming events. The pool can also support coastal-dependent activities such as swim lessons for future watercraft uses, paddlecraft lessons, scuba-diving lessons, and for radio-controlled model sailboats. It is recommended that year-round heating be required for the pool. Additional waterpark amenities, like splash pads, can be incorporated within the lagoon upgrades. Surf or wave pools are also sought-after by the public; however, space requirements may restrict this amenity’s feasibility. An Olympic pool addition to Seaside Lagoon is subject to successful design options per the existing RFP for Seaside Lagoon.

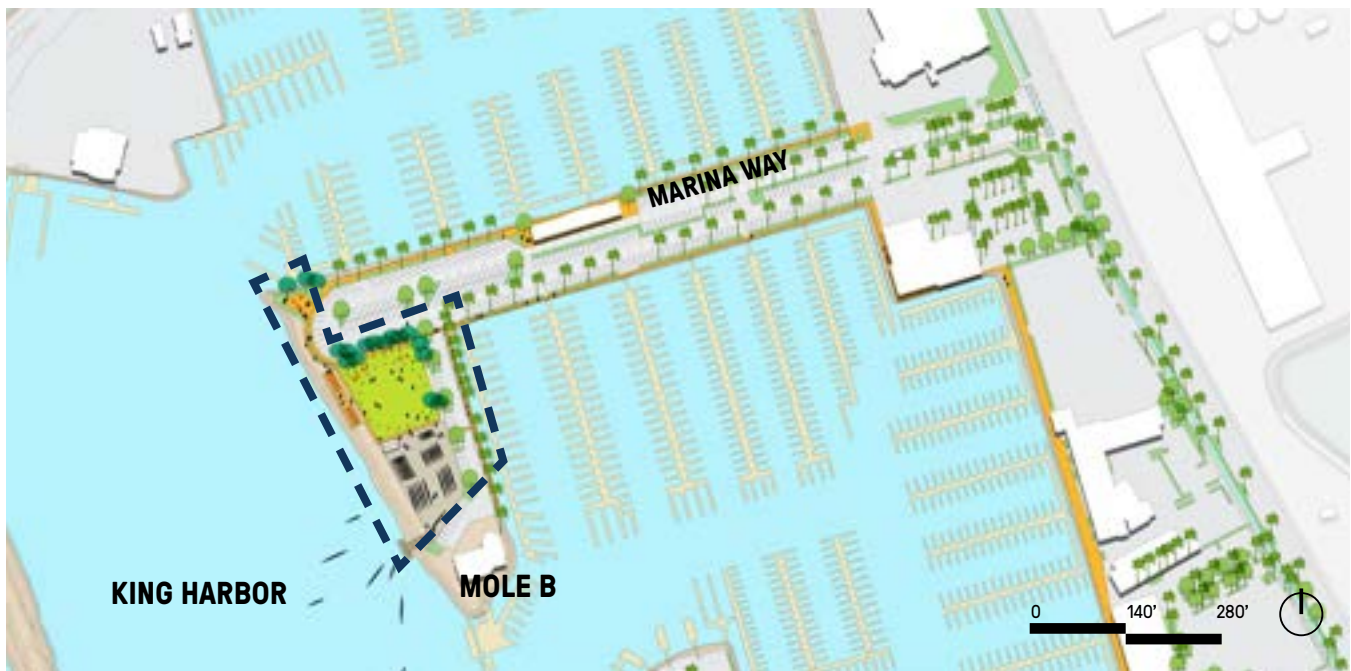
Natural character zone boundary

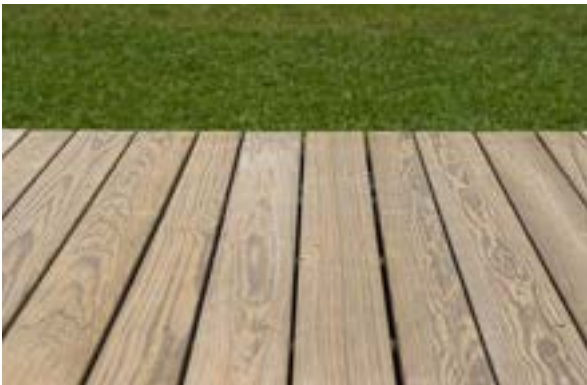
Deck wrapping the park

ADA access to the stepped deck must be ensured via a ramp. Parts of the lawn edge can remain open to provide a variety of views. The walkway between the park and the outrigger clubs can be comprised of the same deck material to create a large wrap-around deck experience. The deck’s materiality should consider a faux wood concrete style.

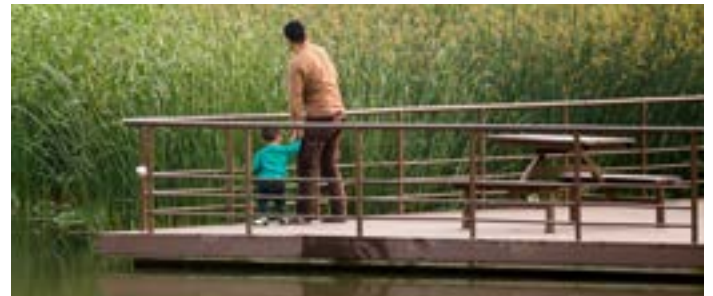
Natural railing look

A natural-looking railing surrounding the deck is recommended to maintain the character of the park.

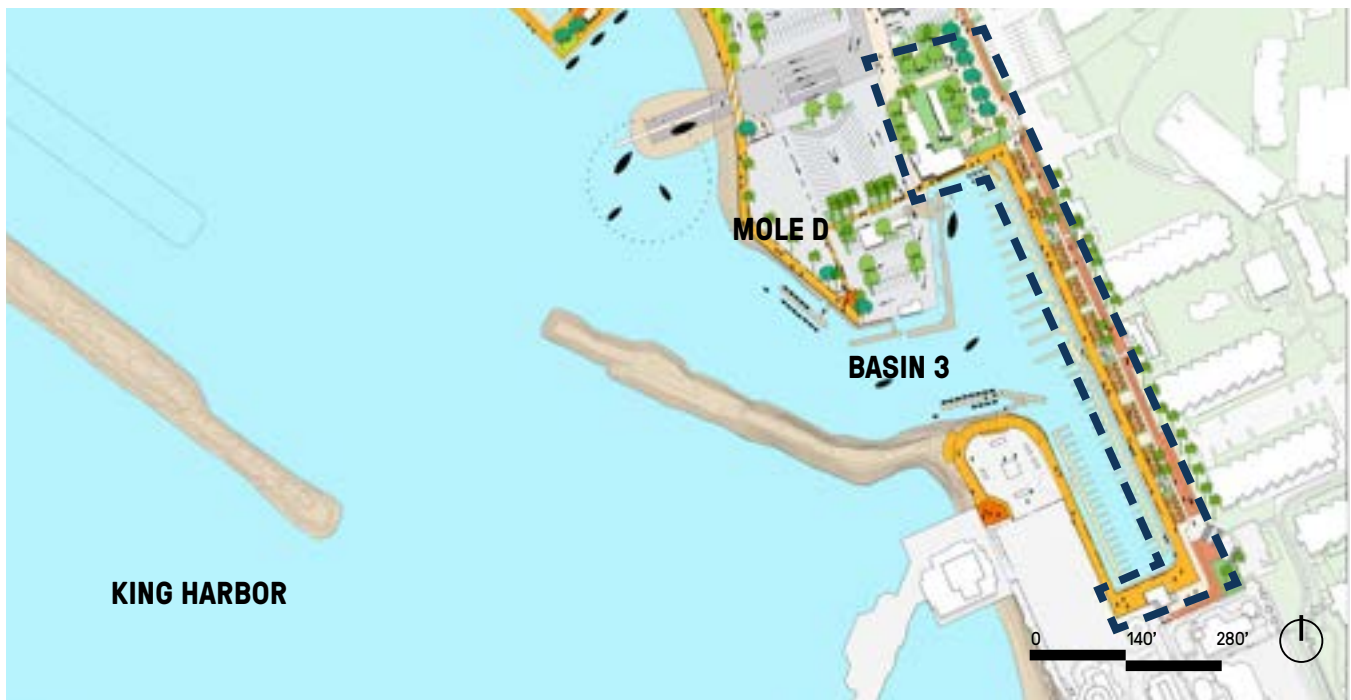
Commercial zone boundary

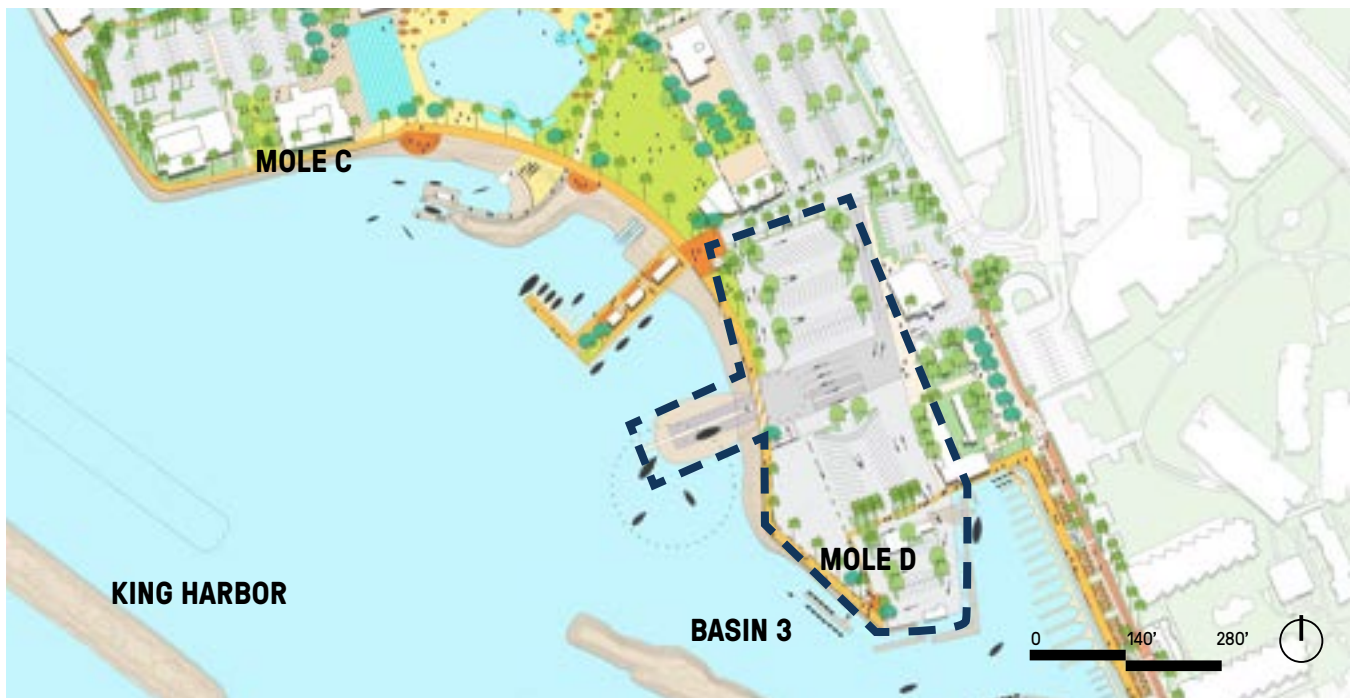
Coastal zone boundary

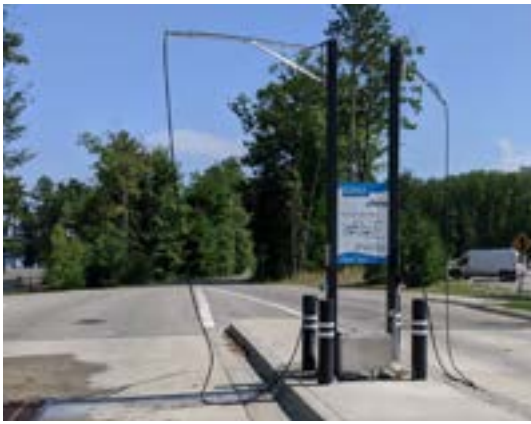
Boat wash station

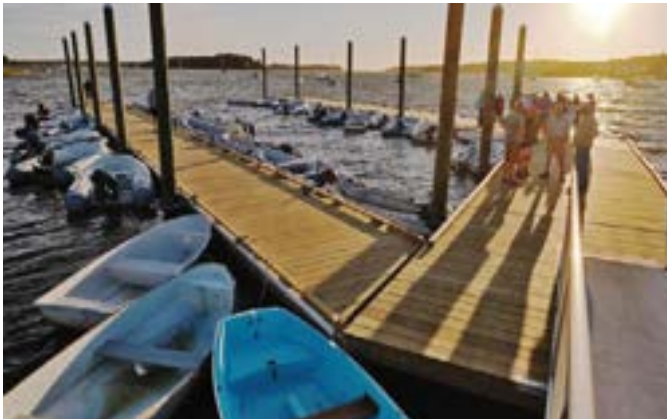
Timber dinghy dock

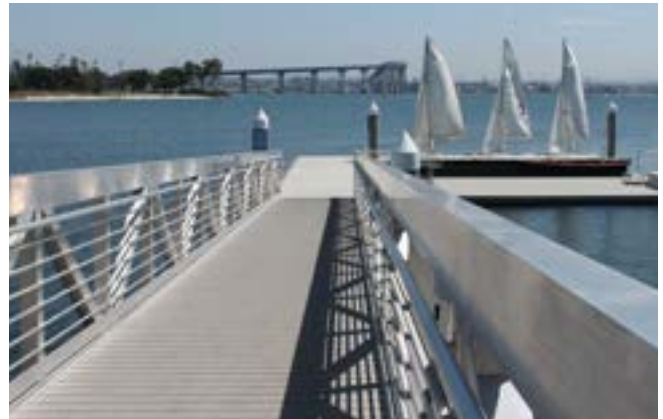
Aluminum dinghy dock

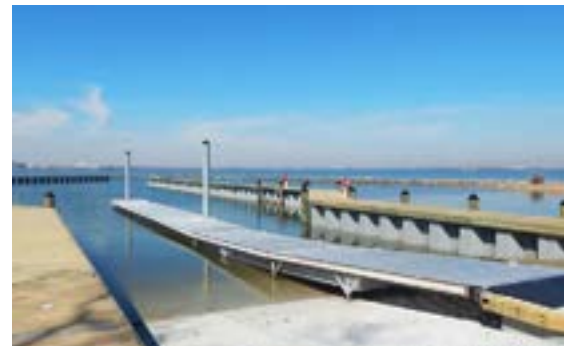
Concrete boat launch

- Concrete paving and parking lot striping comprise a majority of the hardscape within this zone. Colored concrete or arrows, in addition to signage, should clearly delineate boat lanes and wash-down lanes.
- The Public Boat Launch should be made of concrete for both lanes, while the center boarding float should be comprised of concrete or steel piles with hinged float sections, allowing it to articulate with the tide.
- Concrete, timber, and aluminum should be considered for dinghy dock materials. If multiple locations are pursued, these should be made of the same material.

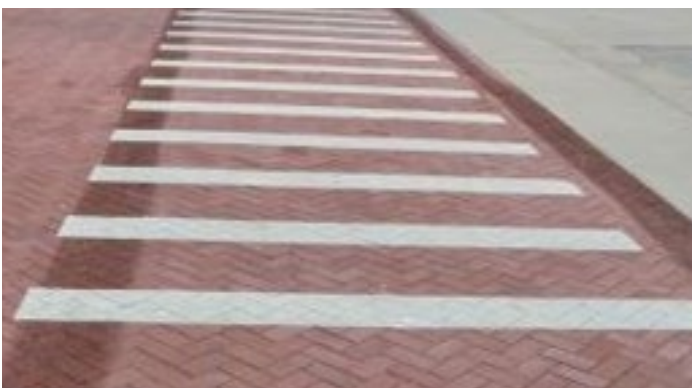
Pavement striping at boat launch

- Where the King Harbor waterfront promenade intersects the boat launch, colored striping is highly recommended. Striping, along with signage, will help warn pedestrians of boat launching in the area.
- Pedestrians should have the option to walk around the Public Boat Launch through an interior pathway north and south of the boat ramp, if they choose to not use the waterfront promenade in the area.
- In areas of the coastal zone where planting areas are available, drought-tolerant plants should be incorporated, with pockets of focal planning for aesthetics.
- The restroom located north of the launch should employ natural, coastal colors for its facade.

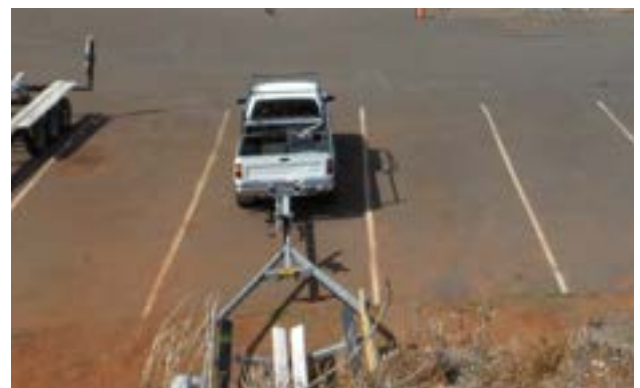
Trailer parking striping

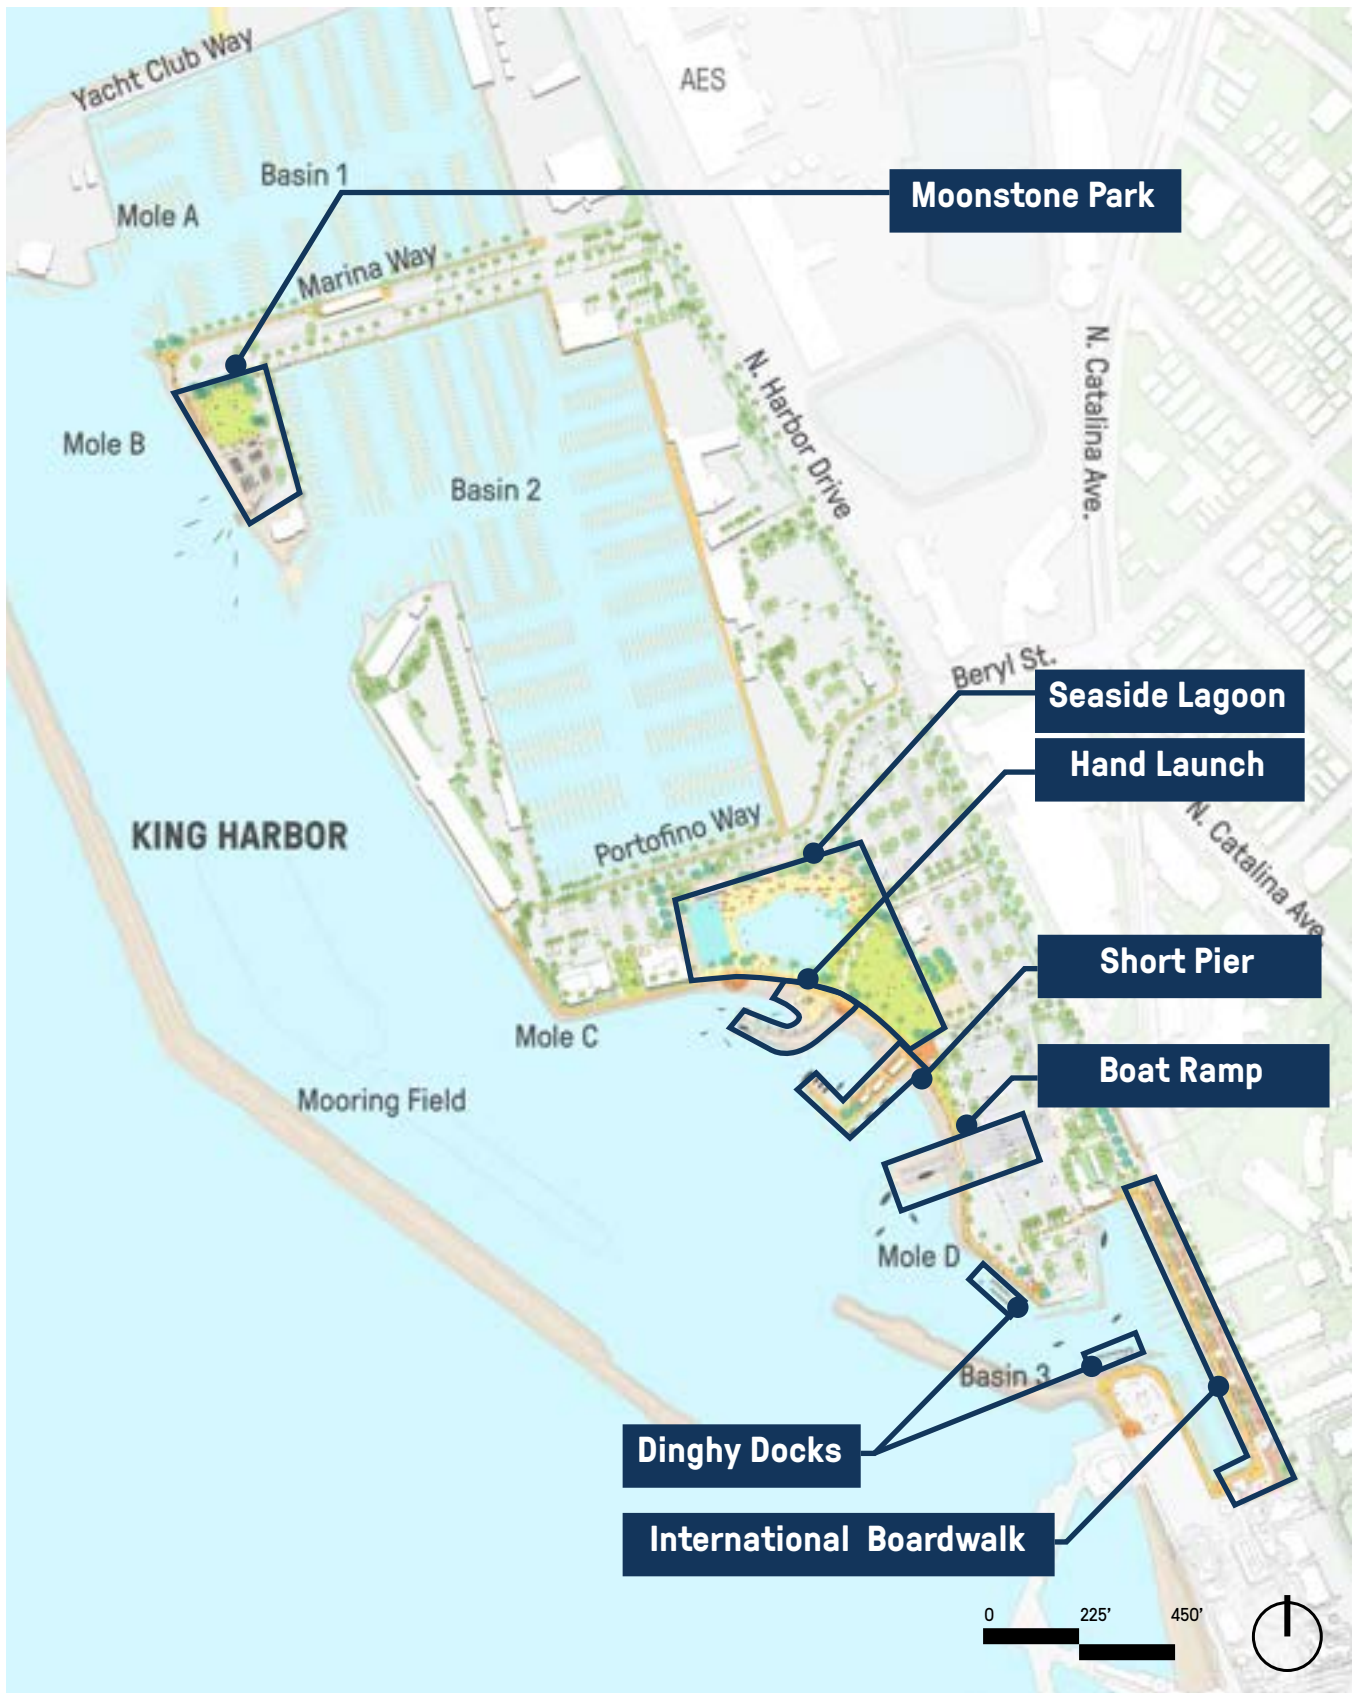
King Harbor key areas' recommendations

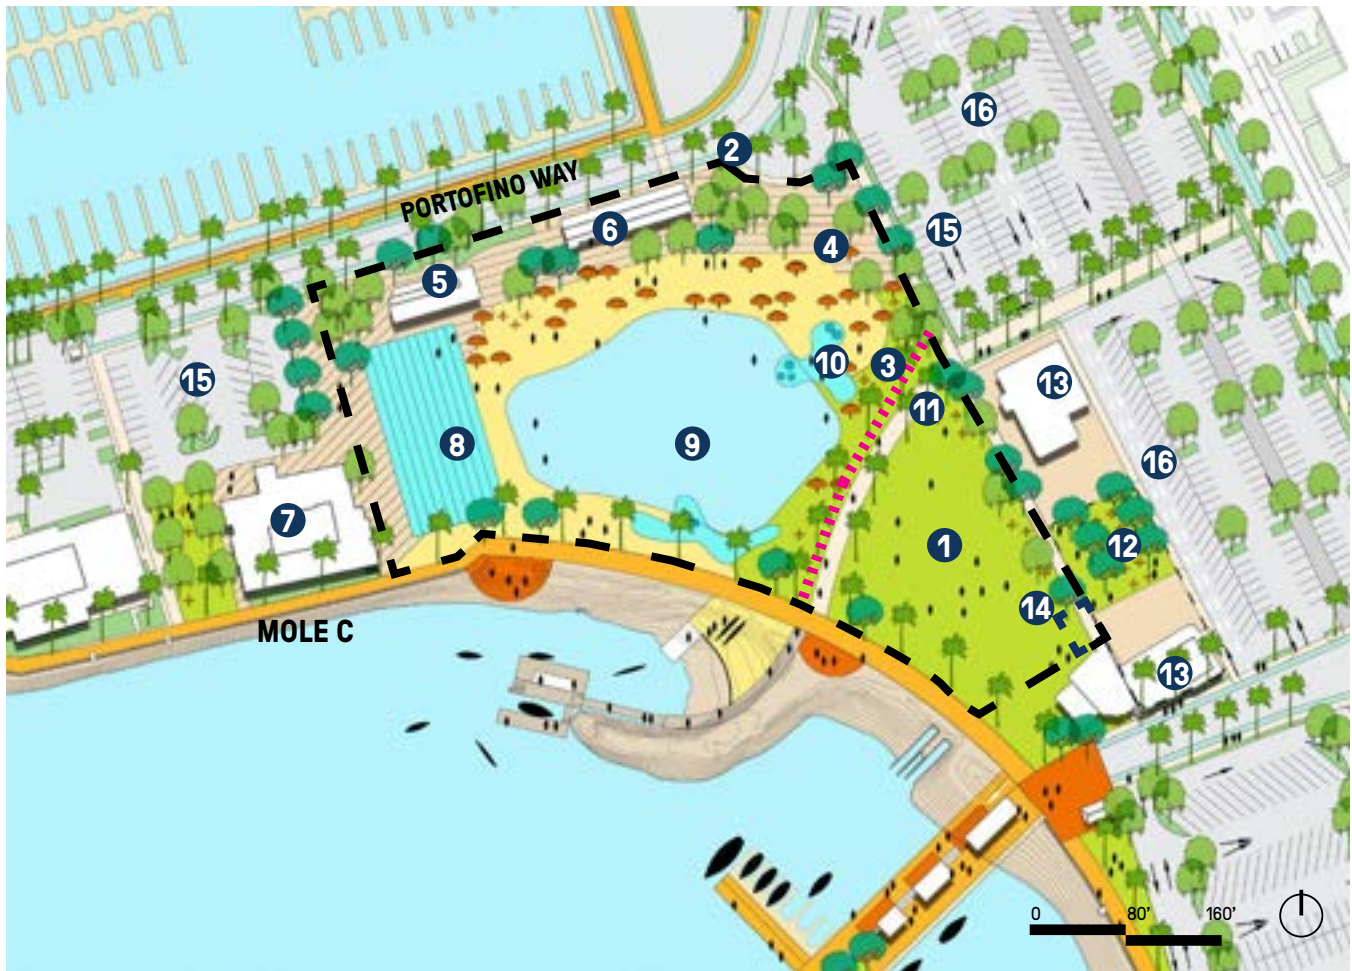
Seaside Lagoon | Hybrid Aquatic/Lagoon and Great Lawn

# SEASIDE LAGOON PRIMARY ITERATION

| 1 Great lawn | 9 Lagoon renovation |
| 7 Area for educational center | 15 Dedicated bus parking |
| 8 Community pool/lap pool | 16 Bike sharrows |

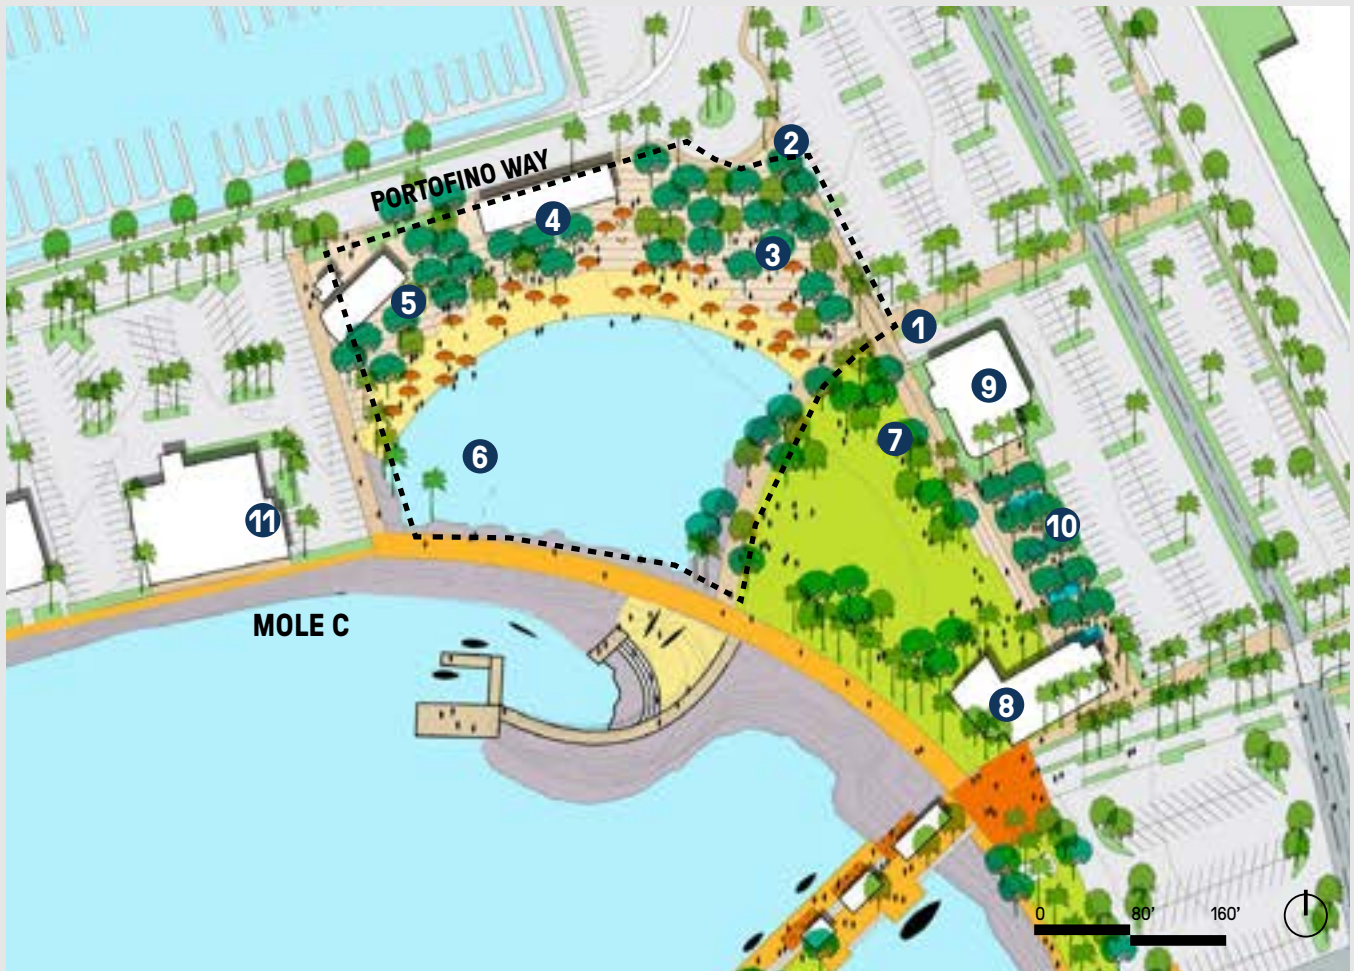
### Iteration Concept 1 | Lagoon Upgrade & Great Lawn

- 1 Direct path to oceanfront
- 2 Refined fence boundary
- 3 Boardwalk plaza
- 4 Restroom
- 5 Community center
- 6 Lagoon renovation
- 7 Public open lawn
- 8 Potential location for bandshell
- 9 Dining option
- 10 Tables and small food vendors
- 11 Potential for educational center

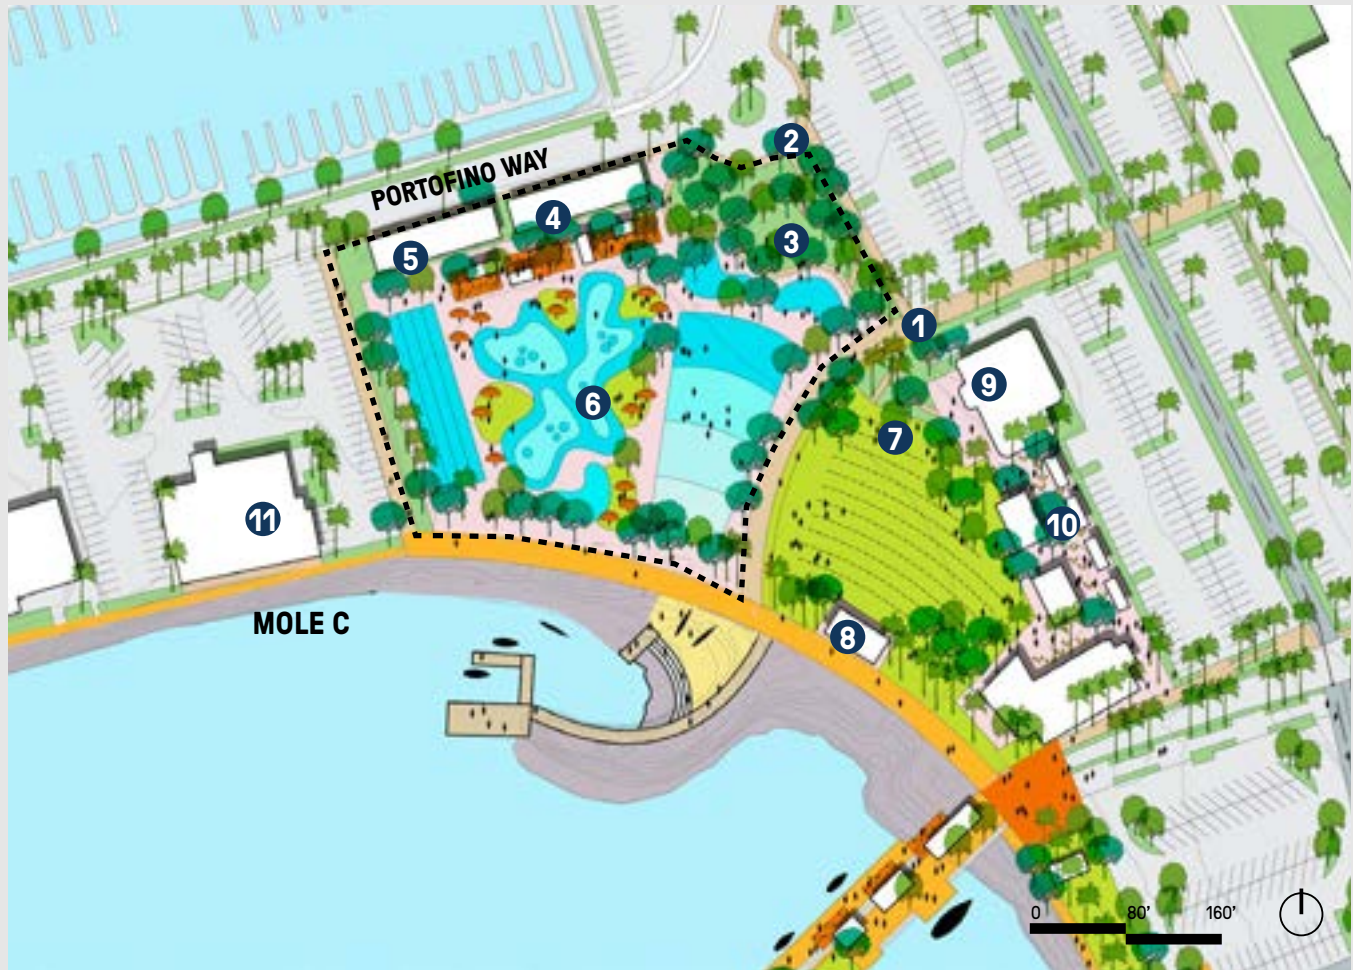
### Iteration Concept 2 | Aquatic Facility & Great Lawn

- ① Direct path to oceanfront
- ② Refined fence boundary
- ③ Stroll park with native planting
- ④ Restroom
- ⑤ Community center
- ⑥ Water park amenities, lap pool, and wave pool
- ⑦ Public open lawn
- ⑧ Potential location for bandshell
- ⑨ Dining option
- ⑩ Tables and small food vendors
- ⑪ Potential for educational center

In this iteration, the traditional lagoon is replaced with aquatic uses such as a wave pool, lap pool, splash pad, and water park features. Similar to Concept Iteration 1, the connection pathway opens to the waterfront lawn, and the picnic area is reshaped as open public space.

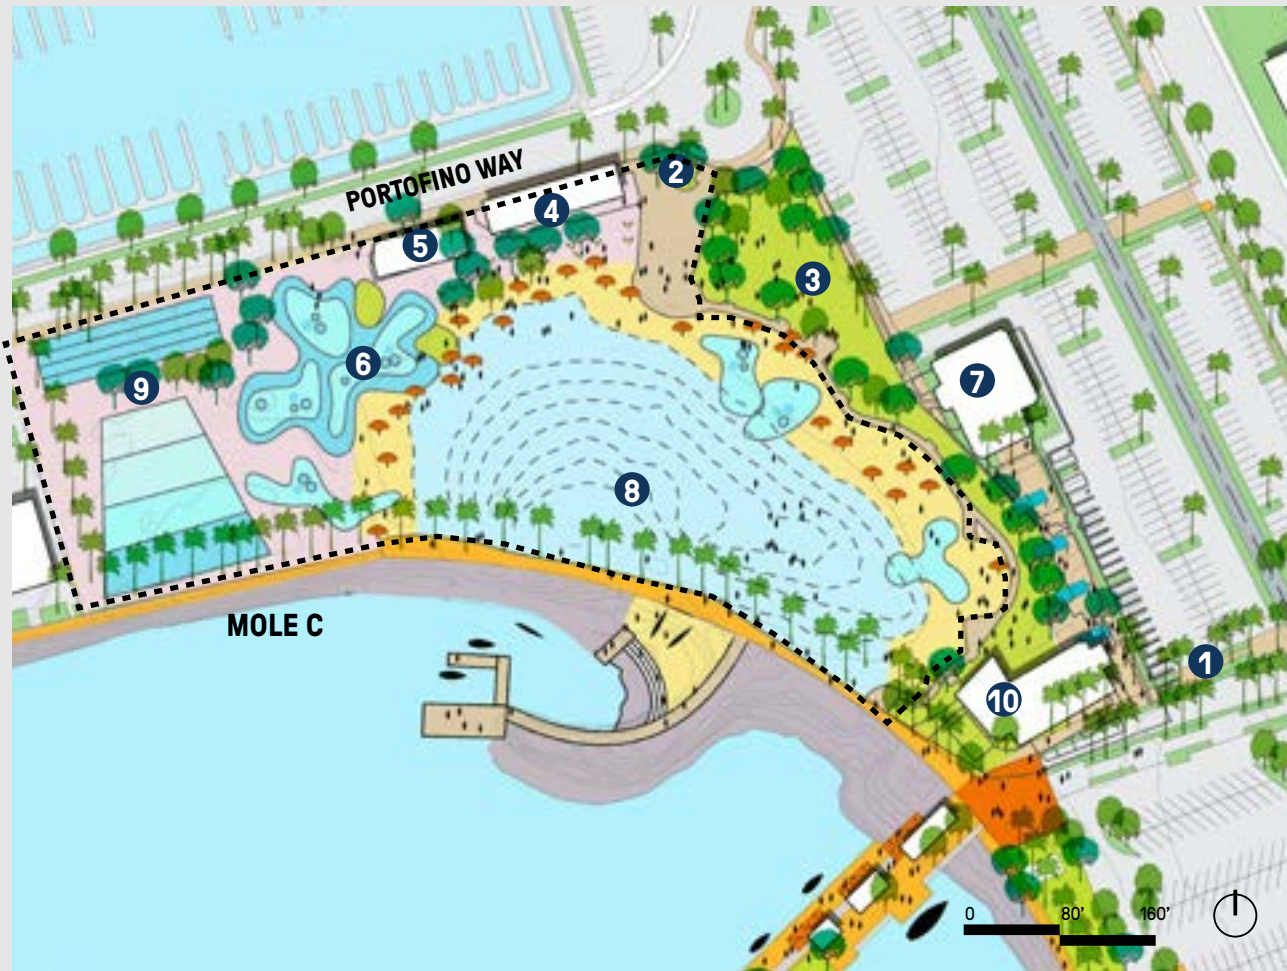
### Iteration Concept 3 | Hybrid Aquatic/Lagoon Expansion & Linear Park

- 1 Direct path to oceanfront
- 2 Refined fence boundary
- 3 Stroll park with native planting and lawn
- 4 Restroom
- 5 Community center
- 6 Water park amenities
- 7 Dining option
- 8 Lagoon renovation
- 9 Lap pool or wave pool
- 10 Potential for educational center

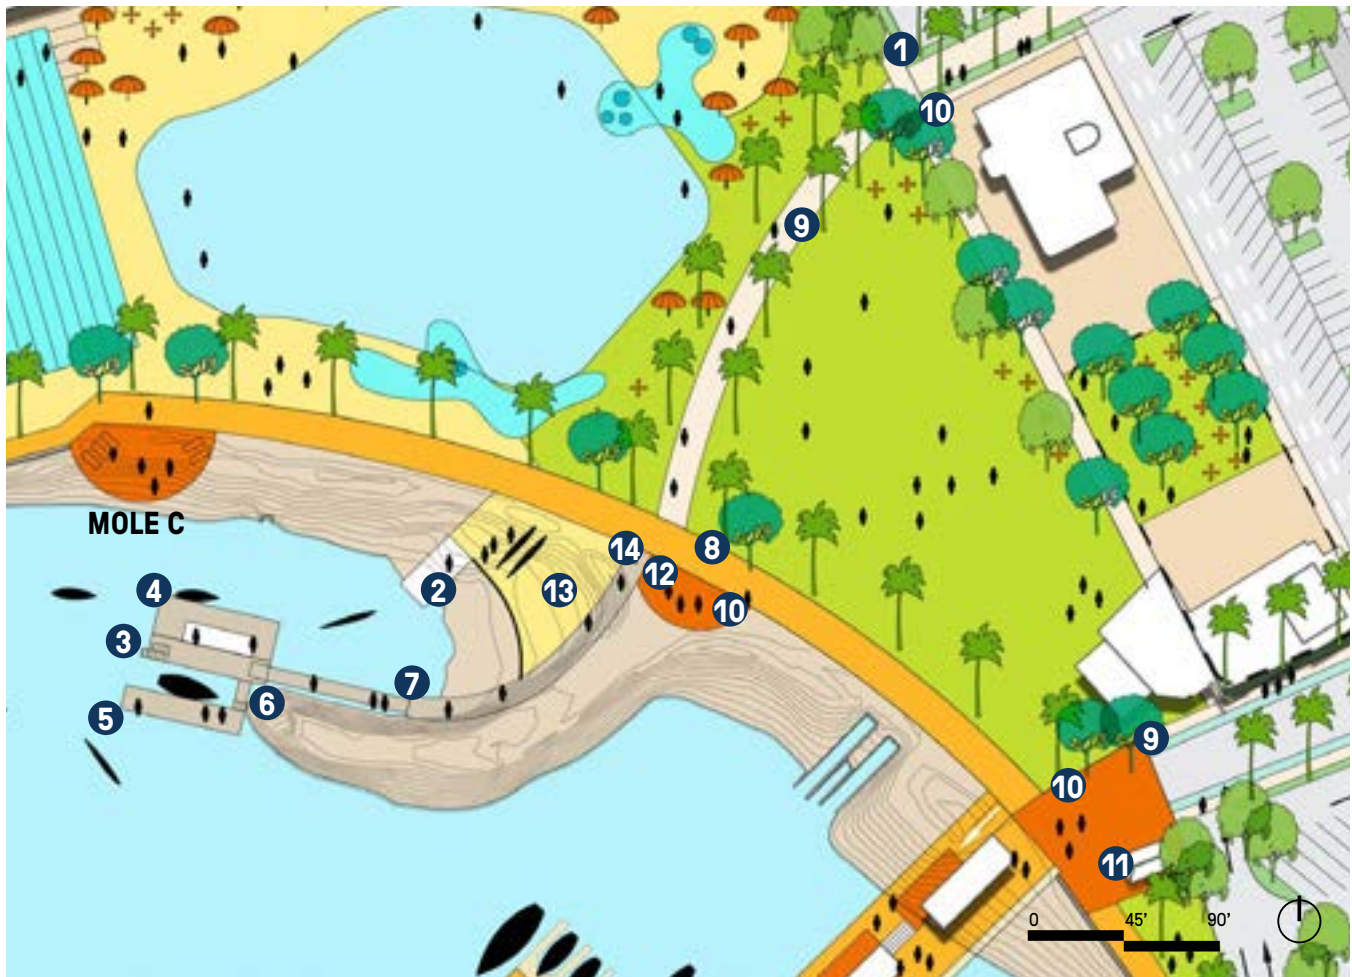
Hand Launch | Zero Depth Launch

| ① Direct pedestrian path to oceanfront | ⑧ Temporary vehicular drop off for events |
| ⑥ Slip for Harbor Patrol only | ⑬ Sandy beach for staging |
| ⑦ ADA gangway | ⑭ Potential paddle craft rack |

the waterfront promenade in front of the Hand Launch be pedestrian-only, with flexibility for vehicular access for larger events. Removable bollards will be located at the edge of the Hand Launch waterfront node to ensure that vehicles do not access the path during authorized times. Consideration for nearby ADA parking is recommended at the closest stalls or at the temporary loading zone.

To access the new float, a 10-foot-wide pathway atop the existing breakwater or a pier structure on the leeward side of the breakwater would be constructed, in a curved alignment mirroring the breakwater. Approximately 80 feet from the new Hand Launch dock, the path/pier would end. A proposed 80-foot-long by 7-foot-wide aluminum gangway would provide access to the Hand Launch dock under all tidal conditions. The length of the gangway complies with Americans with Disabilities Act (ADA) requirements, providing an ADA-compliant path of travel to the Hand Launch dock.

The existing Hand Launch location experiences eddy currents and high-energy waves depending on the strength and approach of surges through the main entrance channel of the harbor. Therefore, a 60-foot-long by 12-foot-wide wave-attenuating dock, with a four-foot draft and two-foot freeboard, is proposed to attenuate wave and surge action within the Hand Launch basin, acting as an extension of the existing rubble mound breakwater. This wave-attenuating dock is anticipated to provide protection to the landing float and low-freeboard dock on its leeward side. The landing float is parallel to the wave attenuating dock, and has similar dimensions. An accessible kayak launch is proposed at the end of the landing float, so that a kayak may be brought directly down the gangway and into the launch. The landing float would also have a bridged connection to the wave-attenuating dock, and provide a slip for Harbor Patrol vessels or chase boats for regattas. No public use would be allowed.

The low-freeboard would be 60 feet long by 20 feet wide and extend north from the landing float. Its freeboard is only eight inches compared to 16 inches for a standard dock, so an aluminum ramp will be required to access it. The 60-foot length was selected to accommodate a 6 person outrigger canoe. The standard and wave attenuating docks are proposed to be concrete floats, while the low-freeboard dock is proposed to be an aluminum-framed structure with composite decking. All docks are proposed to be secured by concrete or epoxy-coated steel guide piles, depending on recommendations from a geotechnical engineering investigation performed during the design process. The docks would be designed in accordance with the 2005 Layout and Design Guidelines for Marina Berthing Facilities by the California Department of Parks and Recreation Division of Boating and Waterways (2005 DBW Marina Design Guidelines).
