# KING HARBOR

PUBLIC AMENITIES PLAN

## King Harbor Public Amenities Plan 100% Draft for City Council Approval

#### **SWA Group**

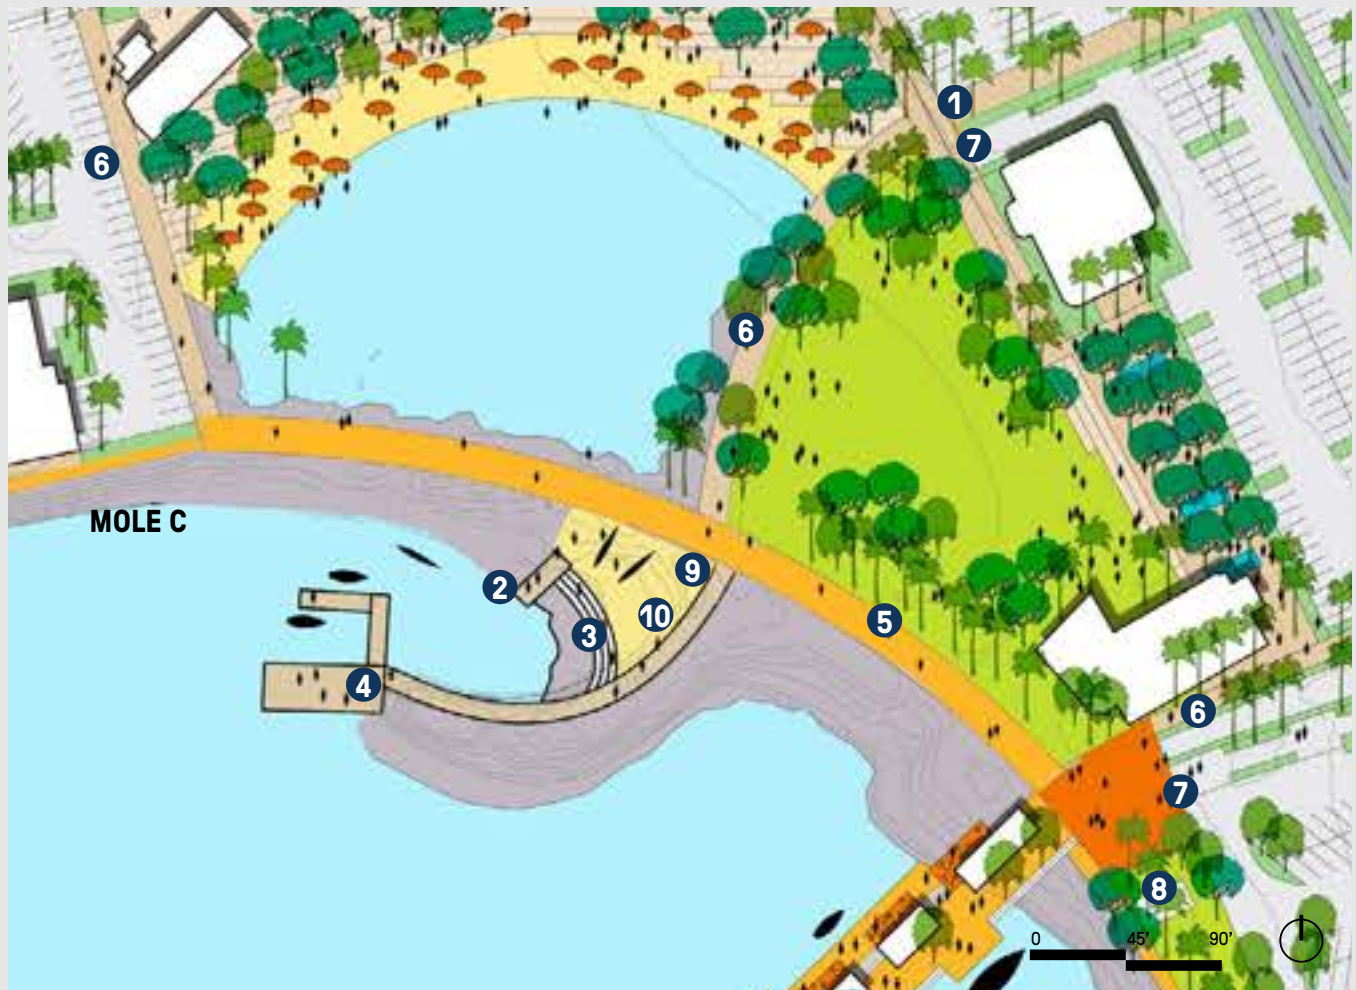
### Iteration Concept 1 | Terraced Steps and Zero Depth Launch

- 1 Direct pedestrian path to oceanfront
- 2 Zero depth entry
- 3 Protected terraced seating
- 4 ADA gangway and floating dock
- 5 Temporary vehicular drop off for events
- 6 Pedestrian path
- 7 Cart rentals for paddlecrafts
- 8 Public restrooms
- 9 Wash-down station
- 10 Sandy beach for staging

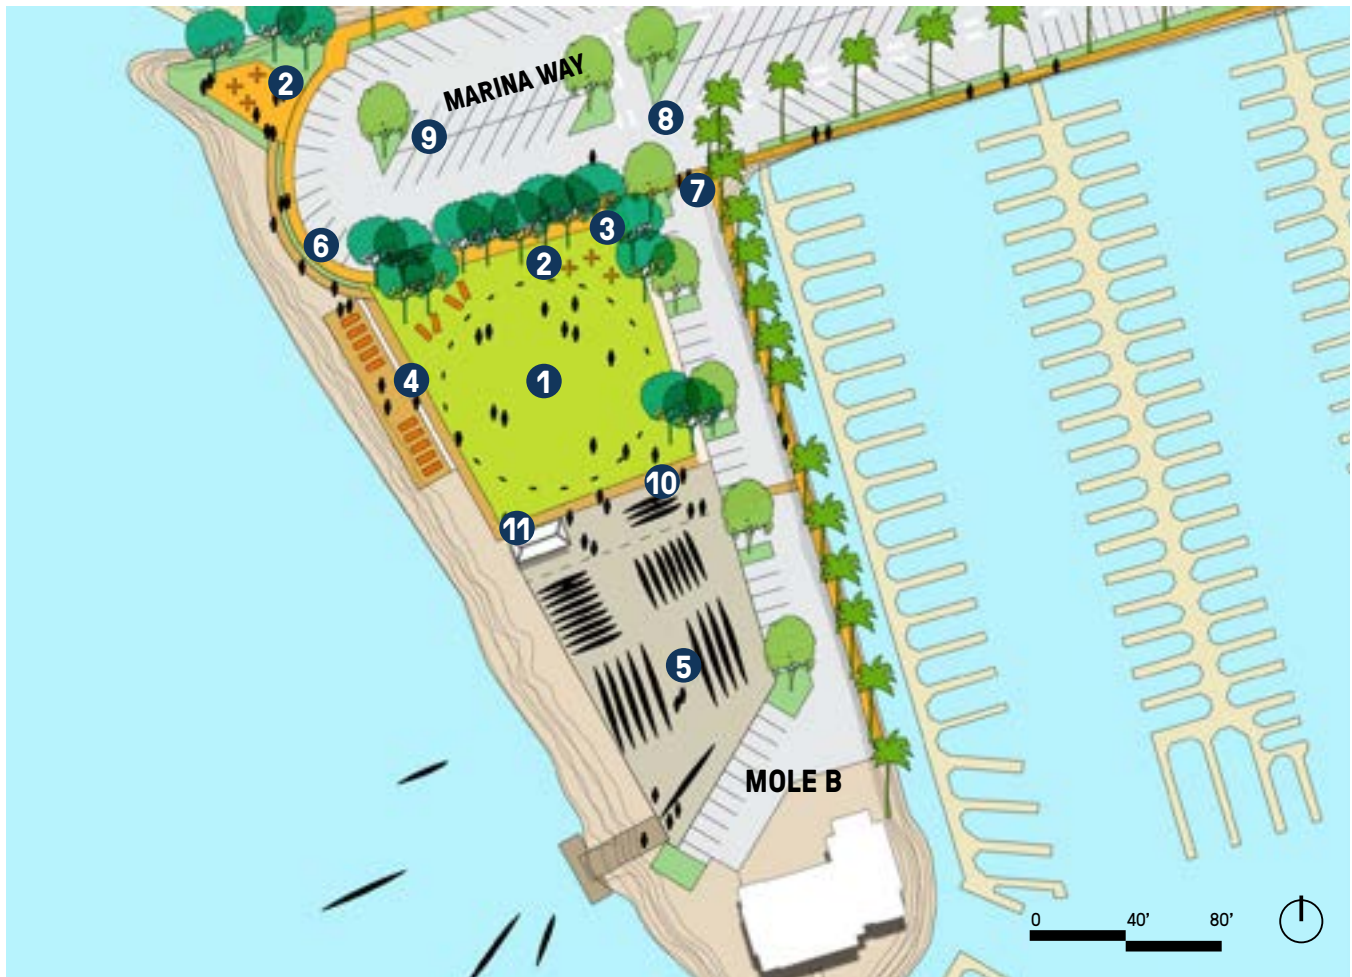
Moonstone Park | *New Public Hand Launch & Outrigger Club Expansion*

| 1 Open space | 7 Signage for free parking |
| 5 Existing outrigger canoe clubs | 11 Public restroom |
| 6 Connected path circulation | |

A helicopter clearance with a 110-foot radius is required for emergency landing. The plan incorporates this radius and ensures the area is clear of any trees or obstructions.

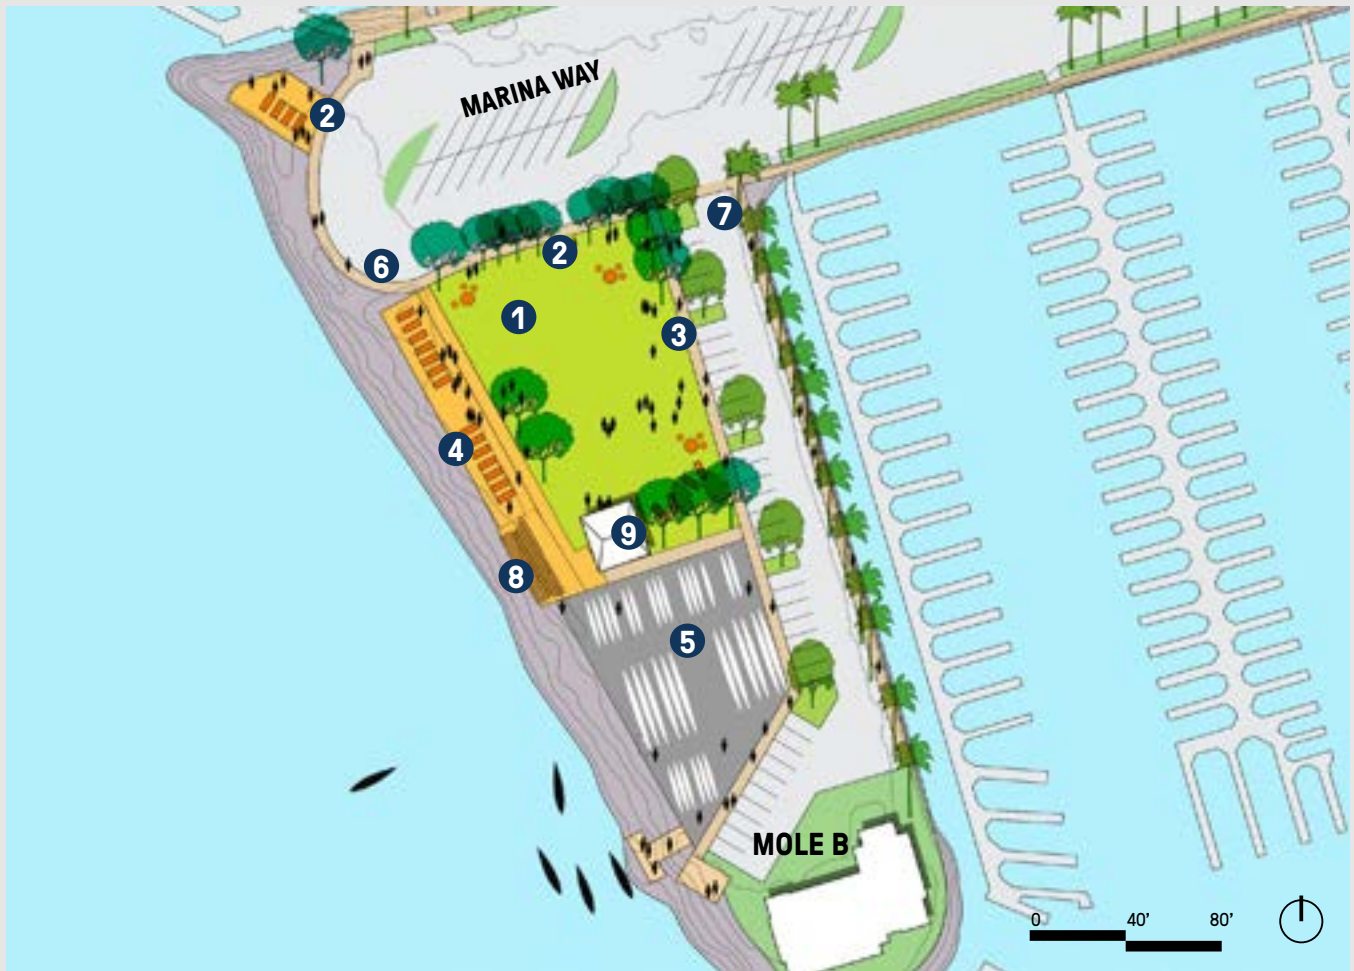
### Iteration Concept 1 | Enhanced Existing Park

- 1 Open space
- 2 Seating and tables
- 3 Trees and shade
- 4 Deck overlook
- 5 Existing outrigger canoe club
- 6 Connected path circulation
- 7 Signage for free parking
- 8 Stepped seating
- 9 Public restroom

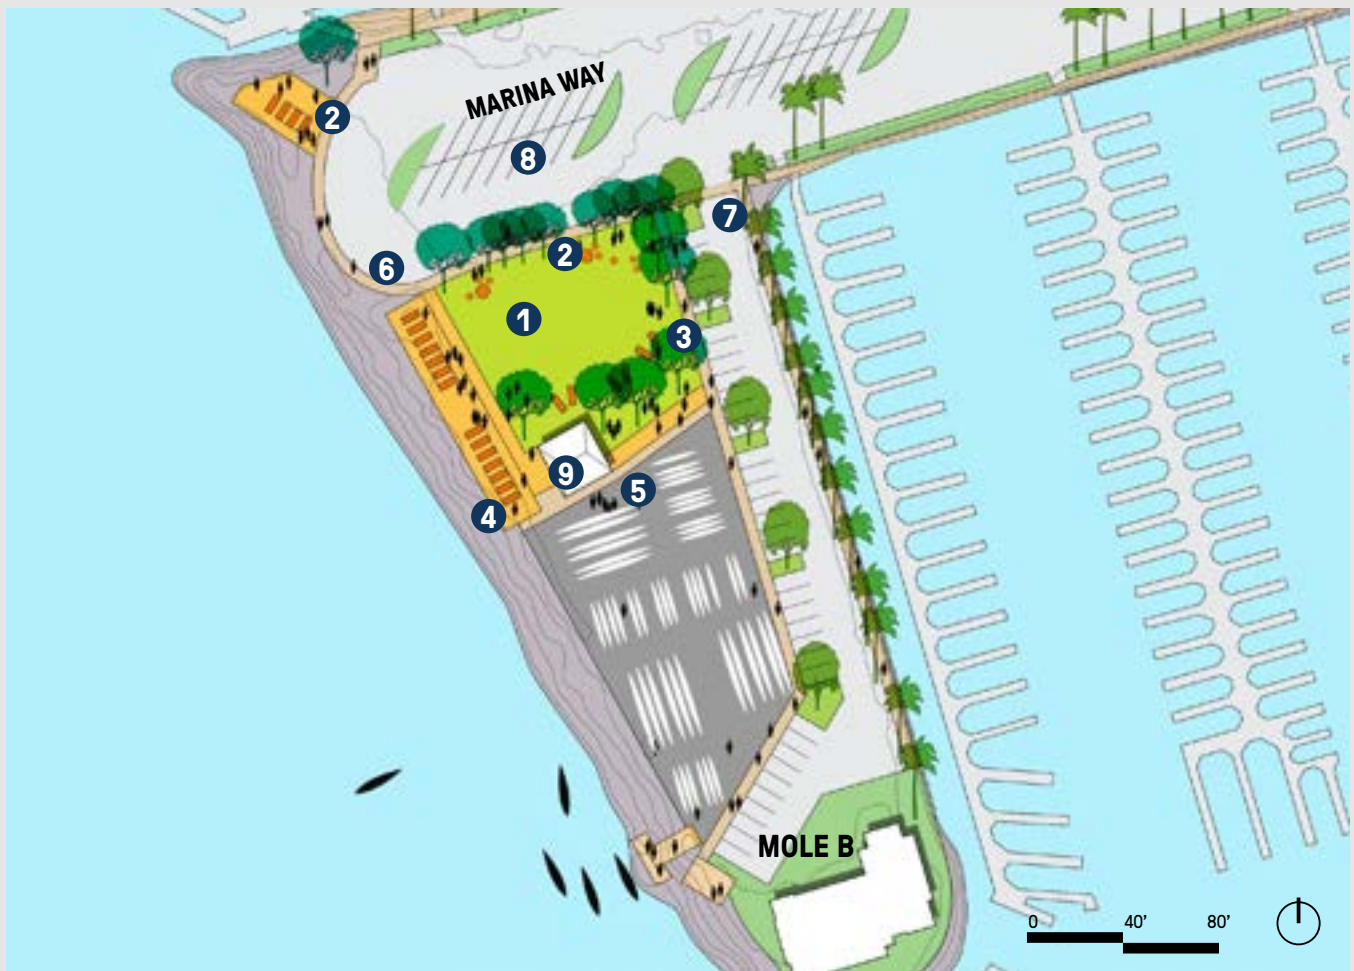
### Iteration Concept 2 | Enhanced Park with Outrigger Club Expansion

- 1 Open space
- 2 Seating and tables
- 3 Trees and shade
- 4 Deck overlook
- 5 Expanded outrigger canoe club
- 6 Connected path circulation
- 7 Signage for free parking
- 8 Trailer parking
- 9 Public restroom

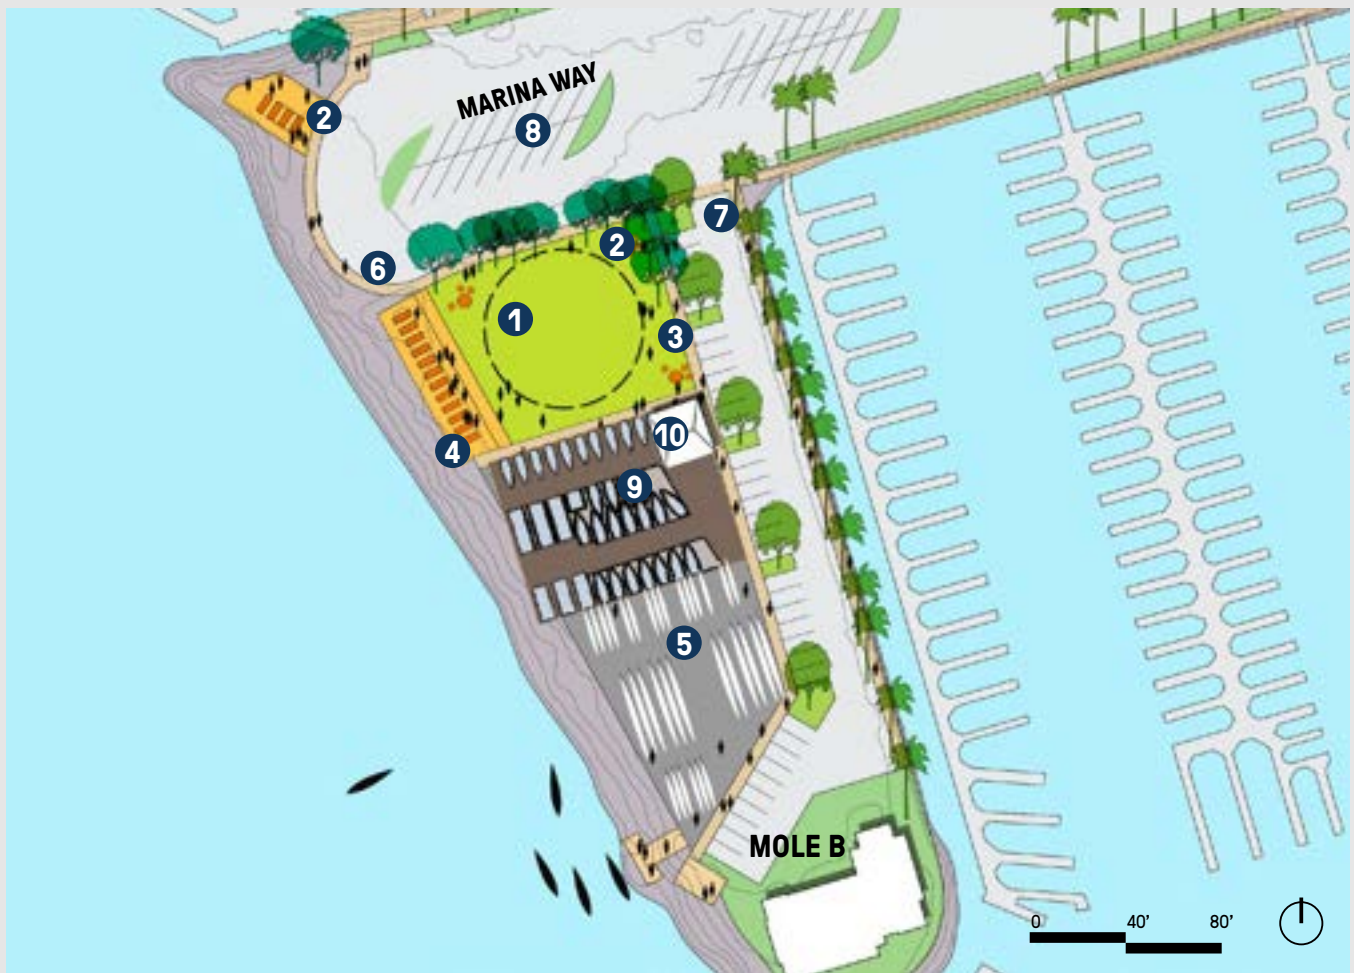
### Iteration Concept 3 | Minimal Park with Dry Boat Storage

- 1 Open space
- 2 Seating and tables
- 3 Trees and shade
- 4 Deck overlook
- 5 Existing outrigger canoe clubs
- 6 Connected path circulation
- 7 Signage for free parking
- 8 Trailer parking
- 9 New public boat storage
- 10 Public restroom

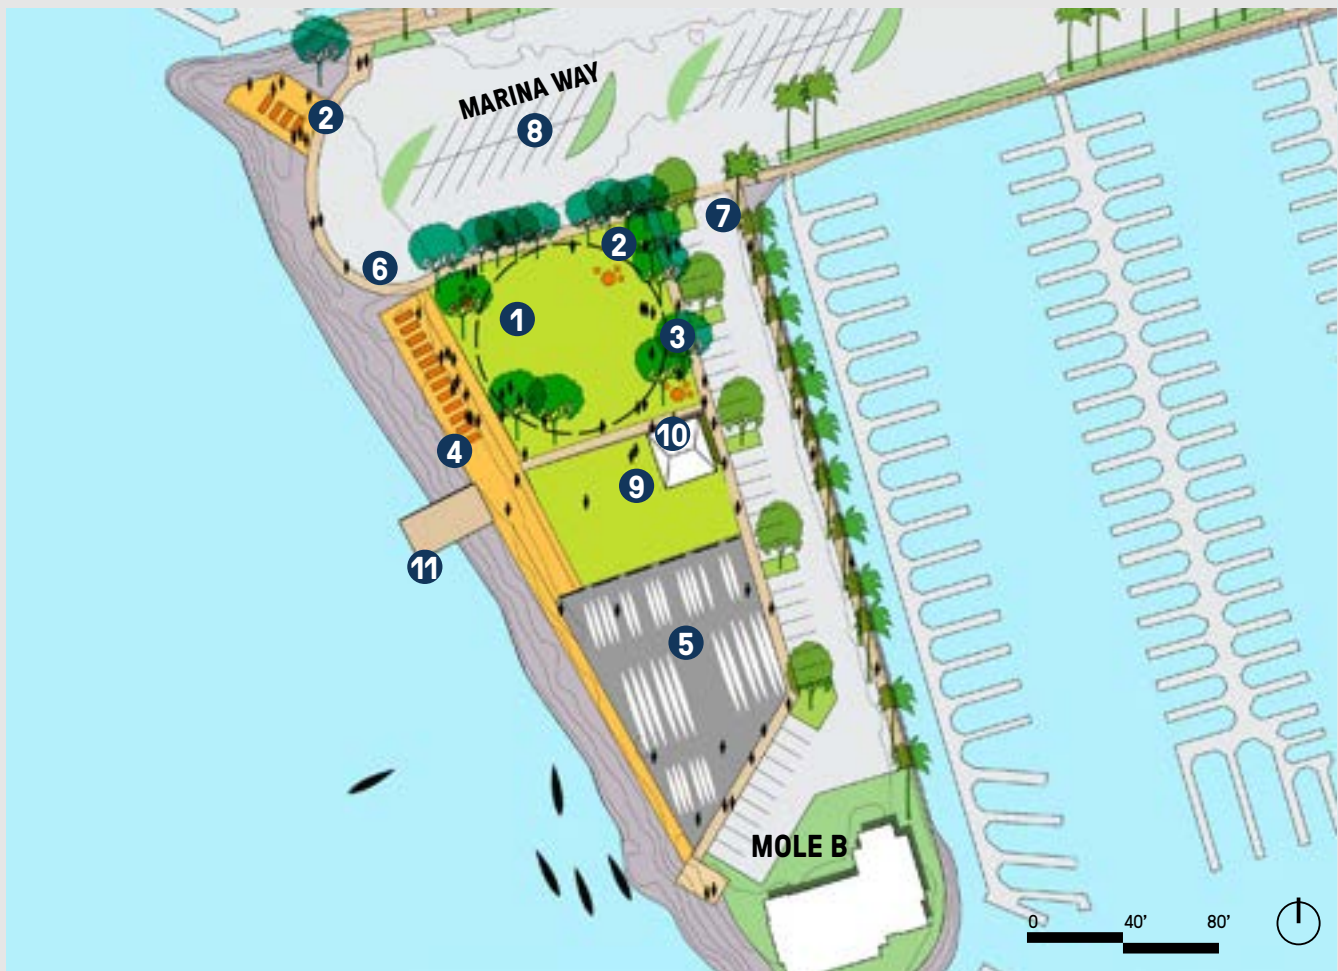
### Iteration Concept 4 | New Public Hand Launch & Outrigger Club Expansion

- 1 Open space
- 2 Seating and tables
- 3 Trees and shade
- 4 Deck overlook
- 5 Existing outrigger canoe club
- 6 Connected path circulation
- 7 Signage for free parking
- 8 Trailer parking
- 9 Shared-use lawn with outrigger clubs
- 10 Public restroom
- 11 New public Hand Launch

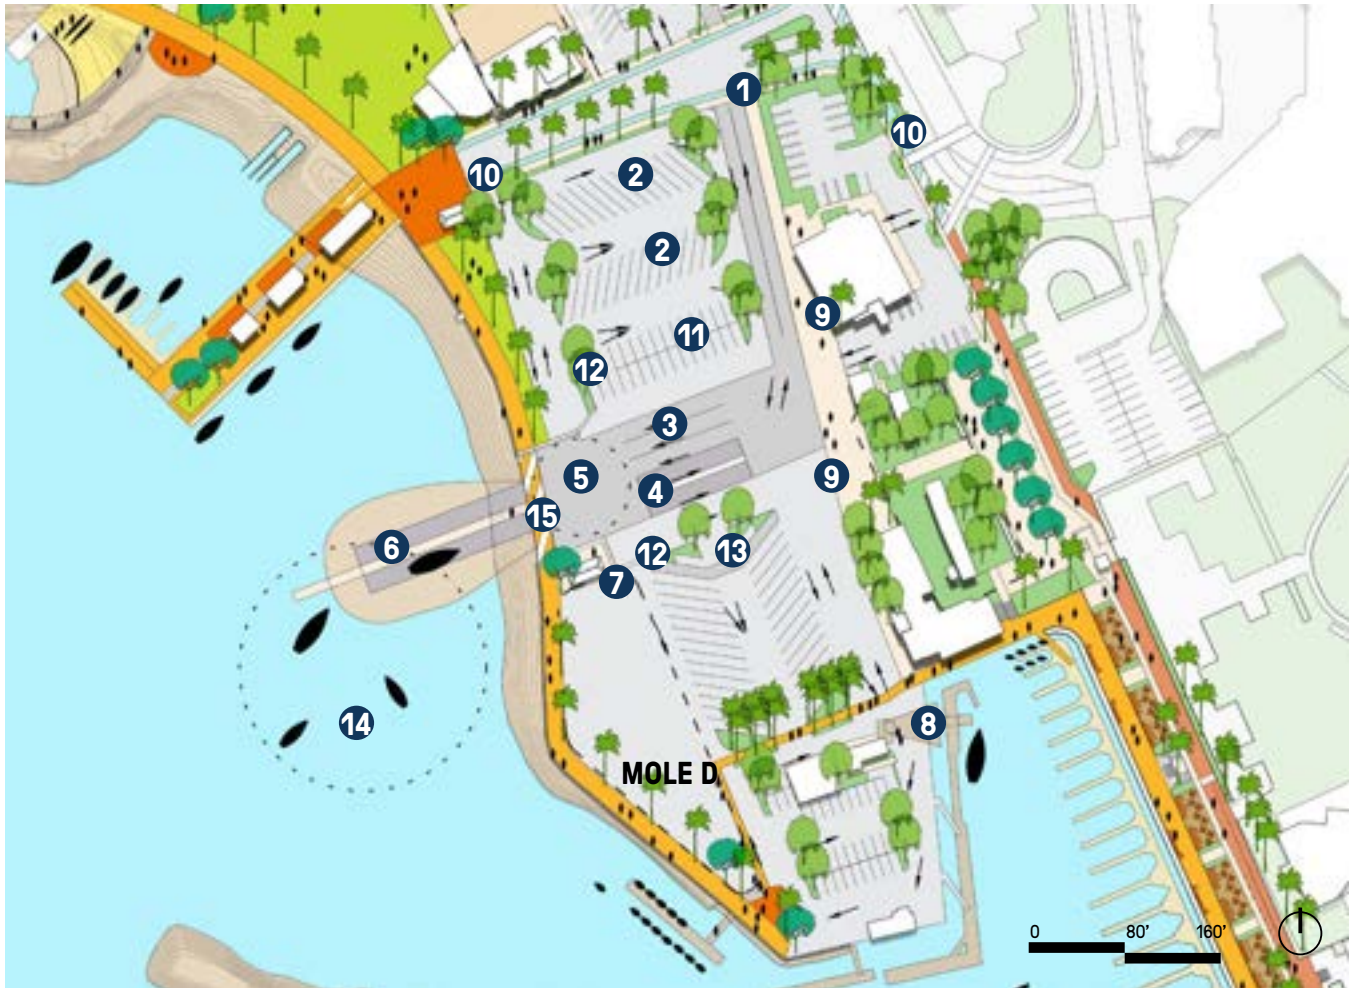
Public Boat Launch Park | *Beryl Street Entrance, Mole D Entry Drive Exit*

| 1 Trailer enter and exit | 9 Pedestrian path |
| 7 Public restroom and showers | 15 Striped pedestrian crossing |
| 8 Existing hoist | |

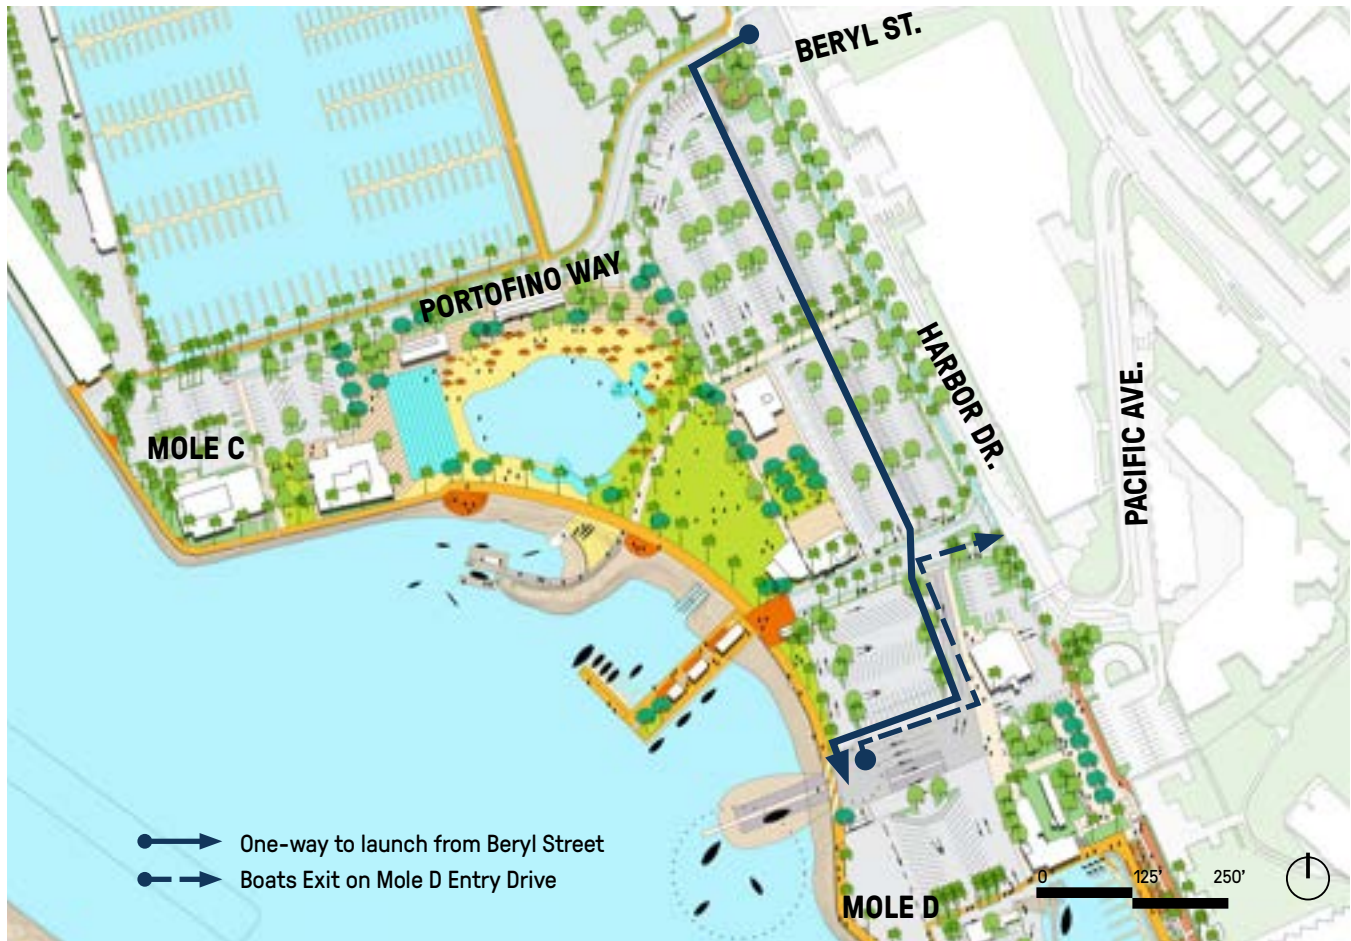
## Public Boat Launch | *Trailer Ingress and Egress Circulation*

### Turning Circle

The turning circle at the top of the boat launch has a diameter of 80 feet to comply with American Association of State Highway and Transportation Officials (AASHTO) Greenbook requirements for passenger vehicles/trucks with boat trailers. The minimum turning circle for a 19-foot-long vehicle pulling a 20-foot boat (42 feet overall length) is 48 feet in diameter, in accordance with Figure 2-31 in the AASHTO Greenbook, which is less than the minimum 60-foot turning circle specified in the 2021 DBW BLF Guidelines. The same vehicle pulling a 32-foot boat (54 feet overall length) requires a turning circle approximately 80 feet in diameter.

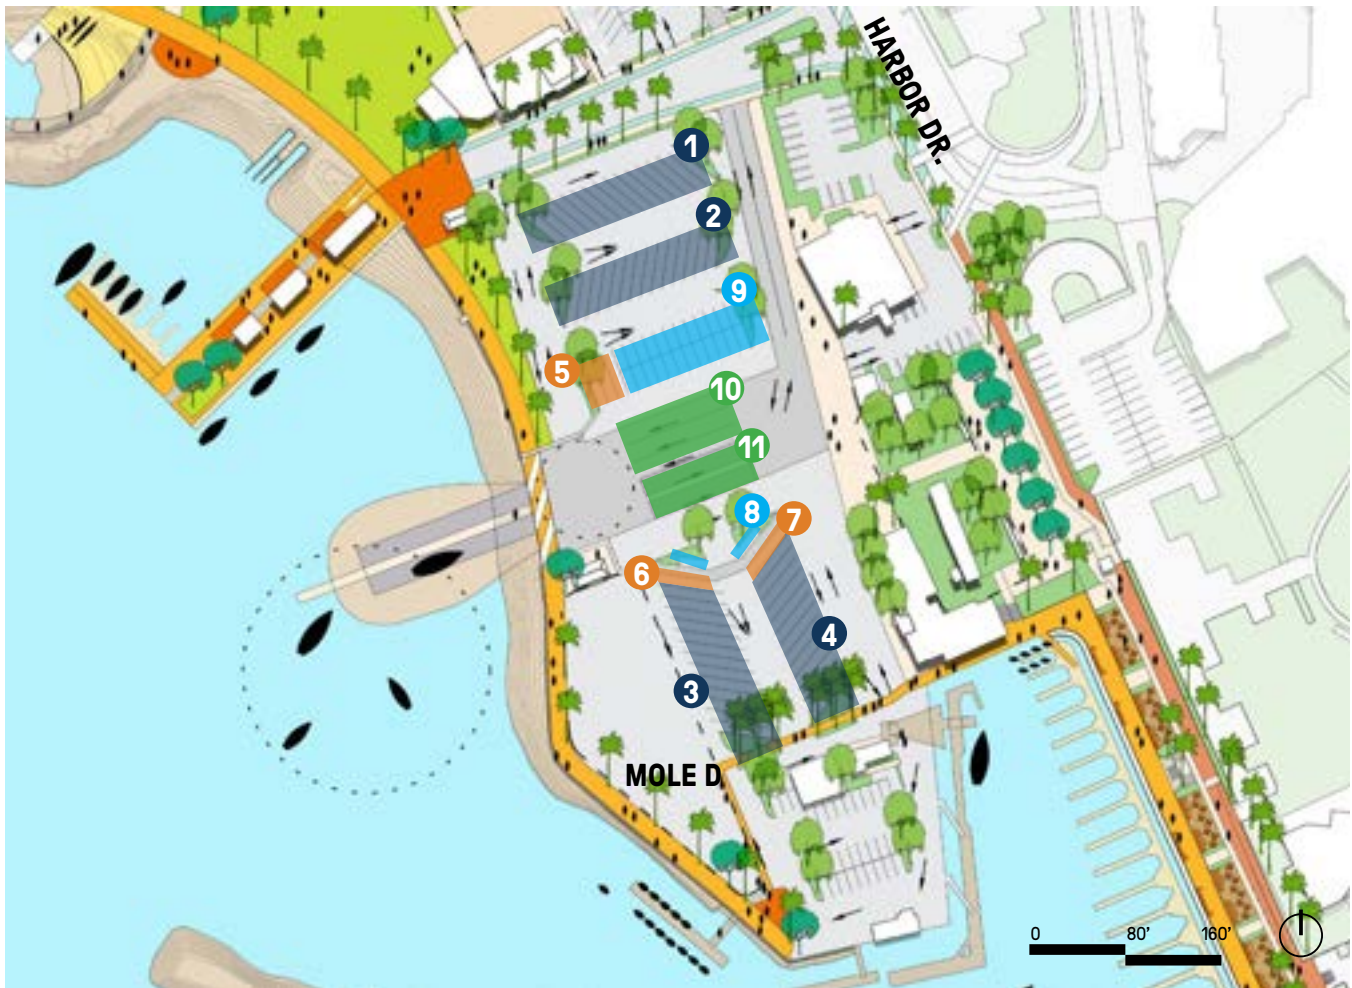
## Public Boat Launch Park | *Stall Allocation Counts*

### Trailer Stall Counts

- ① 15 stalls- 40' long
- ② 14 stalls- 40' long
- ③ 14 stalls- 55' long
- ④ 14 stalls- 45' long

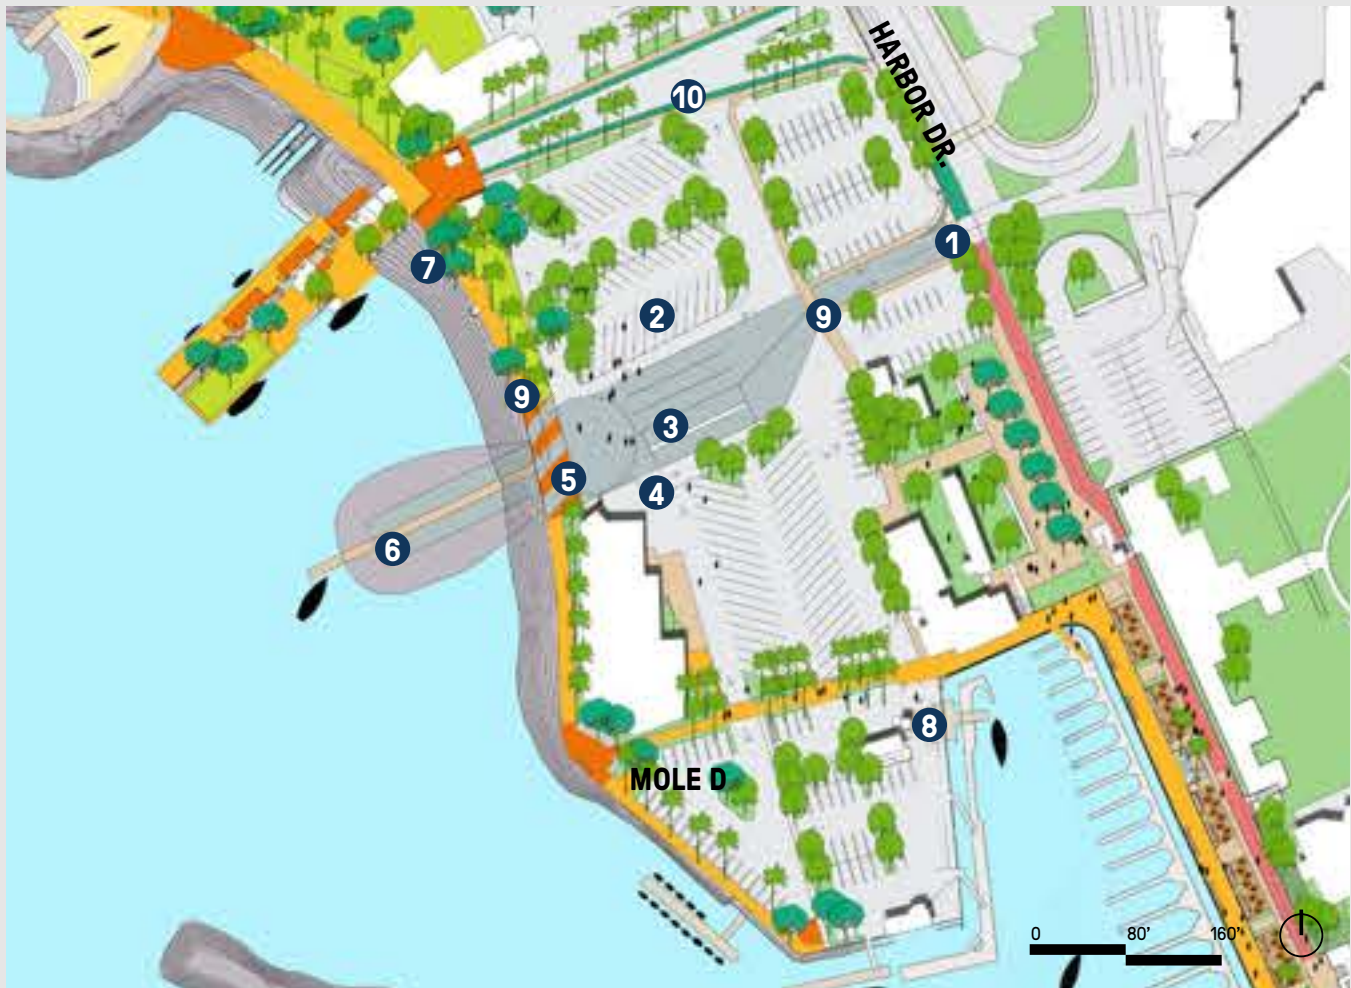
Iteration Concept 1 | Pacific Avenue Entrance, Mole D Entry Drive Exit

- 1 Trailer enter and exit
- 2 Trailer parking
- 3 Launch queuing lanes
- 4 Wash down lanes
- 5 Turning circle
- 6 Ramps
- 7 Public restroom
- 8 Existing hoist
- 9 Pedestrian crossover path
- 10 Car entry and exit

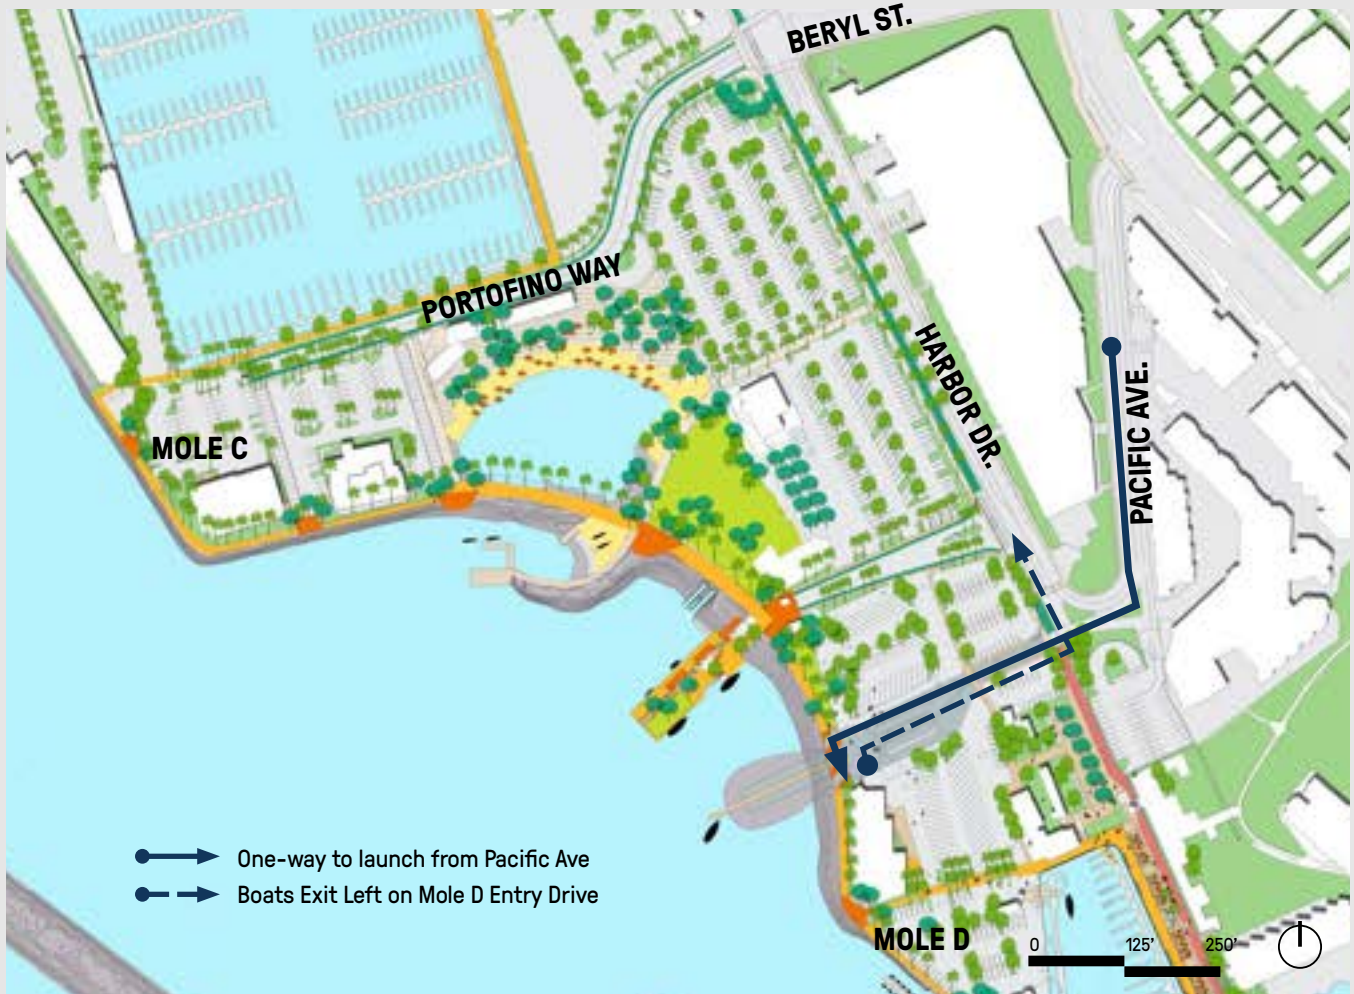
### Iteration Concept 1 | Trailer Ingress and Egress Circulation

### Iteration Concept 1 – Vehicular Circulation

Concept 1 proposes a new entrance from Pacific Avenue. Boats will enter via a dedicated lane that will cross through the existing Captain Kidd's building location. Captain Kidd's will continue operating, but will need to move to a new location within the Harbor. Benefits of having a Pacific Avenue entrance include: a boat queuing lane would be "off-site" on Pacific Avenue, pedestrian and bicycle conflicts would be minimized, and boat congestion on Harbor Drive in the AM peak hours would be minimized. Concerns with this iteration include traffic impacts on Pacific Avenue, the need for Captain Kidd's to be relocated within the harbor, and the impact of new boat traffic on nearby neighbors.

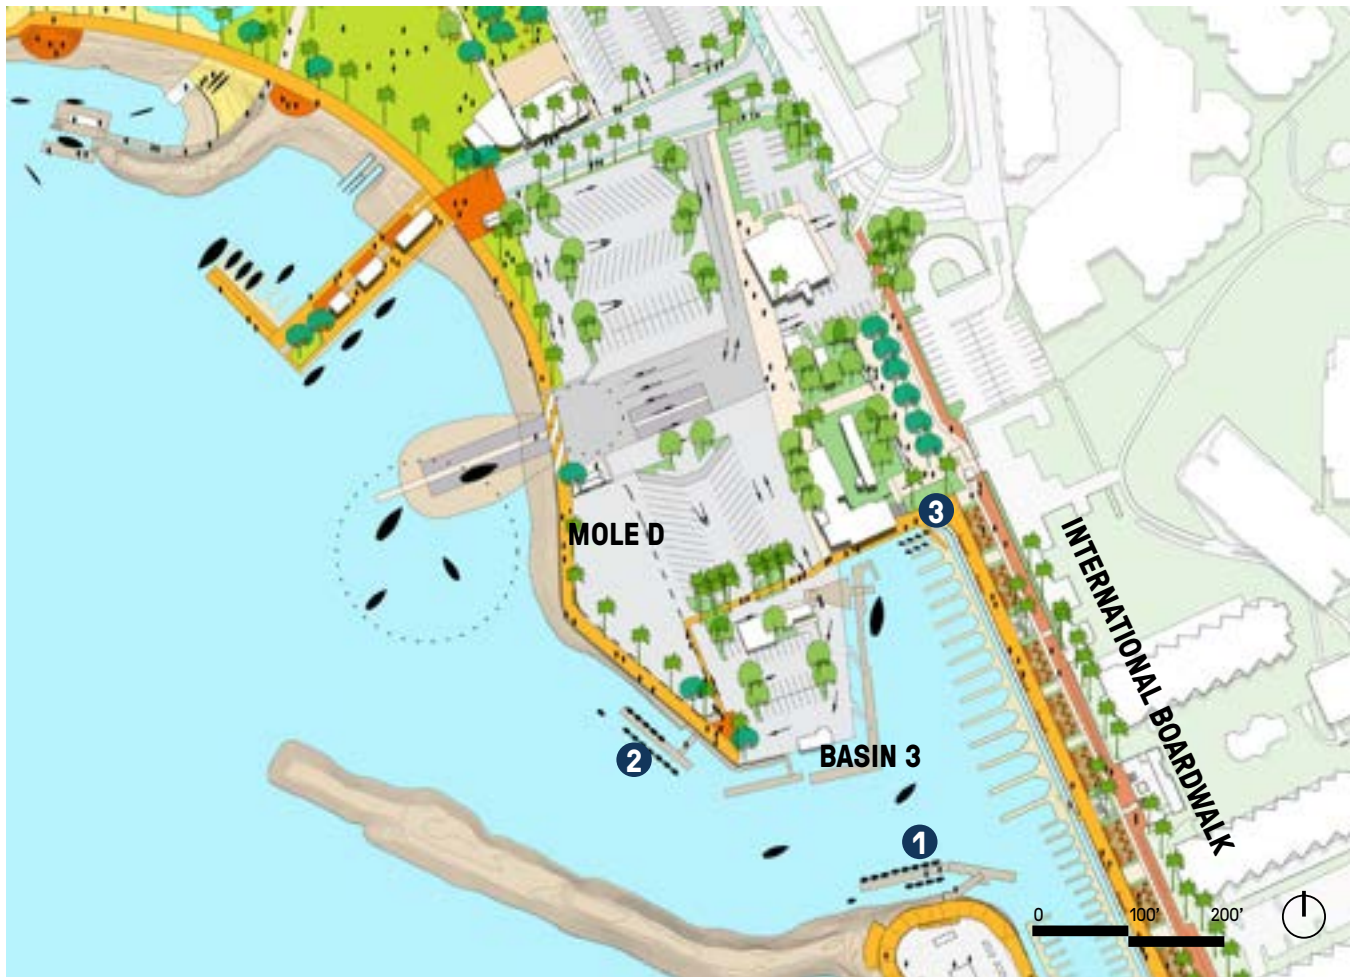
Dinghy Dock | *Proposed Locations*

- ① Expansion of existing excursion launch
- ② Near proposed boat launch
- ③ Northern slip within Basin 3

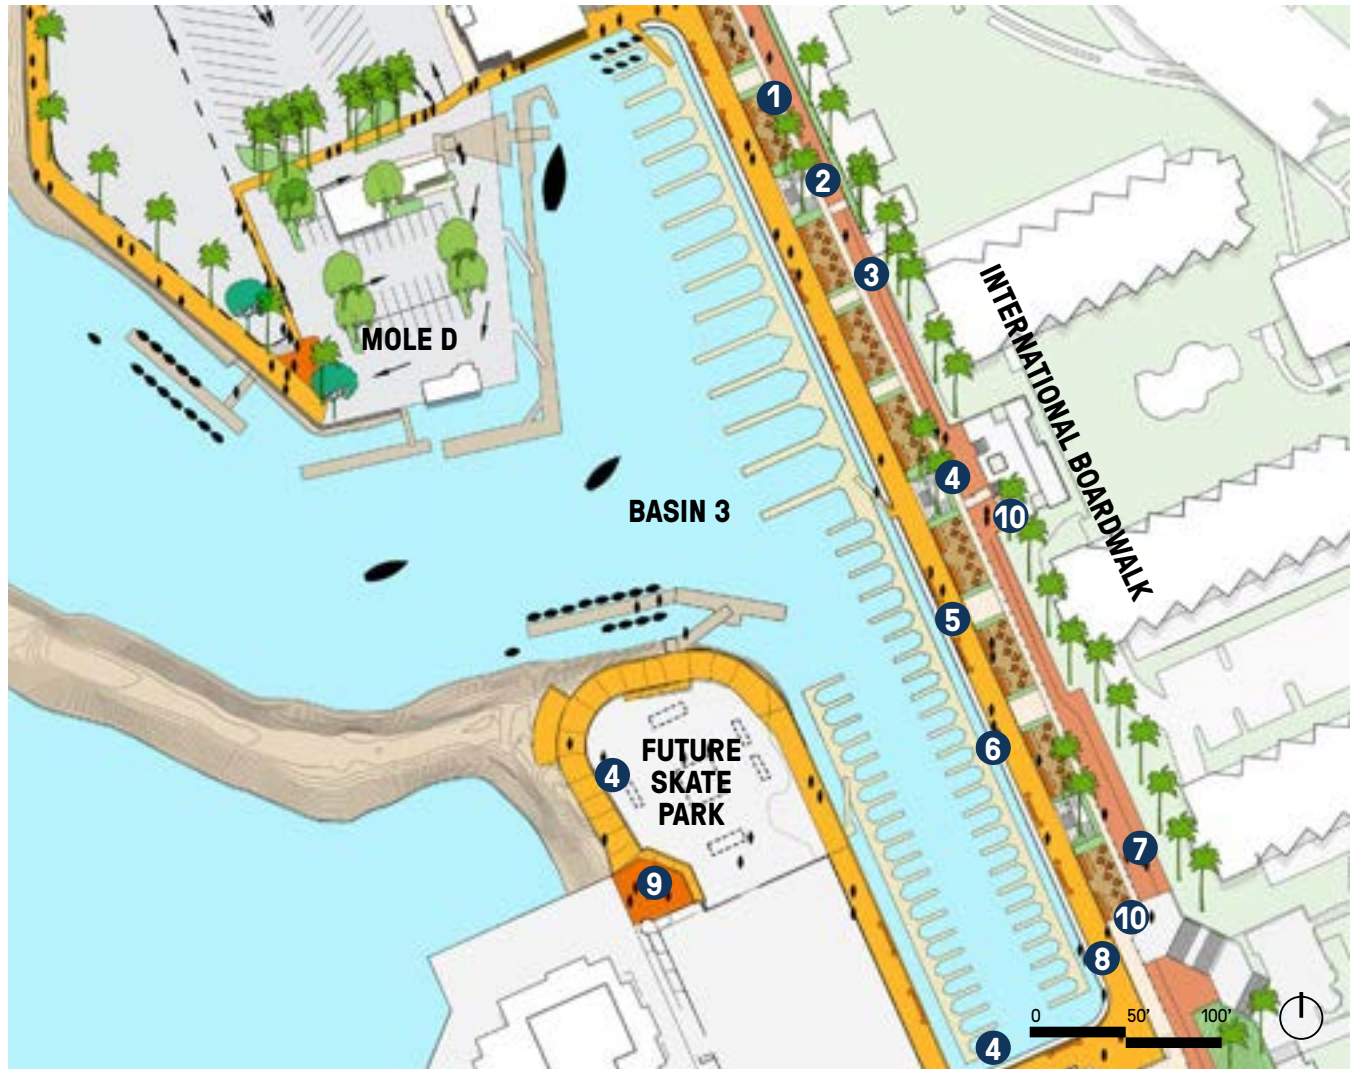
International Boardwalk | *Revitalized Boardwalk and Amenities*

- 1 Upper deck dining spaces
- 2 Prominent staircases to upper deck
- 3 Viewing decks
- 4 Updated restrooms
- 5 Pathway improvements
- 6 Revised sea wall design
- 7 Separation of pedestrian and bike path
- 8 Improvements to furnishings
- 9 Node: improved connection to Horseshoe Pier
- 10 Additional bike parking nodes

International Boardwalk will receive improvements that allow its foundational infrastructure to remain intact. As part of the Phase 1 upgrade, updates to the International Boardwalk include pathway improvements, updated signage, and improved furnishings to enhance the user experience. It is important to embrace the local charm of International Boardwalk and not to over-design the space.

Prioritization of immediate improvements to International Boardwalk will provide an enhanced visitor experience. A new, repaved pathway along the boardwalk (in front of the restaurants) provides much-needed cosmetic improvements. Along the path updated seating, tables, planters, and lighting provide a design refresh. Designs should avoid blocking views from restaurants at the lower levels. Updated restrooms at all three locations on International Boardwalk are also recommended.

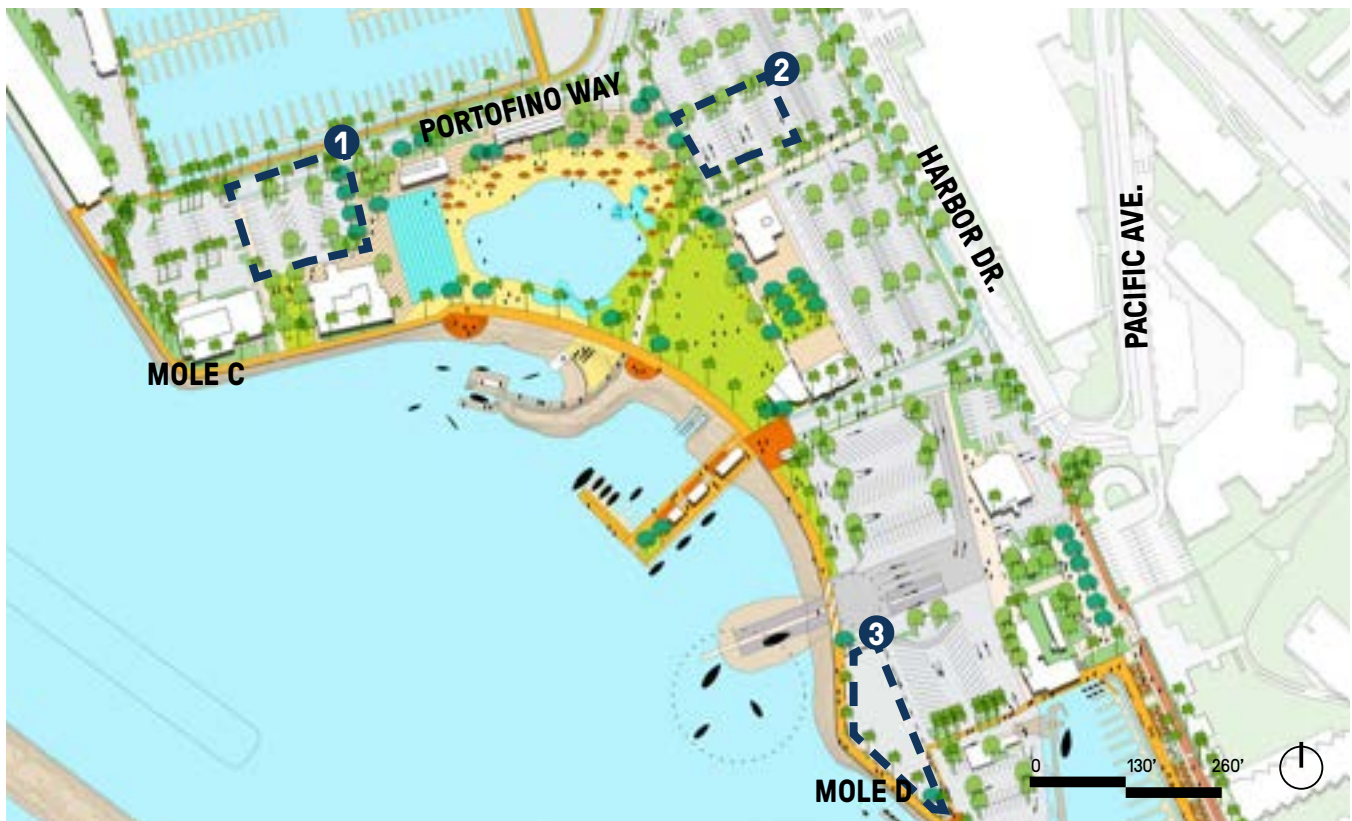
Three locations have been identified as potential future dry boat storage if the market demands a location

- ① Parking lot of future educational center
- ② Parking lot of Seaside Lagoon
- ③ Near future boat launch at Samba by the Sea

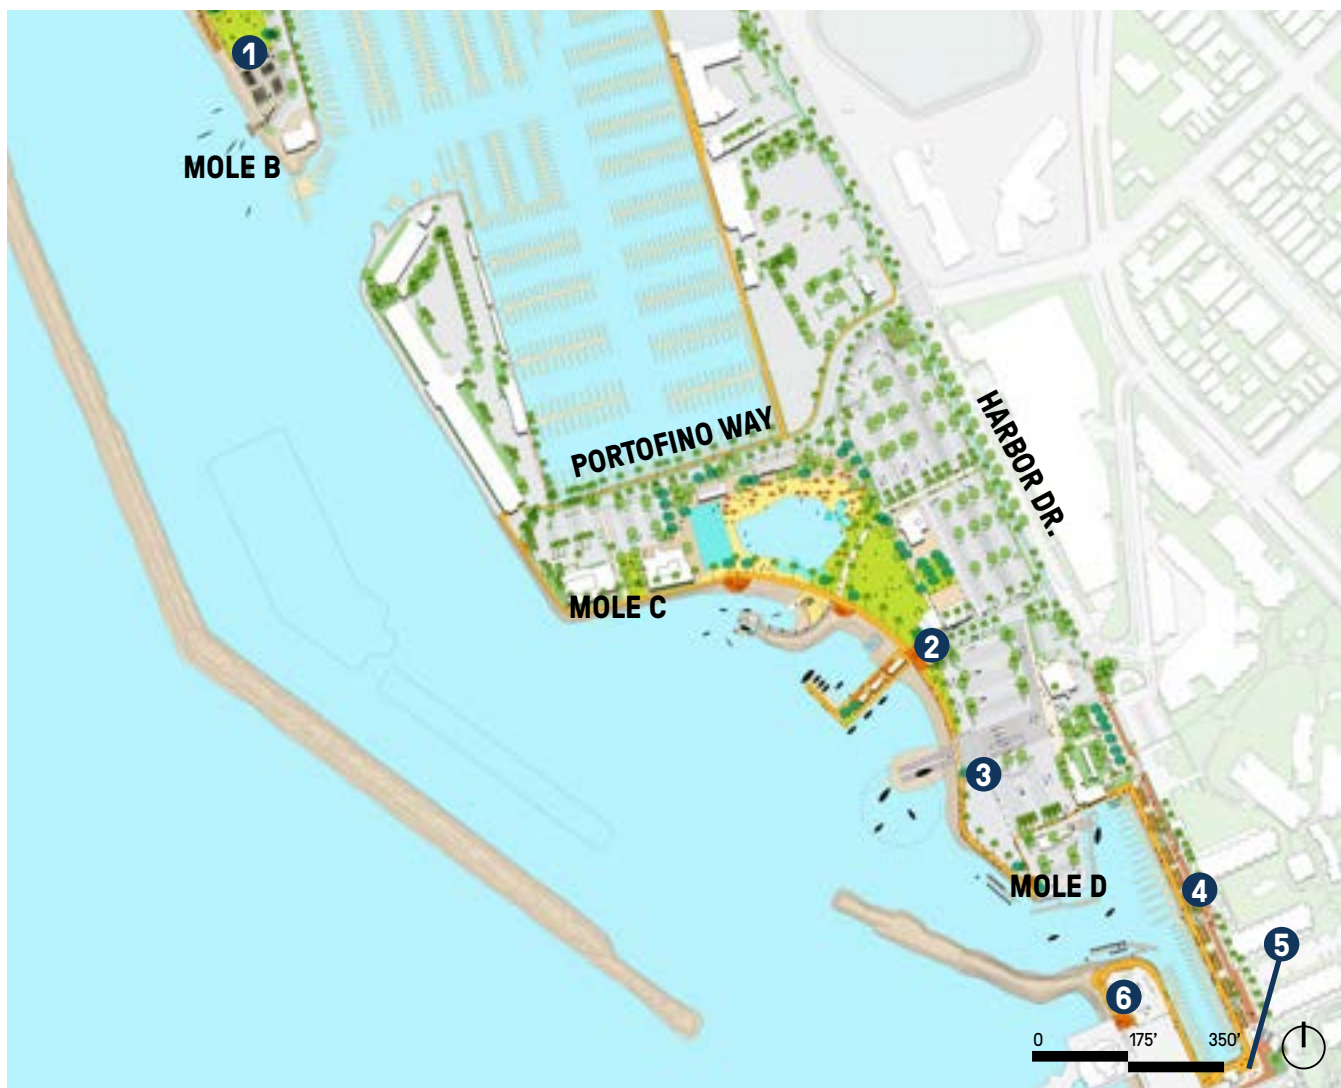
Public restrooms, existing and planned

- 1 New Restroom: Bathroom and Shower
- 2 New Restroom: Bathrooms Only
- 3 New Restroom: Bathroom and Shower
- 4 Renovated Restrooms
- 5 Renovated Restrooms
- 6 Renovated Restrooms

Public restrooms were the number-one missing amenity based off of the first community survey. Two locations are recommended to offer showers, at Moonstone Park and near the Public Boat Launch. The three new bathroom locations include:

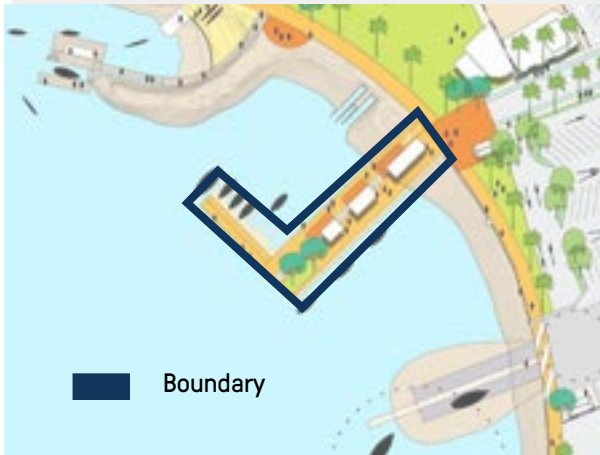
| SHORT PIER | | | | | | |

| SHORT PIER | | | | | | |
|---|--|---|---|---|---|---|
| | | New Fixed Pier | | | | |
| | | Steel Pier Piles | 60 | EA | \$28,028.00 | \$1,681,680 |

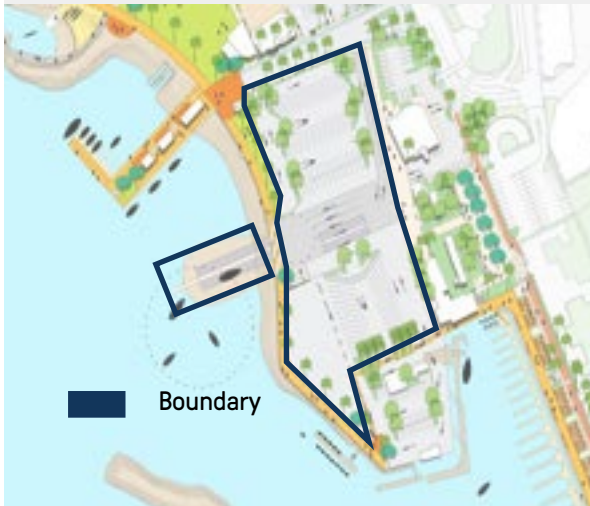
PUBLIC BOAT LAUNCH

Construction Cost Detail: Public Boat Launch Continued

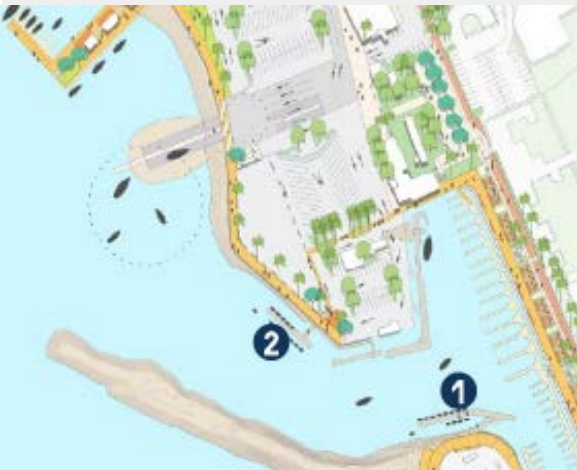
DINGHY DOCK

| Site Controls | Scope of Work | | | | Quantity | Unit | \$ / SF | Total Cost |
|---|---|--|--|---|---|---|---|---|
| <div>Proposed Locations</div> <div>Hardscape1,872 SF100%</div> <div>Landscape</div> <div>Total1,872 SF</div> <div>Notes and Assumptions</div> <div>Scope: Proposed dinghy dock locations</div> <div>Demolition: n/a</div> <div>Non-demolition: Dinghy docks</div> <div>Utilities: Square footage reflects the total square footage of scope boundary</div> <div>Hardscape: n/a</div> <div>Landscape: n/a</div> <div>Site Furnishings: n/a</div> <div>Site Structures: n/a</div> <div>Special Structures: As noted as separate docks, north and south</div> | <b>Demolition</b> | | | | <b>1,872</b> | <b>SF</b> | | |
