# KING HARBOR

PUBLIC AMENITIES PLAN

## King Harbor Public Amenities Plan 100% Draft for City Council Approval

#### **SWA Group**

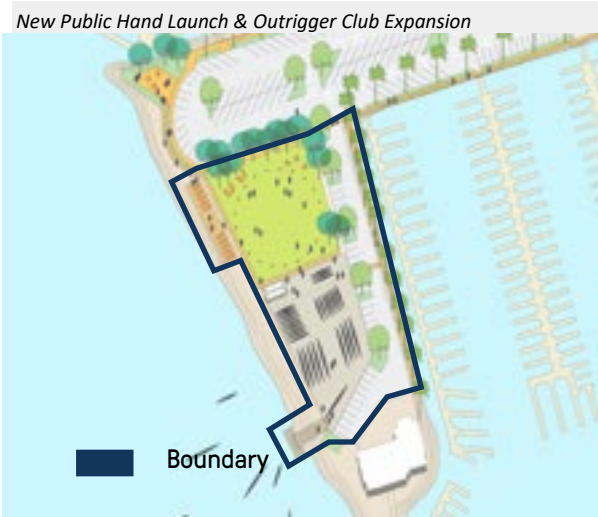
| MOONSTONE PARK | | | | | | | | |
|---|--|---|---|---|---|---|---|---|
| <div><div>New Public Hand Launch &amp; Outrigger Club Expansion</div><div><div>Building Footprint</div><div>2,706 SF</div><div>7%</div></div><div><div>Hardscape</div><div>19,565 SF</div><div>48%</div></div><div><div>Landscape</div><div>18,547 SF</div><div>45%</div></div><div><div>Total</div><div>40,818 SF</div></div></div> | | | <b>Demolition</b> | | <b>40,818</b> | <b>SF</b> | <b>\$3.00</b> | <b>\$122,454</b> |
| <div><div>Notes and Assumptions</div><div>Scope: Existing open lawn, parking, and outrigger clubs</div><div>Demolition: Existing open lawn</div><div>Non-demolition: Parking and outrigger clubs</div><div>Utilities: Square footage reflects the total square footage of scope boundary</div><div>Hardscape: Includes new colored concrete, repaved asphalt due to existing condition, and artificial turf for outrigger clubs</div><div>Landscape: Assumes 20% 15-gallon, 40% 5-gallon, 40% 1-gallon plant mix in shrubs areas at 24" on center spacing, includes basic irrigation system and controls, new open lawn</div><div>Site Furnishings: Includes seating, trash receptacles, bike racks, drinking fountains, general signage, and art</div><div>Site Structures: Includes faux wood deck overlook, three concrete steps, railing, and new public restroom with shower</div></div> | | | | | | | | |

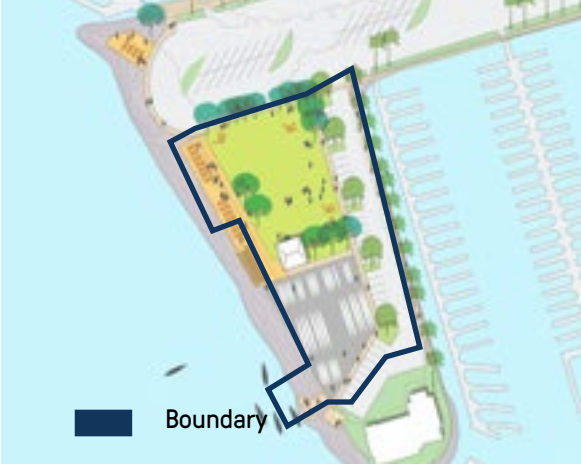
MOONSTONE PARK - ITERATION CONCEPT 1

| Site Controls | | | Scope of Work | | Quantity | Unit | \$ / SF | Total Cost |
|---|--|--|---|--|---|---|---|---|
| <p>Concept 1 - Enhanced Existing Park</p> <p>Building Footprint 4,031 SF 10%</p> <p>Hardscape 20,037 SF 47%</p> <p>Landscape 18,217 SF 43%</p> <p><b>Total 42,285 SF</b></p> <p><b>Notes and Assumptions</b></p> <p><u>Scope:</u> Existing open lawn, parking, and outrigger clubs</p> <p><u>Demolition:</u> Existing open lawn</p> <p><u>Non-demolition:</u> Parking and outrigger clubs</p> <p><u>Utilities:</u> Square footage reflects the total square footage of scope boundary</p> <p><u>Hardscape:</u> Includes new colored concrete and repaved asphalt due to existing condition</p> <p><u>Landscape:</u> Assumes 20% 15-gallon, 40% 5-gallon, 40% 1-gallon plant mix in shrubs areas at 24" on center spacing, includes basic irrigation system and controls, new open lawn</p> <p><u>Site Furnishings:</u> Includes seating, trash receptacles, bike racks, drinking fountains, general signage, and art</p> <p><u>Site Structures:</u> Includes faux wood deck overlook, three concrete steps, railing, and new public restroom with shower</p> | | | <b>Demolition</b> | | <b>42,285</b> | <b>SF</b> | <b>\$3.00</b> | <b>\$126,855</b> |

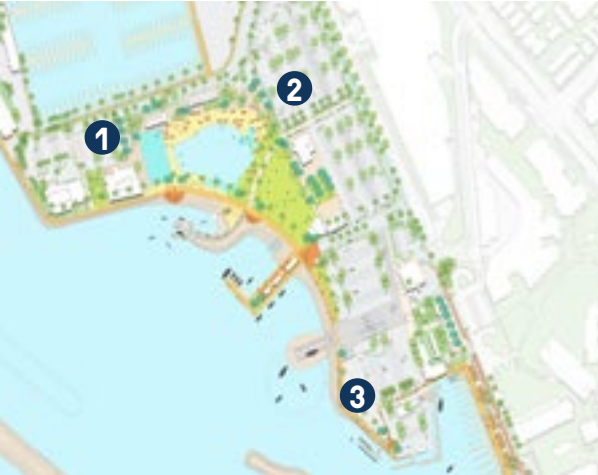
Design Options: Boat Storage Locations

Option 1: Boat Storage Space #1

| | Quantity | Unit | Unit Cost | Total |
|---|---|---|---|---|
| Patch and repair (E) asphalt paving | 18,996 | SF | \$4.00 | \$75,984 |
